PROJECT REPRESENTATIVE'S DAILY REPORT

Pg. 1
 Report No. 017
 Date: 2014-09-10
 Day: Wednesday

Architect: Kang Associates
Project: Renovation and Addition to Tewksbury Town Hall
OPM: CBI Consulting Inc. **Clerk of the Works:** Jeff Barnes
Contractor: G.V.W., Inc.

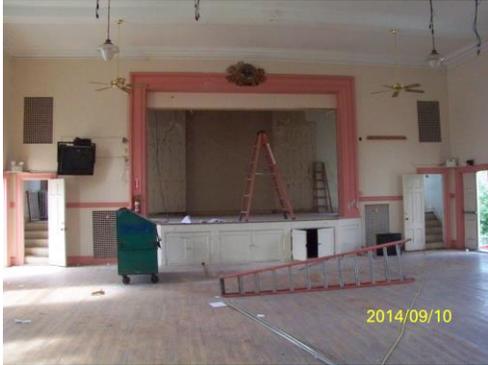
Photo showing the wall on the stage removed.

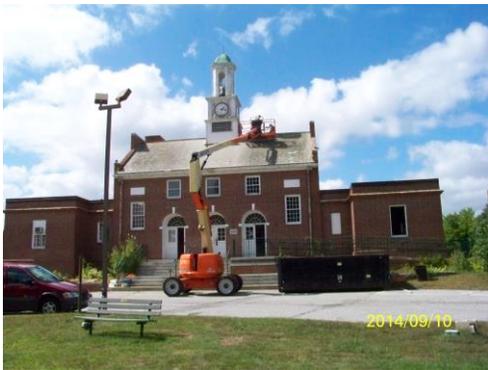
Photo showing workers prepping to install the roof jacks.

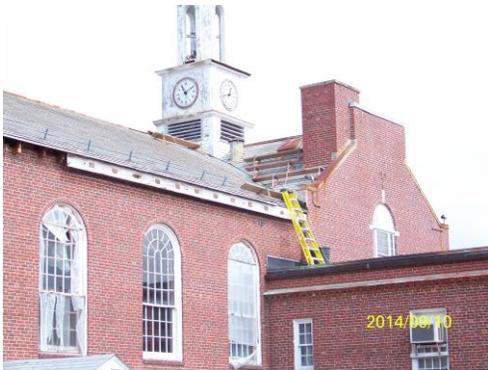
Photo showing roof jacks installed on the south elevation.

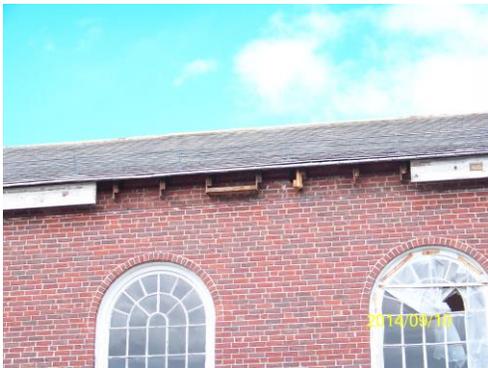
Photo showing removed fascia on the south elevation. This was removed to expose as-built conditions.

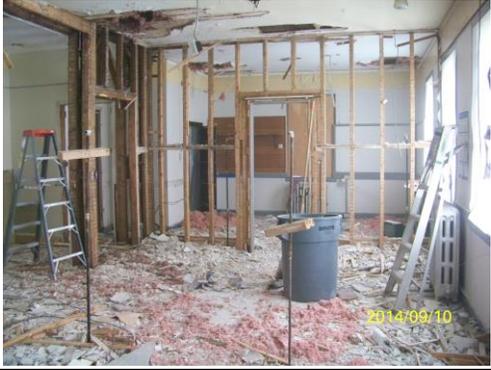
Photo showing demolition of the north wing on the first floor, looking west.

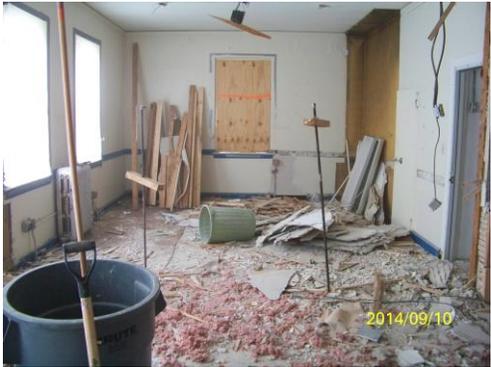
Photo showing the north wing looking east.

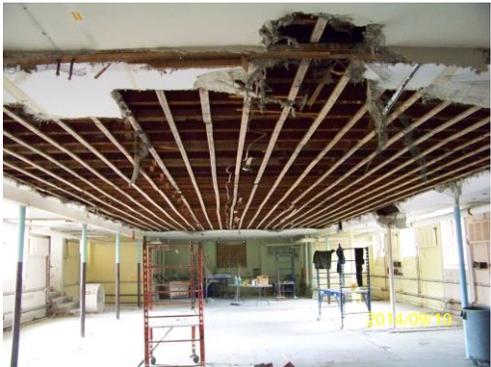
Photo showing the ceiling demolition in the basement.

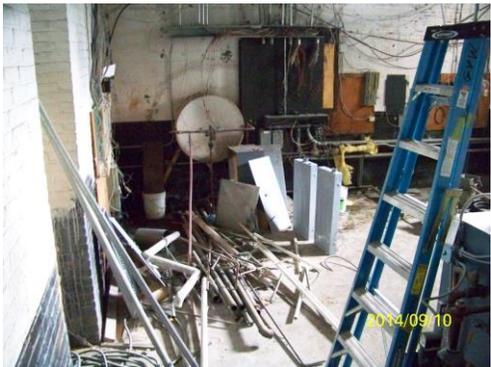
Photo showing pile of MEP debris from today's activities.
