PROJECT REPRESENTATIVE'S DAILY REPORT

Pg. 1
 Report No. 018
 Date: 2014-09-11
 Day: Thursday

Architect: Kang Associates
Project: Renovation and Addition to Tewksbury Town Hall
OPM: CBI Consulting Inc. **Clerk of the Works:** Jeff Barnes
Contractor: G.V.W., Inc.

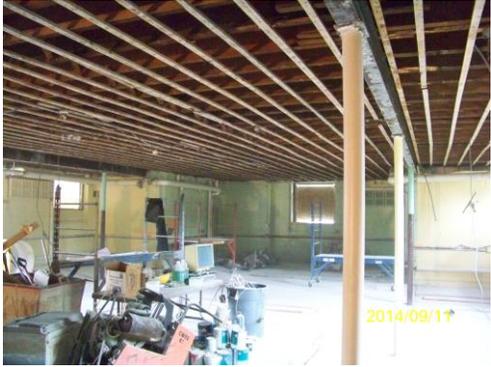
Photo showing ceiling demo underway in the basement.

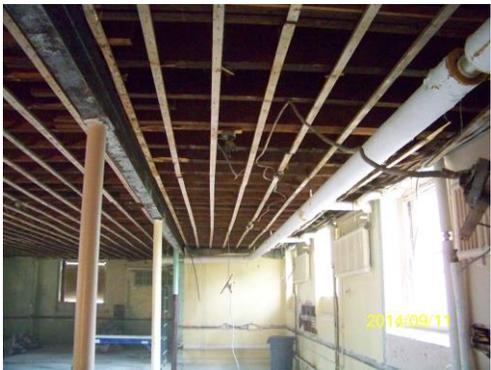
Photo showing ceiling demo looking east to west.

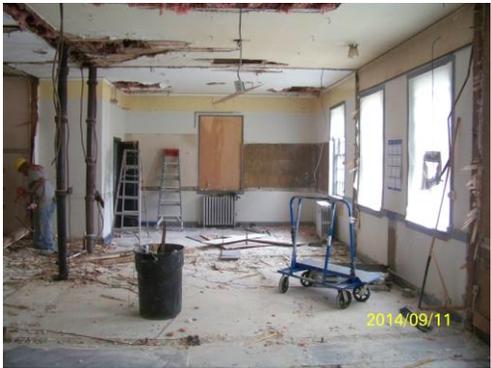
Photo of north wing demo looking north.

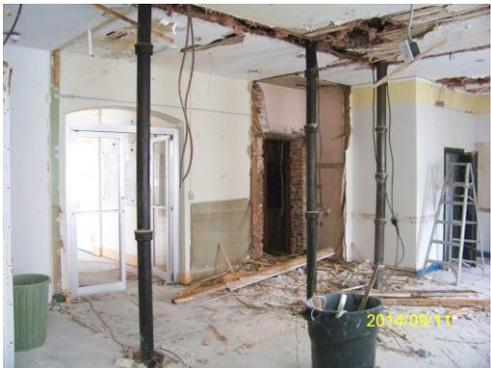
Photo of north wing demo looking northwest.

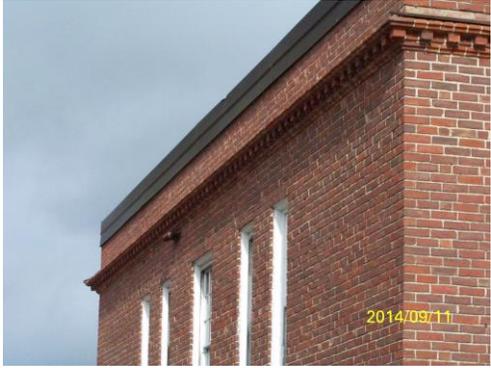
Photo showing water table along the south wing that has been removed.

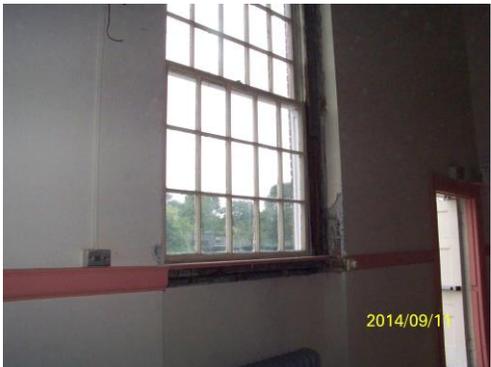
Photo showing some of the framing removed from around a window in the meeting hall.

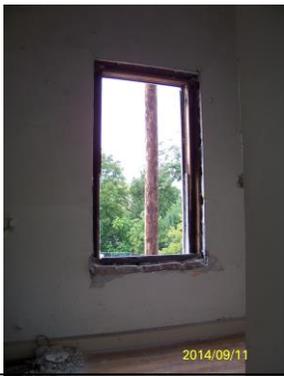
Photo showing the framing removed from around a window behind the stage.

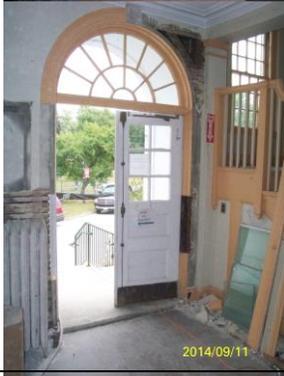
Photo showing some of the door frame removed at one of the front doors. This work revealed a large cavity behind the door frame on both sides.

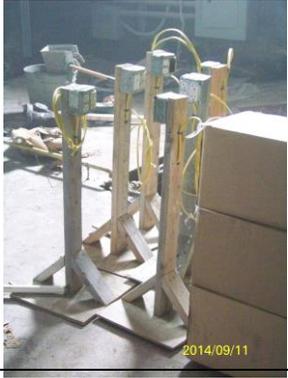
Photo showing some of the temp power stations the electrician created.
