# PROJECT REPRESENTATIVE'S DAILY REPORT

Pg. 1  
 Report No. 024  
 Date: 2014-09-19  
 Day: Friday

**Architect:** Kang Associates  
**Project:** Renovation and Addition to Tewksbury Town Hall  
**OPM:** CBI Consulting Inc. **Clerk of the Works:** Jeff Barnes  
**Contractor:** G.V.W., Inc.

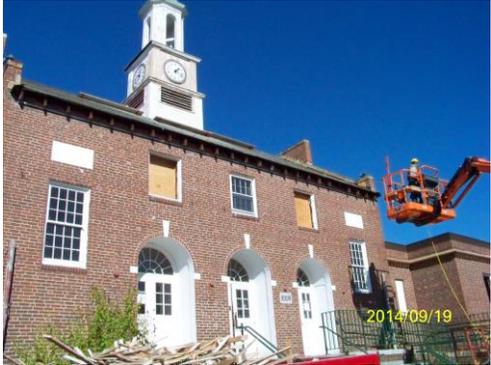
Photo showing the framework for the new fascia and soffit being installed along the east (front) elevation.

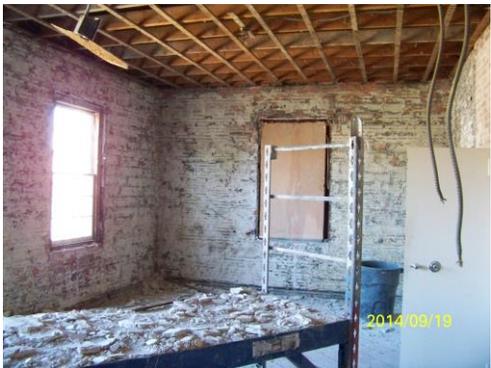
Photo showing the demolition of the north wing, first floor, in progress.

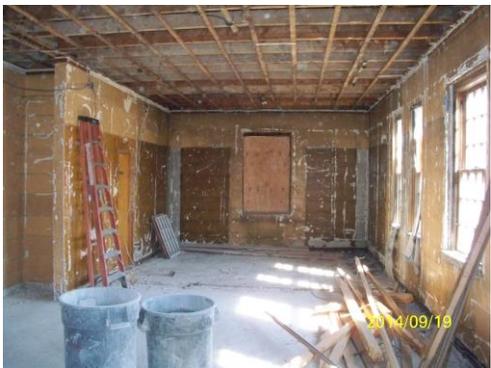
Photo showing the demolition of the south wing, first floor, in progress.

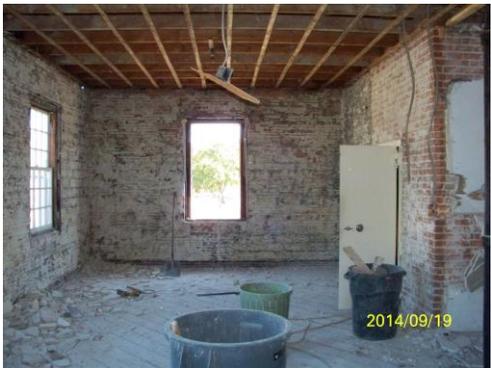
Photo showing north wing demolition, first floor.

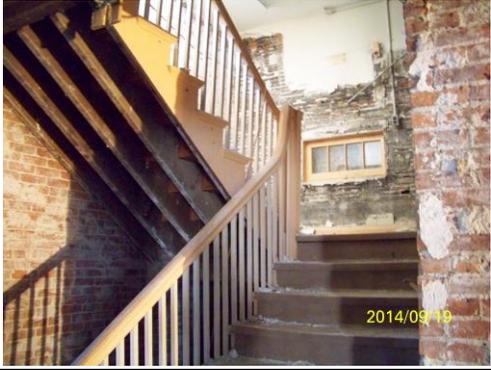
Photo showing demolition of north stairwell in progress.

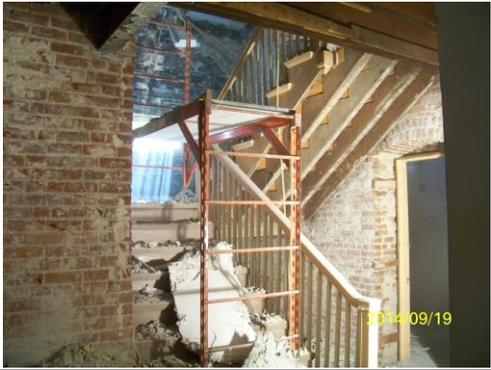
Photo showing demolition of the south stairwell in progress.

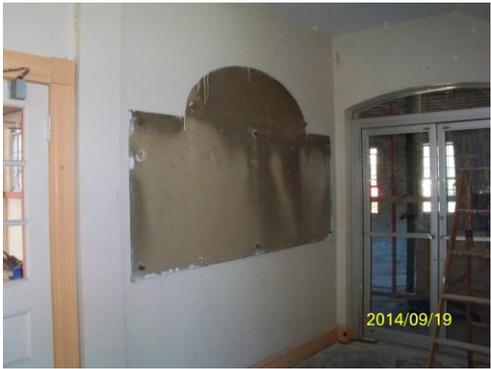
Photo showing (1) of (2) marble wall plaques removed.

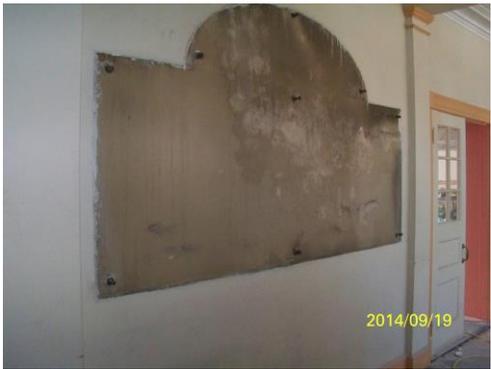
Photo showing the second wall plaque removed.

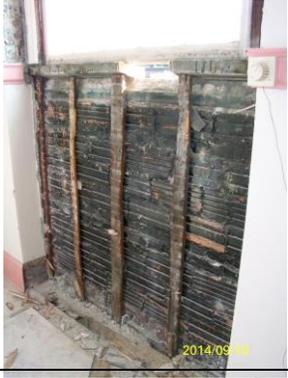
- 1) Carpenters started installation of framework for new fascia and soffit on the east (front) elevation.
- 2) Demolition is continuing in the basement: both stairwells are in the process of being demolished; flooring is being removed; one of the footings for an existing post was excavated. This excavation revealed a sand base. GVW would like the structural engineer to review this when he's on site Monday morning.
- 3) Demolition is continuing on the first floor, north and south wings.
- 4) The marble war memorial plaques were removed and stored.
- 5) Demo on the second floor offices started.
- 6) The conditions beneath the windows in the meeting hall will need to be reviewed by the architect as the existing conditions may require additional work in order to install the new windows.

Photo showing interior finish removed to expose the inside face of the exterior wall of a window in the meeting hall. This condition may require additional work in order to provide a suitable bearing condition for the new window. See 1/A12 for details.

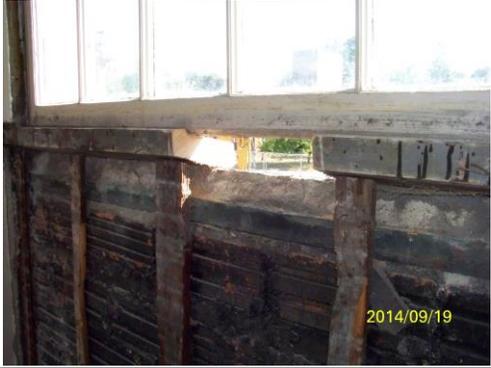
Photo showing close-up of existing window sill.
