PROJECT REPRESENTATIVE'S DAILY REPORT

Pg. 1
 Report No. 029
 Date: 2014-09-26
 Day: Friday

Architect: Kang Associates
Project: Renovation and Addition to Tewksbury Town Hall
OPM: CBI Consulting Inc. **Clerk of the Works:** Jeff Barnes
Contractor: G.V.W., Inc.

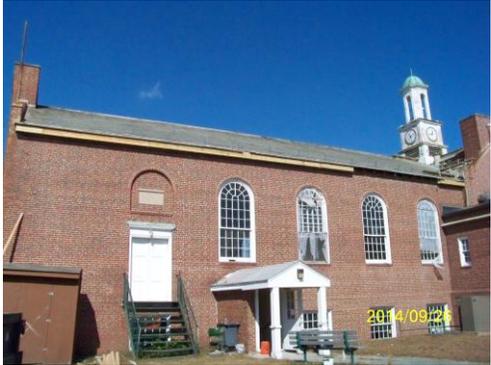
Photo showing the framework in place for the fascia and soffit on the south elevation.

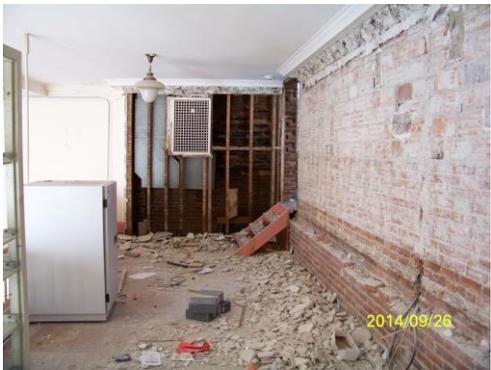
Photo showing demolition of the balcony looking north.

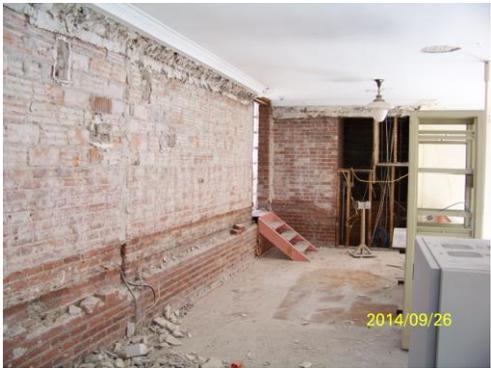
Photo showing demolition of the balcony looking south.

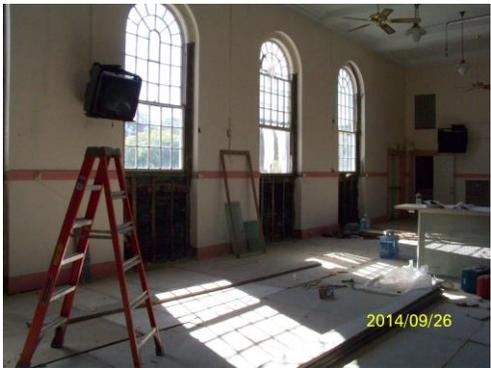
Photo showing demo of the finish beneath the windows along the south elevation of the meeting hall.

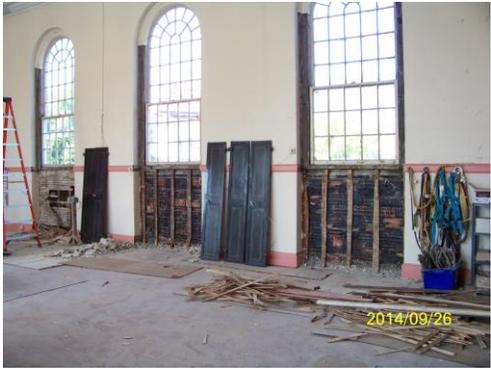
Photo showing finishes being demolished along the north meeting wall.

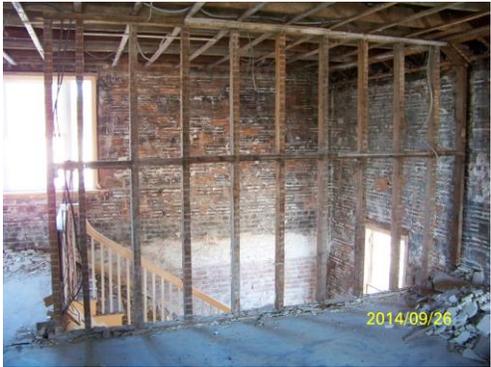
Photo looking into the north stairwell from the second floor.

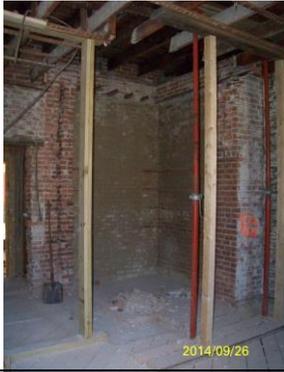
Photo showing a vault on the first floor completely demolished.

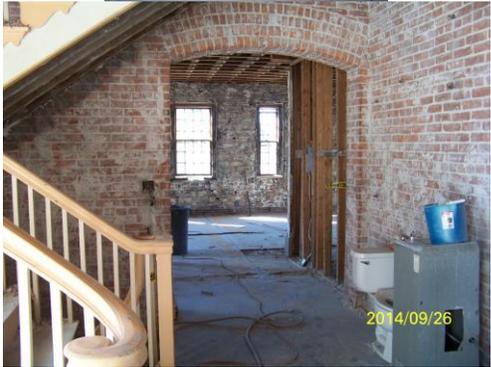
Photo looking into the south wing on the first floor.

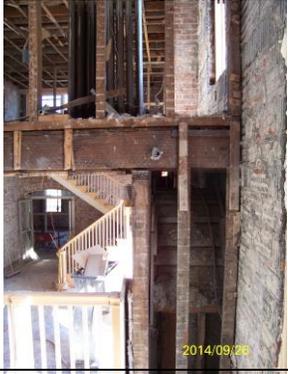
Photo of a cross section of the second floor above the lobby.

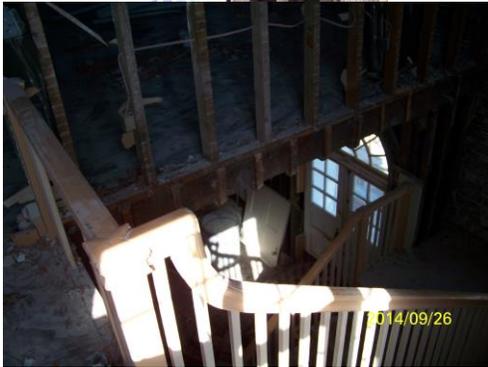
Photo looking down into the lobby from the south stairs.
