PROJECT REPRESENTATIVE'S DAILY REPORT

Pg. 1
 Report No. 030
 Date: 2014-09-29
 Day: Monday

Architect: Kang Associates
Project: Renovation and Addition to Tewksbury Town Hall
OPM: CBI Consulting Inc. **Clerk of the Works:** Jeff Barnes
Contractor: G.V.W., Inc.

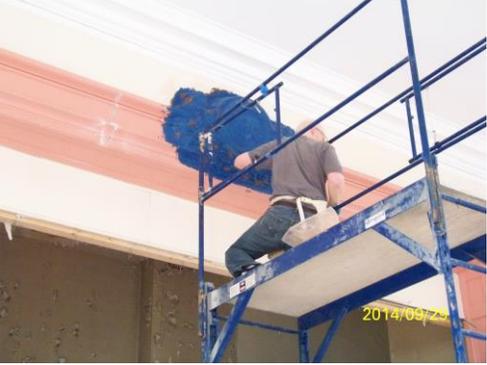
<p>Photo showing the plasterer getting ready to apply a plastic resin that will hold the rubber mold (in blue).</p>

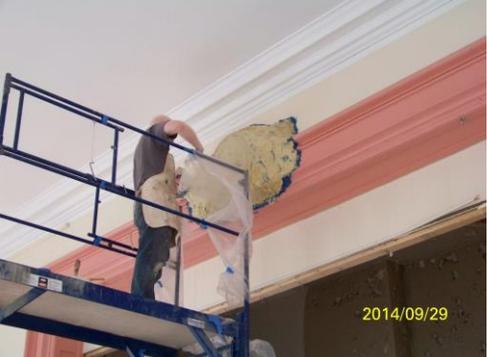
<p>Photo showing the plasterer applying the plastic resin to the rubber mold.</p>

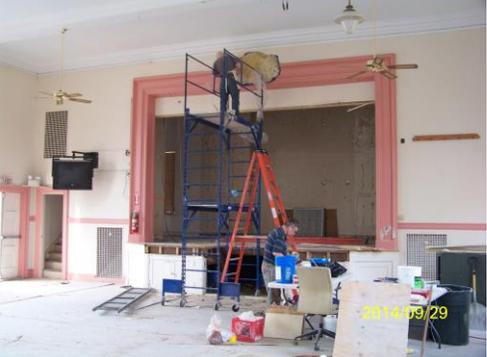
<p>Photo showing the plasterers working.</p>

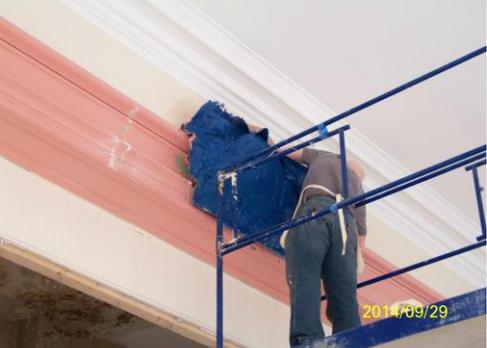
<p>Photo showing the rubber mold being removed.</p>

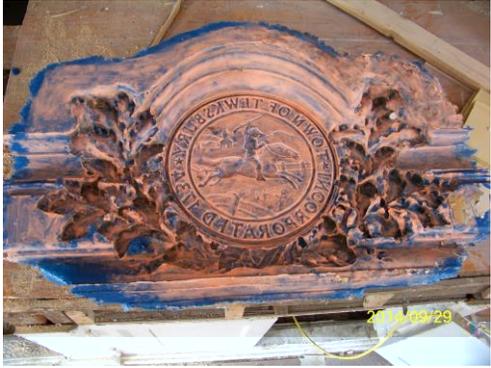
Photo showing the mold resting in the plastic casing (not visible).

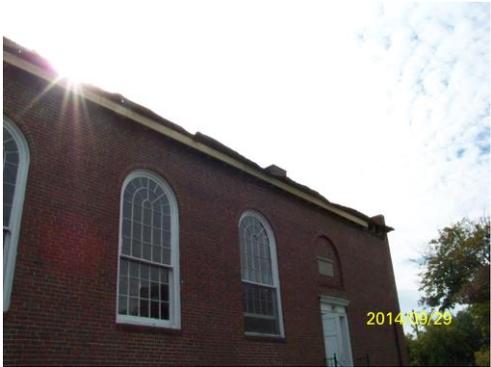
Photo showing the framework for the fascia and soffit on the north elevation of the meeting hall.

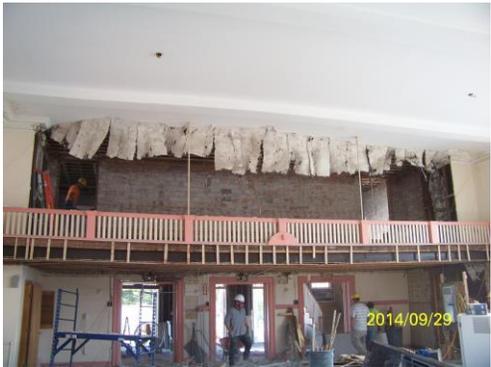
Photo showing the balcony demolition under way.

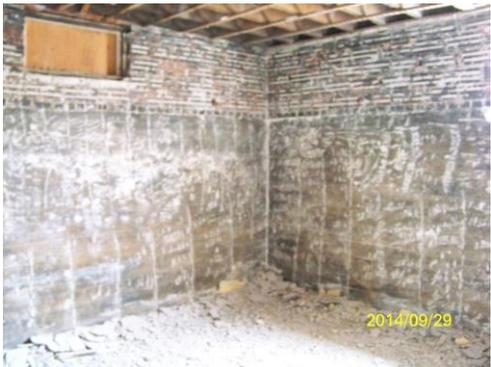
Photo showing room in basement with the plaster removed from the walls.

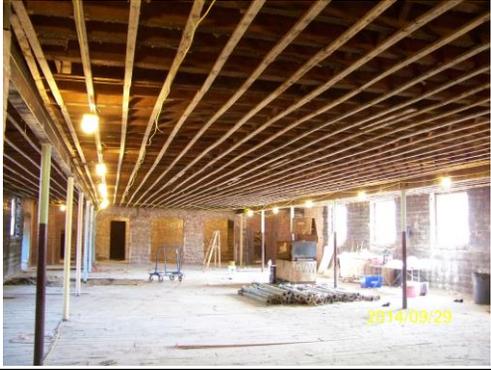
Photo showing temp construction lights in place in the basement.

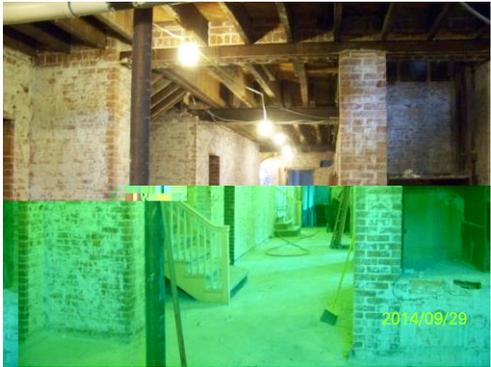
Photo showing temp lights installed in the basement hallway.

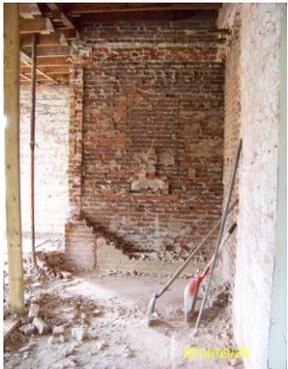
Photo showing one vault demolished.

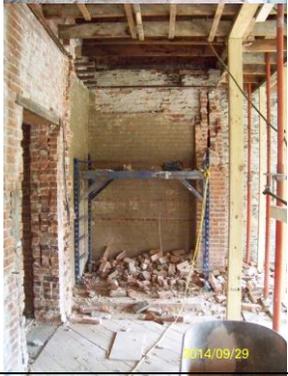
Photo showing other vault demolished.

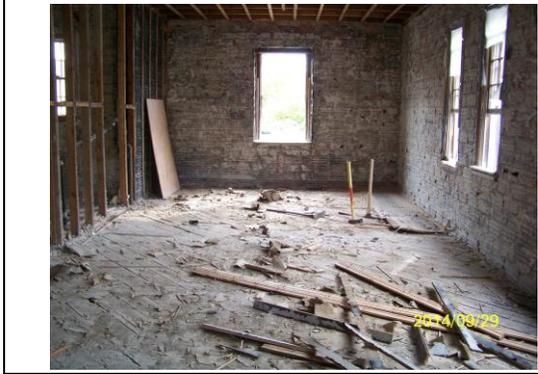
Photo showing first floor in south wing.
