# PROJECT REPRESENTATIVE'S DAILY REPORT

Pg. 1  
 Report No. 036  
 Date: 2014-10-07  
 Day: Tuesday

**Architect:** Kang Associates  
**Project:** Renovation and Addition to Tewksbury Town Hall  
**OPM:** CBI Consulting Inc. **Clerk of the Works:** Jeff Barnes  
**Contractor:** G.V.W., Inc.

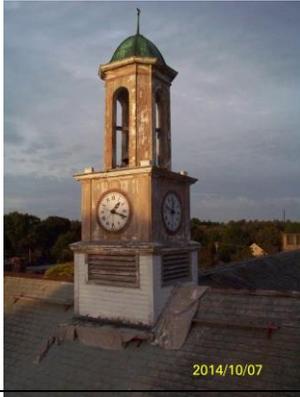
Photo of the cupola that has been prepped for priming.

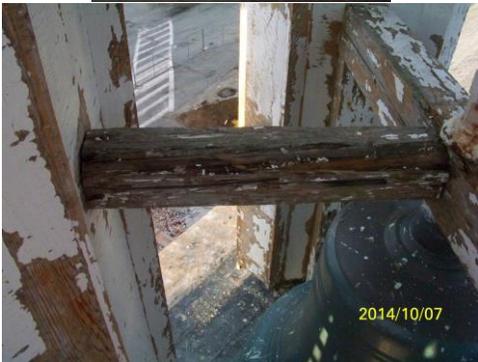
Photo showing a deteriorated cross piece that will be replaced.

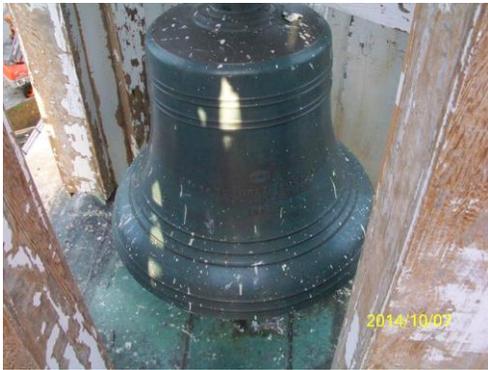
Photo showing the bell. The paint drops and splatters are from previous painting efforts.

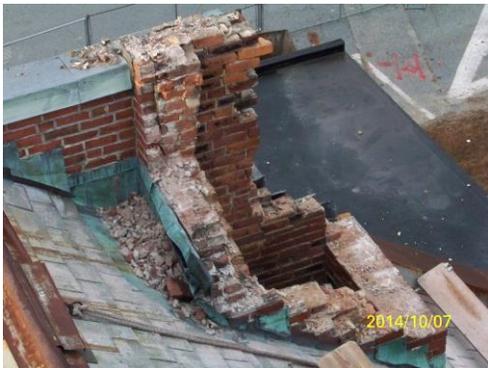
Photo showing the demolished chimney.

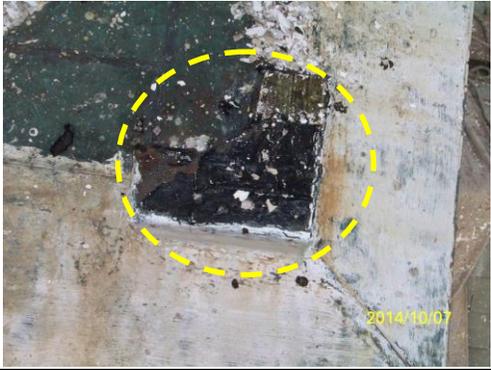
Photo showing (1) of (4) curbs on the cupola. They are covered with EPDM which has failed. It is recommended that these four curbs be covered in 16oz copper to mitigate water intrusion.

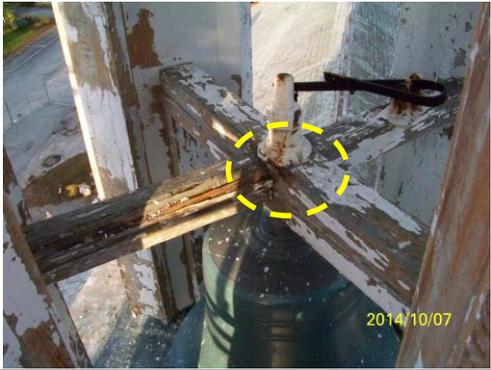
Photo showing the bell support structure. The wood is in satisfactory condition. There is minor deterioration beneath the screw. It is recommended that this area be protected with a galvanized metal plate to extend the life span of the connection.

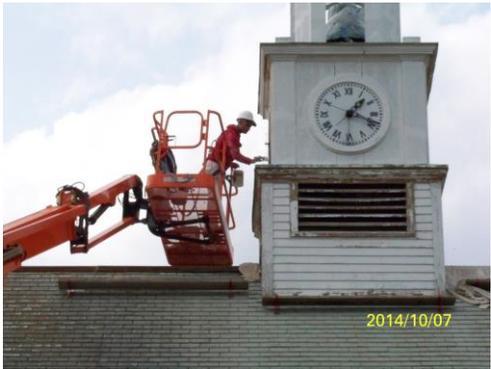
Photo showing the primer being applied.

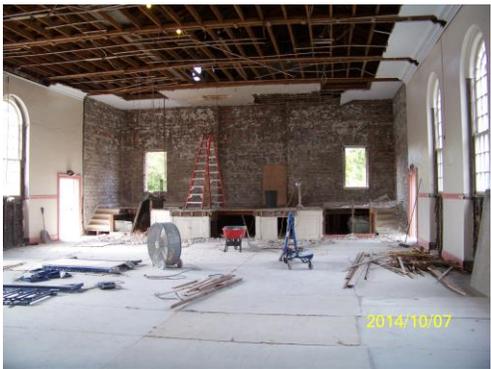
Photo showing continued demolition of the meeting hall and stage area.

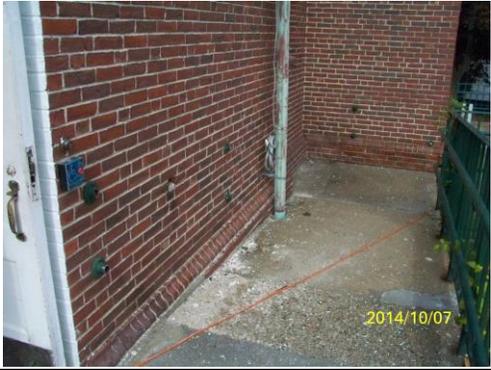
Photo showing handrails removed.

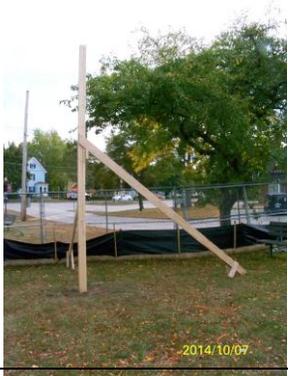
Photo showing one of the temp poles installed.
