# PROJECT REPRESENTATIVE'S DAILY REPORT

Pg. 1  
 Report No. 038  
 Date: 2014-10-09  
 Day: Thursday

**Architect:** Kang Associates  
**Project:** Renovation and Addition to Tewksbury Town Hall  
**OPM:** CBI Consulting Inc. **Clerk of the Works:** Jeff Barnes  
**Contractor:** G.V.W., Inc.

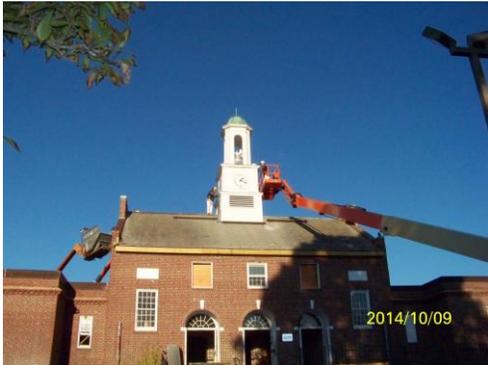
Photo showing painters working on the cupola: sanding, priming and sealing.

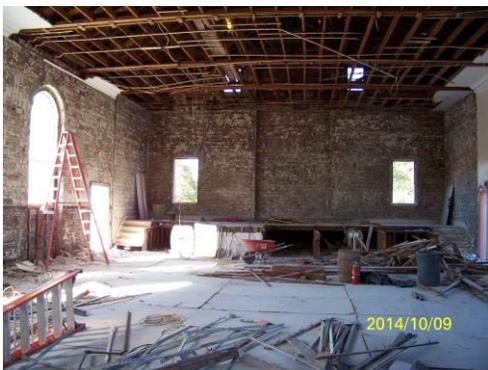
Photo showing the meeting hall undergoing demolition to remove the ceiling and plaster parge coat from the walls. This photo is looking west (where the stage was located).

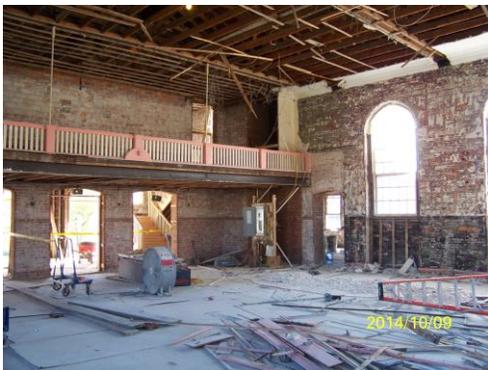
Photo showing the meeting hall and balcony undergoing demolition. This photo is looking southeasterly.

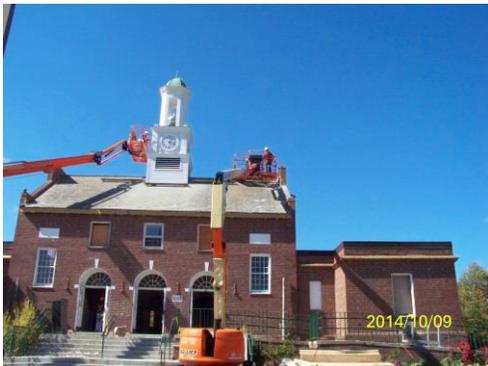
Photo showing the mason removing the copper step flashing from the roof line.
