PROJECT REPRESENTATIVE'S DAILY REPORT

Pg. 1
 Report No. 042
 Date: 2014-10-16
 Day: Thursday

Architect: Kang Associates
Project: Renovation and Addition to Tewksbury Town Hall
OPM: CBI Consulting Inc. **Clerk of the Works:** Jeff Barnes
Contractor: G.V.W., Inc.

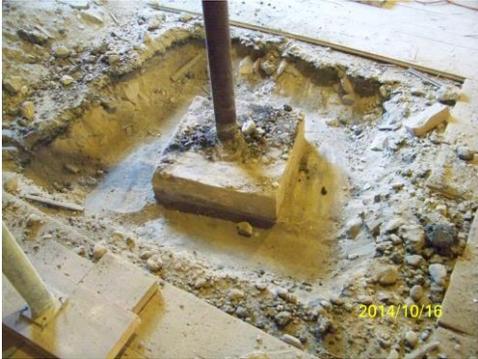
Photo showing an excavated footing.

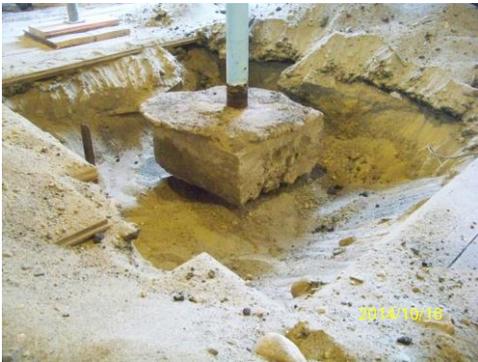
Photo showing another excavated footing.

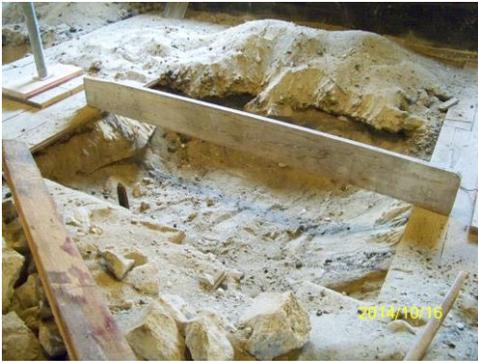
Photo showing location of footing after demolition.

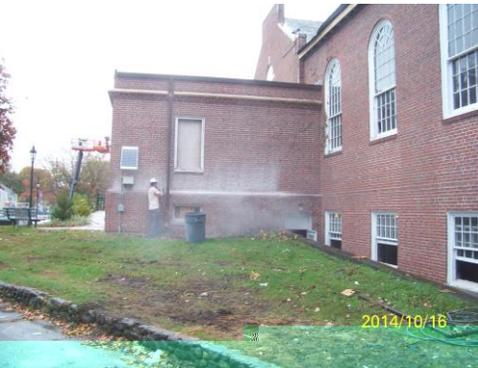
Photo showing a mason cutting out mortar joints on the west elevation of the north wing.

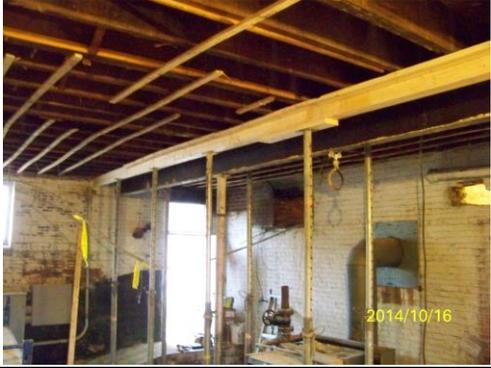
Photo showing some of the shoring installed in the basement.

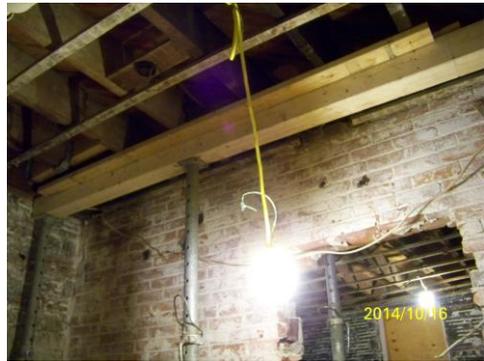
Photo showing more shoring in the basement.

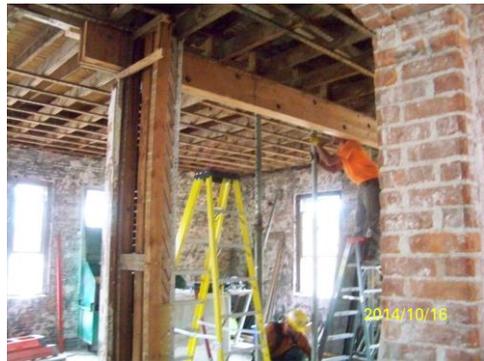
Photo showing carpenters installing shoring on the first floor, south wing.

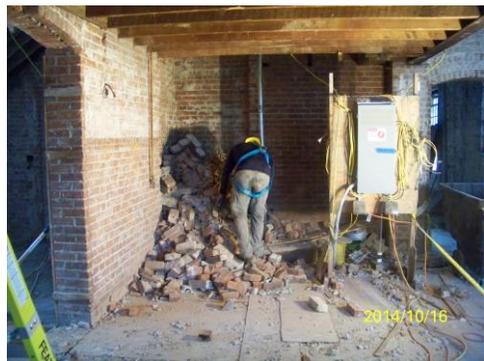
Photo showing demo of the chimney continuing at the first floor.
