PROJECT REPRESENTATIVE'S DAILY REPORT

Pg. 1
Report No. 051
Date: 2014-10-29
Day: Wednesday

Project: Renovation and Addition to Tewksbury Town Hall

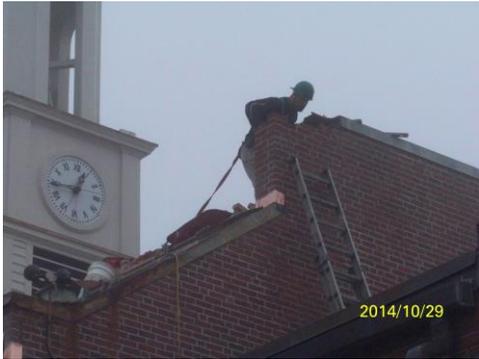
Photo showing mason working on the upper parapet on the south elevation.

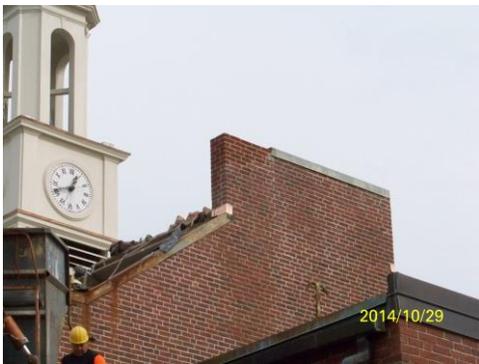
Photo showing completed parapet.

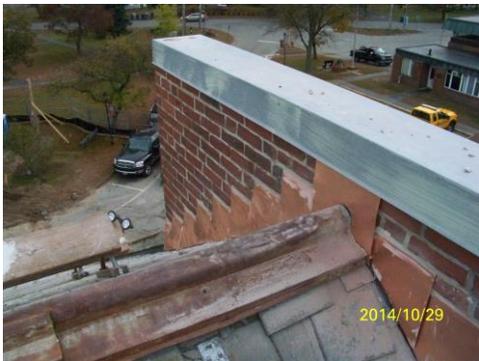
Photo showing south side parapet with step flashing installed.

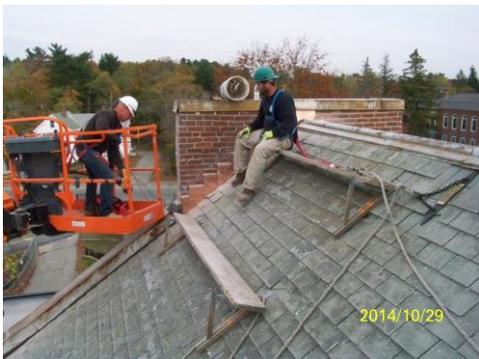
Photo showing masons prepping to work on the north elevation parapet.

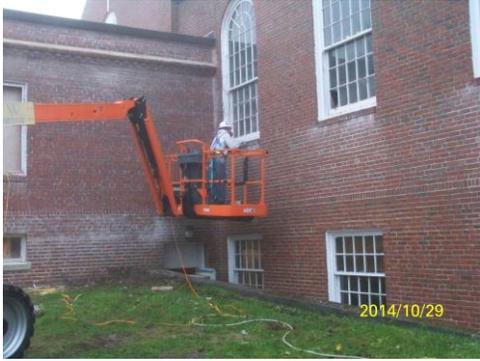
Photo showing mason cutting out mortar joints on the north elevation of the meeting hall.

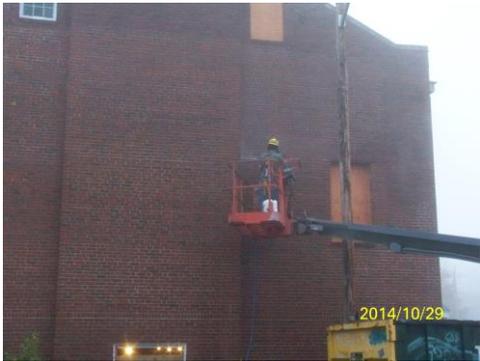
Photo showing mason power washing the west elevation.

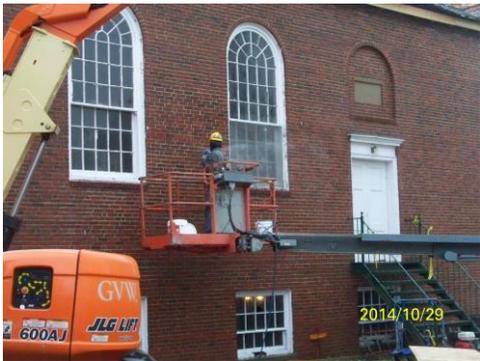
Photo showing the mason power washing the north elevation of the meeting hall.

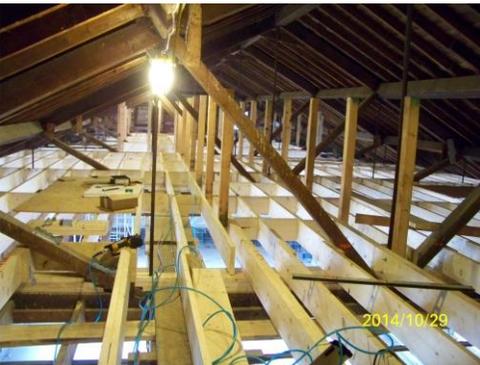
Photo showing attic framing continuing.

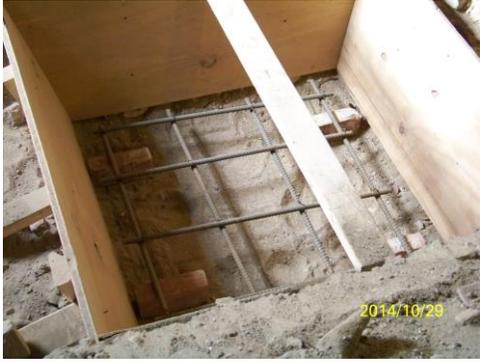
Photo showing rebar mat at the bottom of a footing.

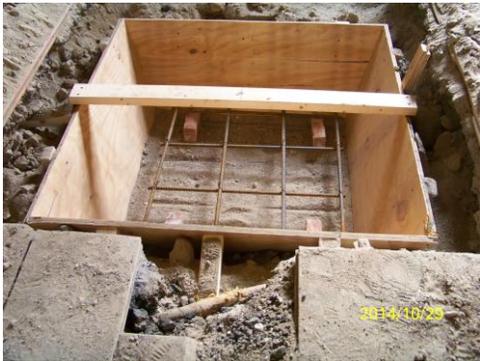
Photo showing another footing location with rebar mat in place.

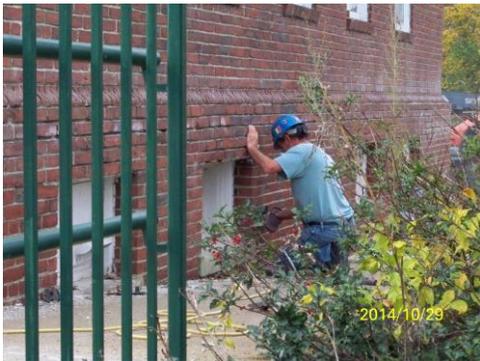
Photo showing laborer removing railing attachments from the façade along the north elevation of the north wing.
