PROJECT REPRESENTATIVE S DAILY REPORT

Pg. 1
 Report No. 054
 Date: 2014-11-03
 Day: Monday

Project: Renovation and Addition to Tewksbury Town Hall

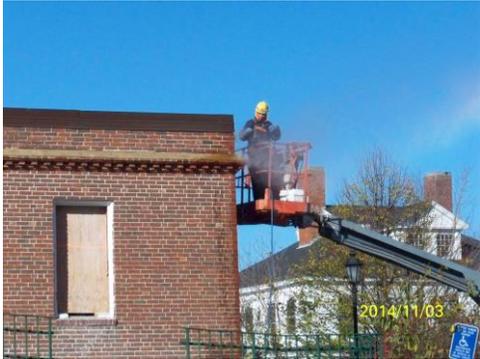
Photo showing mason power washing the north elevation of the north wing.

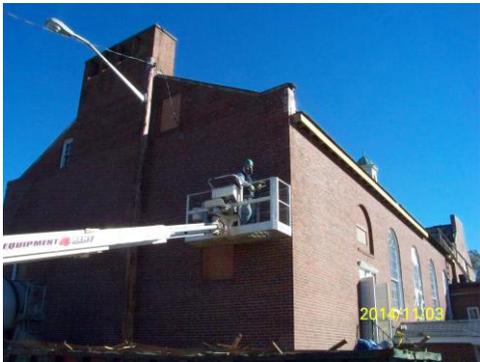
Photo showing mason pointing the masonry on the west elevation.

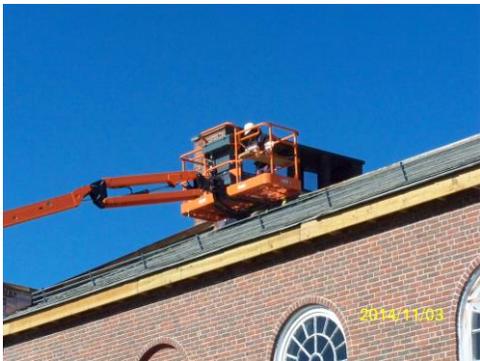
Photo showing mason installing step flashing along the roof line of the west elevation.

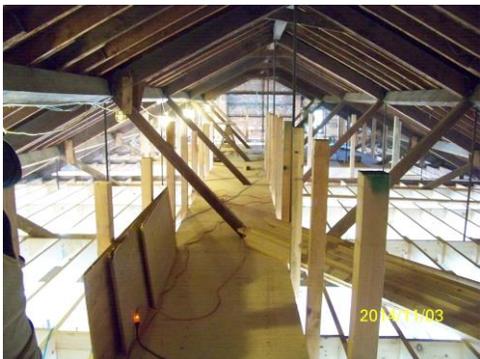
Photo showing the catwalk with decking in place.

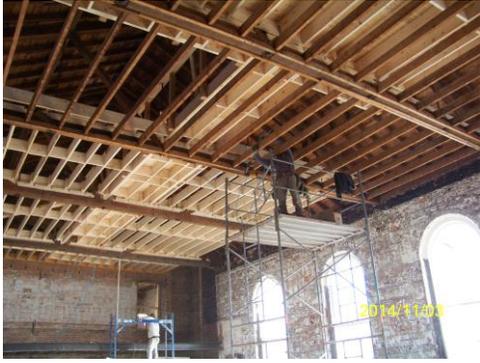
Photo showing carpenter working on the framing for the attic space.

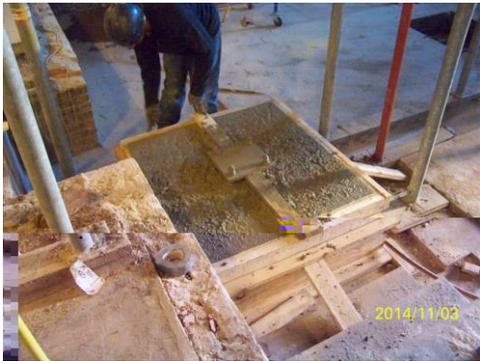
Photo showing a new footing that was placed in the mechanical room.

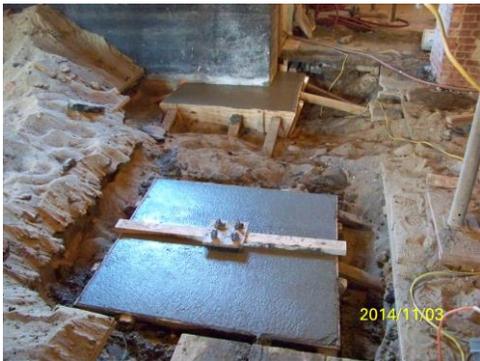
Photo showing new footings in the basement.

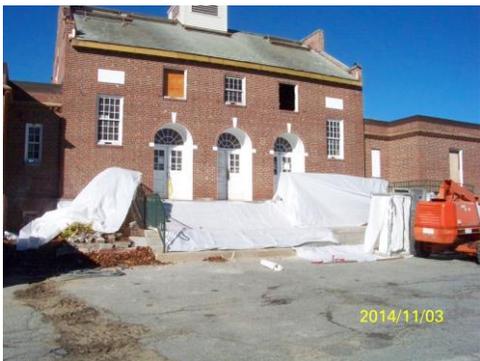
Photo showing the set-up for the roof abatement.

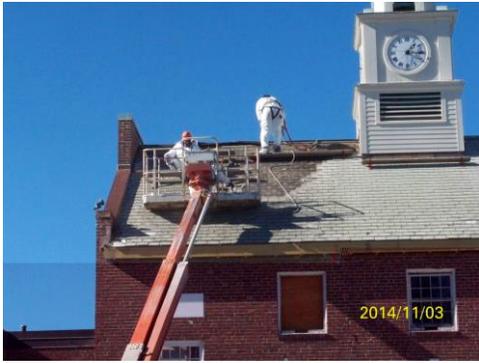
Photo showing roof abatement under way.

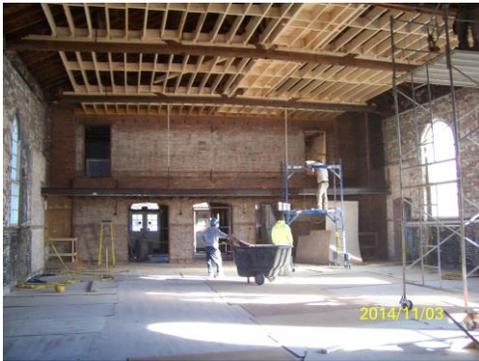
Photo showing balcony demolition in progress.

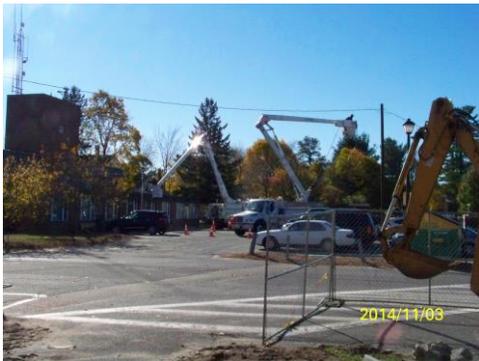
Photo showing NGRID installing the temporary secondary lines.

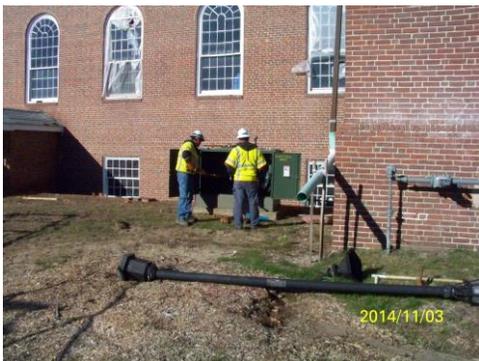
Photo showing NGRID working on disconnecting the transformer that is to be removed.
