PROJECT REPRESENTATIVE'S DAILY REPORT

Pg. 1
 Report No. 058
 Date: 2014-11-07
 Day: Friday

Project: Renovation and Addition to Tewksbury Town Hall

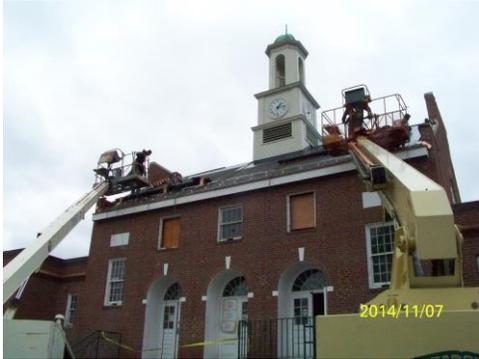
Photo showing roofers installing shingles on east side of main building.

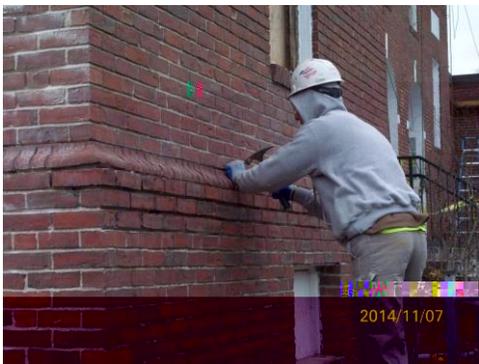
Photo showing mason performing detail work at the joints on the coping band along the south wing.

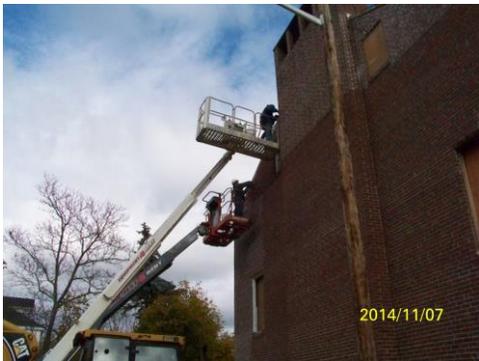
Photo showing masons continuing the pointing operation on the west elevation.

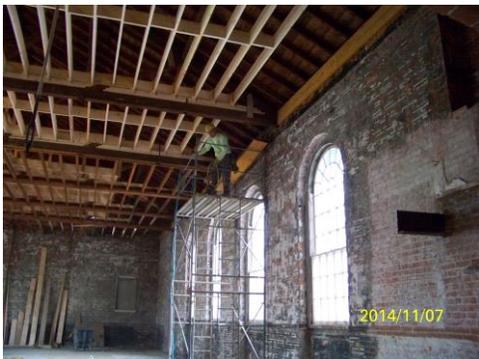
Photo showing carpenter setting the rim joist in the meeting hall.

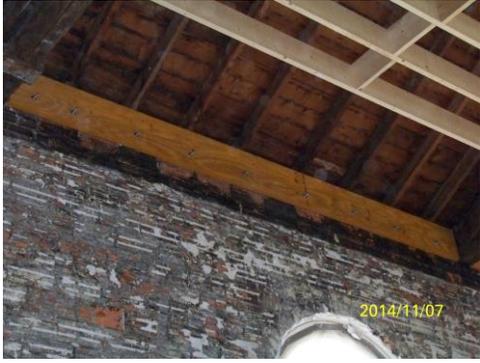
Photo showing the rim joist anchored to the masonry wall.

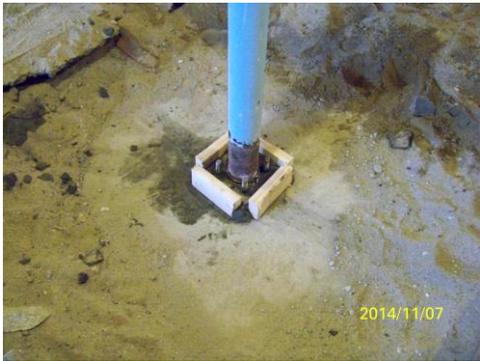
Photo showing the form to keep the grout beneath the base plate.

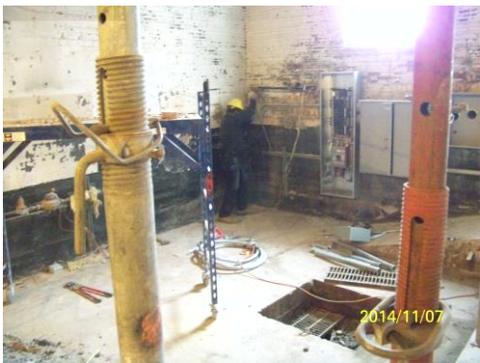
Photo showing workman removing abandoned electrical equipment.

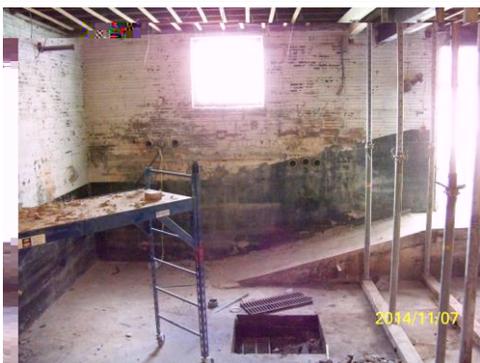
Photo showing the abandoned electrical equipment removed from the wall.

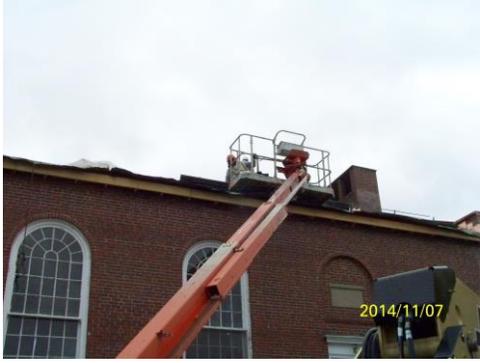
Photo showing the abatement crew working on the north side of the meeting hall roof.

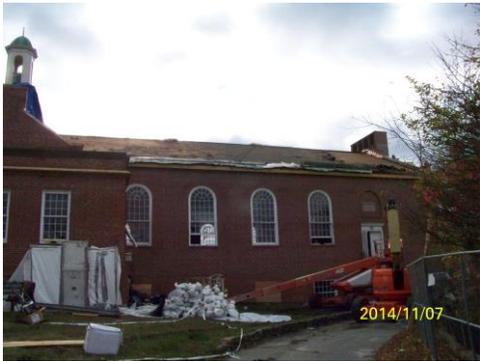
Photo showing the north side of the meeting hall roof.
