PROJECT REPRESENTATIVE'S DAILY REPORT

Pg. 1
 Report No. 063
 Date: 2014-11-17
 Day: Monday

Architect: Kang Associates
Project: Renovation and Addition to Tewksbury Town Hall
OPM: CBI Consulting Inc. **Clerk of the Works:** Jeff Barnes
Contractor: G.V.W., Inc.

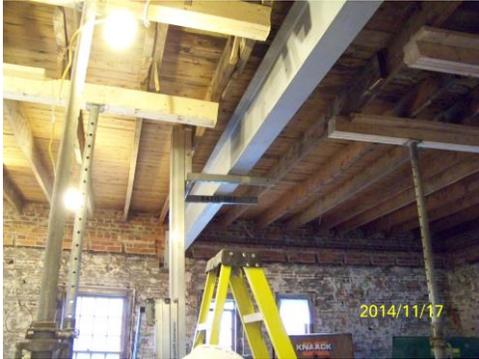
Photo showing a beam being lifted into place in the south wing.

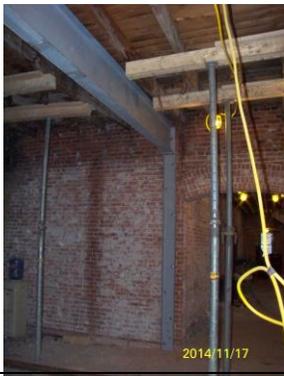
Photo showing beam and channel in place in the south wing.

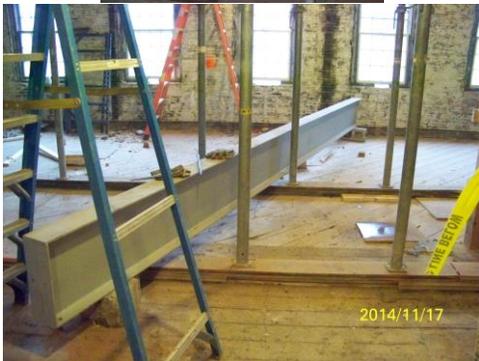
Photo showing beam in the north wing getting ready to be lifted into place.

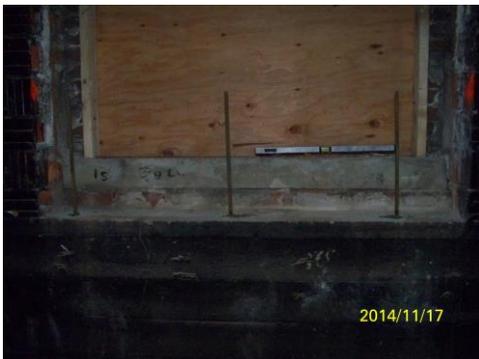
Photo showing window opening in basement along the north elevation prepped and ready for infill.

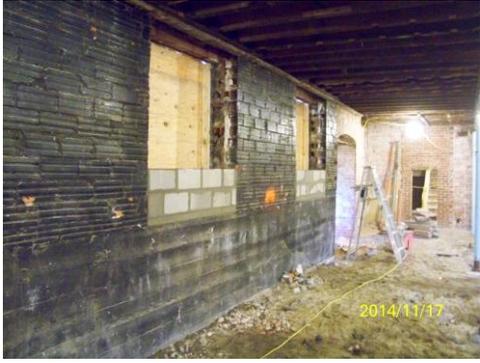
Photo showing the infills in place at two window openings along the north elevation.

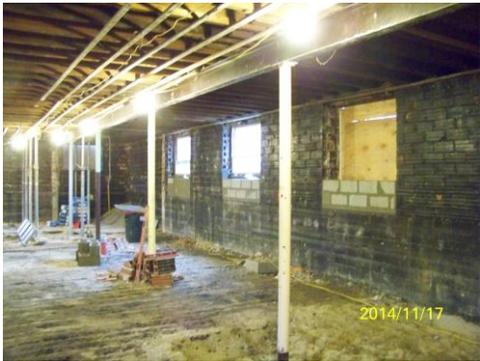
Photo showing window openings infilled along the south elevation of the basement.

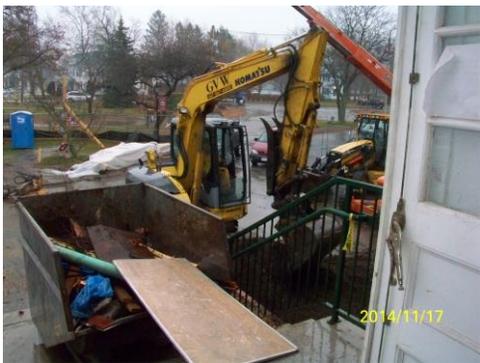
Photo showing excavator clearing the site along the east elevation.

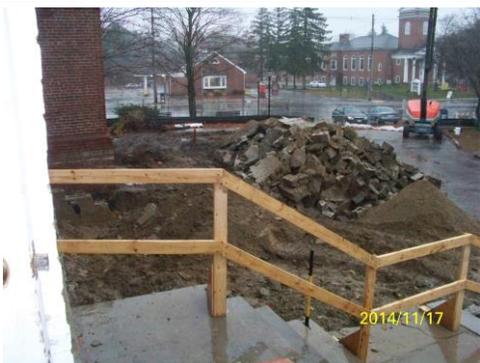
Photo showing excavation under way along the northeast corner of the building.

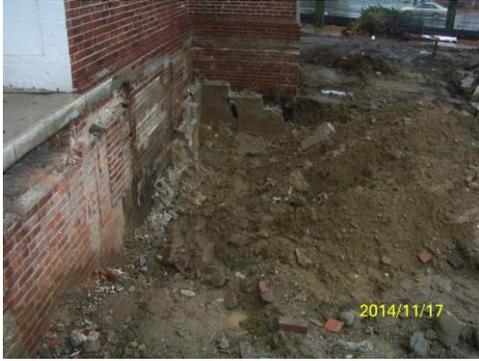
Photo showing the former location of the ADA ramp and north side of the stairs.

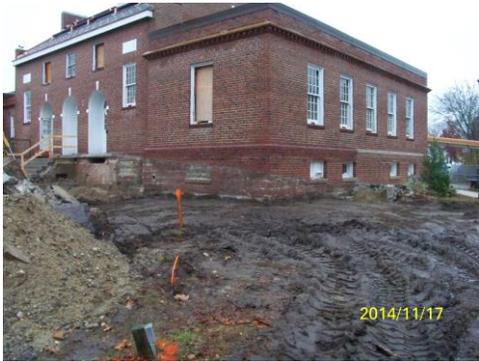
Photo showing the northeast corner of the building with the site walls and ramp removed.

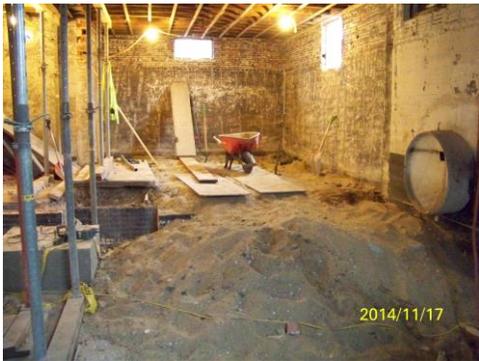
Photo showing the area in the basement adjacent to the boiler room. This is the southeast corner.

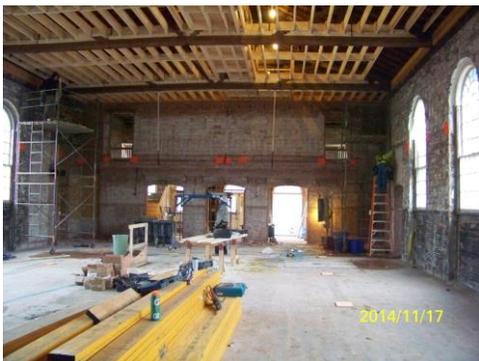
Photo showing carpenters laying out floor levels for the second floor and installing lag bolts at the attic floor.
