PROJECT REPRESENTATIVE'S DAILY REPORT

Pg. 1
Report No. 066
Date: 2014-11-20
Day: Thursday

Architect: Kang Associates
Project: Renovation and Addition to Tewksbury Town Hall
OPM: CBI Consulting Inc. **Clerk of the Works:** Jeff Barnes
Contractor: G.V.W., Inc.

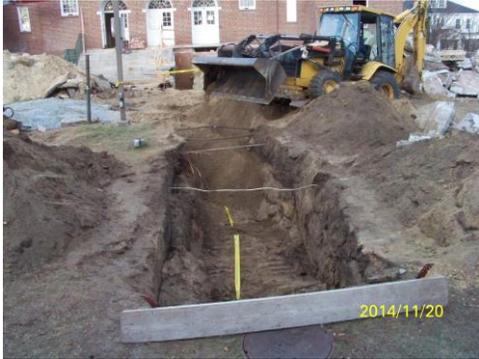
Photo showing trench being back filled. This is the location of the drain pipe from the building to the manhole.

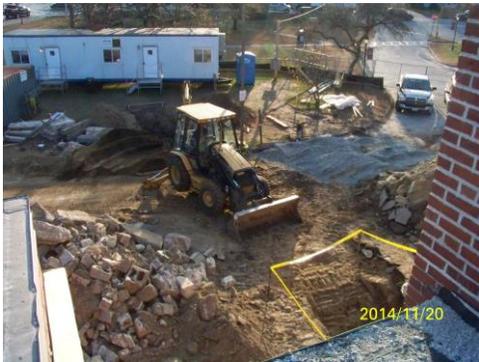
Photo showing aerial view of the back filling in progress.

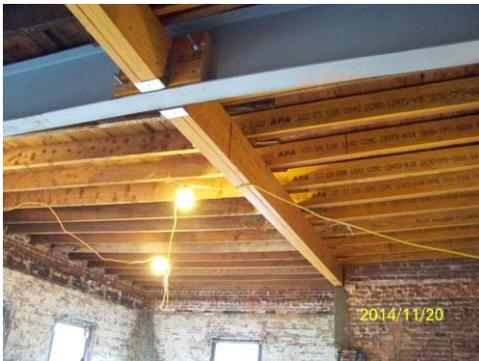
Photo showing sistered roof joists. This is in the south wing.

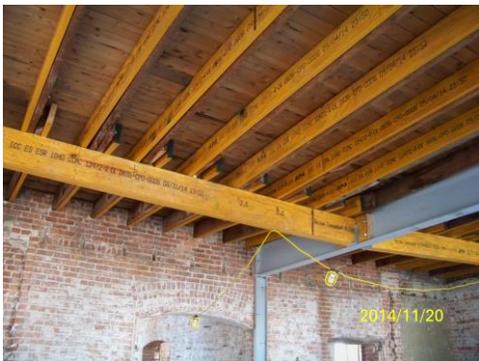
Photo showing sistered roof joists.

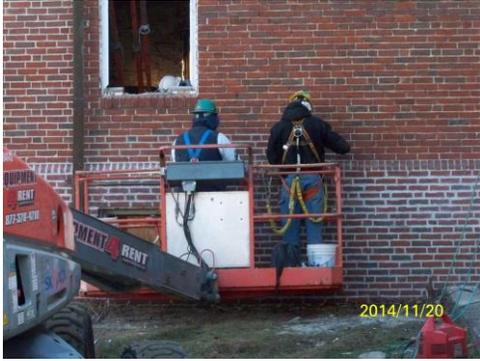
Photo showing masons working on the west elevation of the north wing.

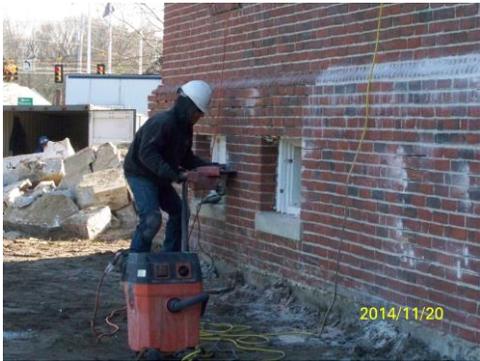
Photo showing mason working on the north elevation of the north wing.

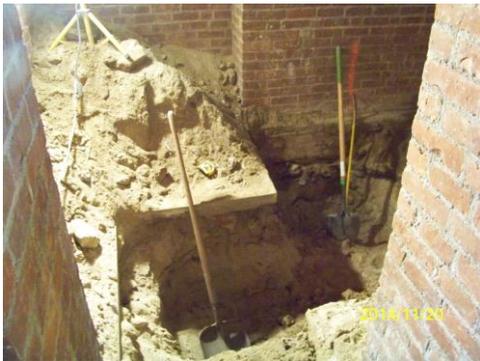
Photo showing trenching efforts underway in a room in the basement.

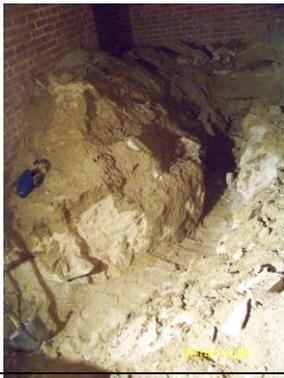
Photo showing trenching efforts in the basement.

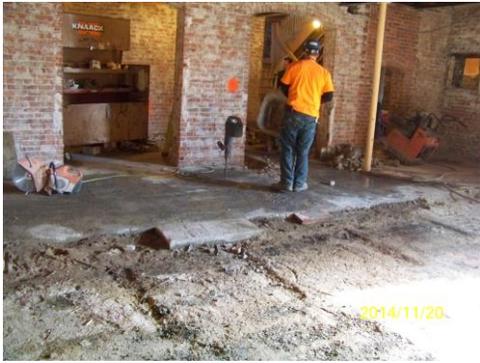
Photo showing the existing slab being prepped and taken apart in sections for trenching plumbing lines.

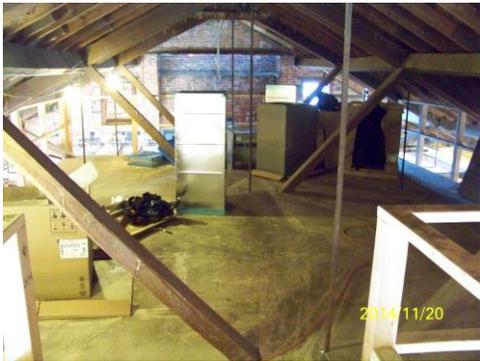
Photo showing some HVAC equipment that was delivered to the site and brought up to the attic.

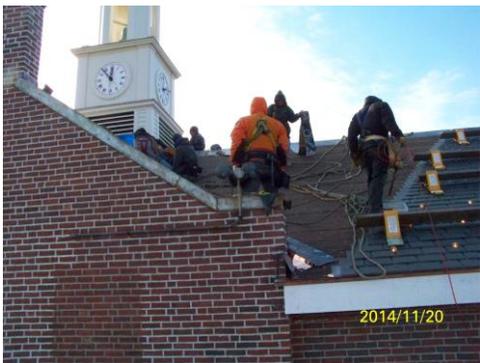
Photo showing roofers working on the northwest section of the main roof and the northeast section of the meeting hall roof.

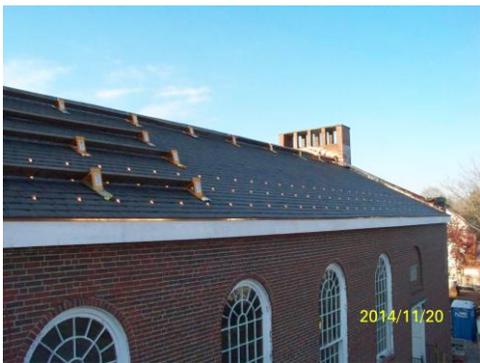
Photo showing the finished roof on the north side of the meeting hall.
