PROJECT REPRESENTATIVE'S DAILY REPORT

Pg. 1
 Report No. 069
 Date: 2014-11-25
 Day: Tuesday

Architect: Kang Associates
Project: Renovation and Addition to Tewksbury Town Hall
OPM: CBI Consulting Inc. **Clerk of the Works:** Jeff Barnes
Contractor: G.V.W., Inc.

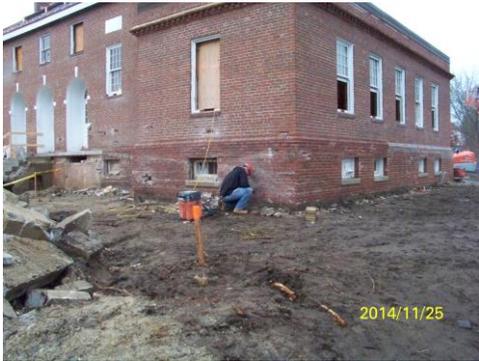
Photo showing mason cutting out mortar joints on the east elevation of the north wing.

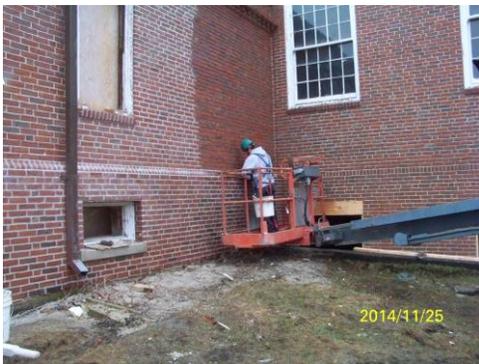
Photo showing a mason pointing the brick band on the west elevation of the north wing.

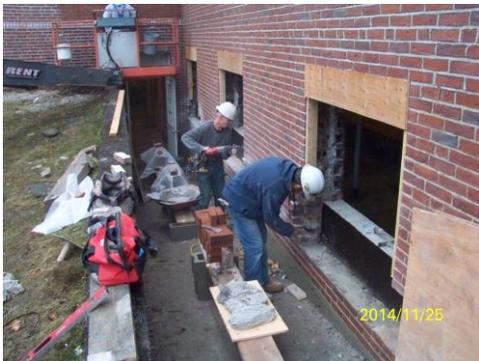
Photo showing masons prepping the window openings for stone sill installation.

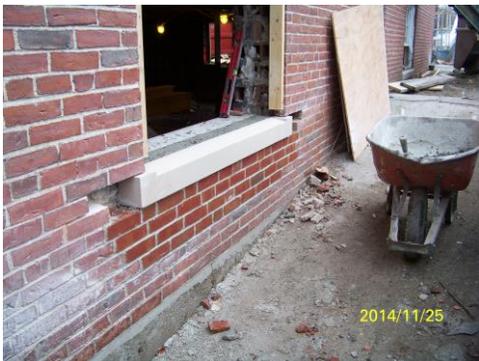
Photo showing a stone sill in place.

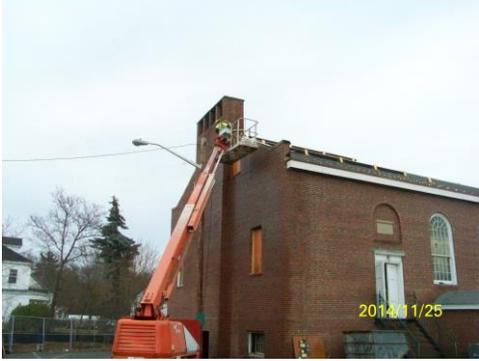
Photo showing a mason washing down the west elevation.

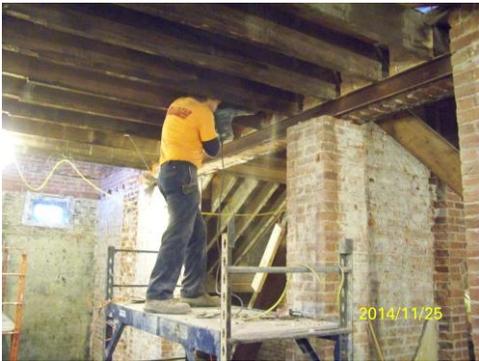
Photo showing a worker notching out the masonry for the installation of first floor framing.

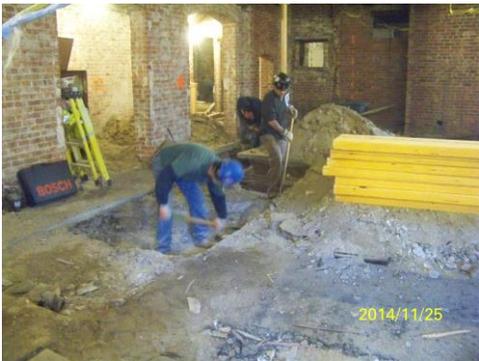
Photo showing workmen continuing with the trenching operations.

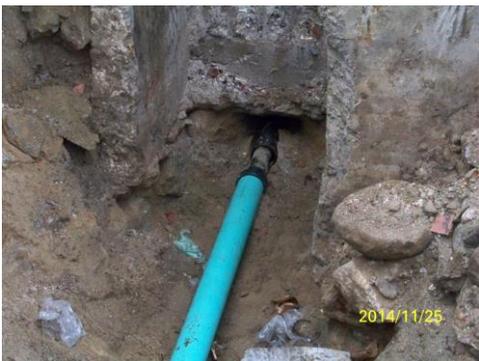
Photo showing the drain pipe tie-in to the sewer line (blue pipe) from the building (black pipe). This was inspected by the plumbing inspector and approved.

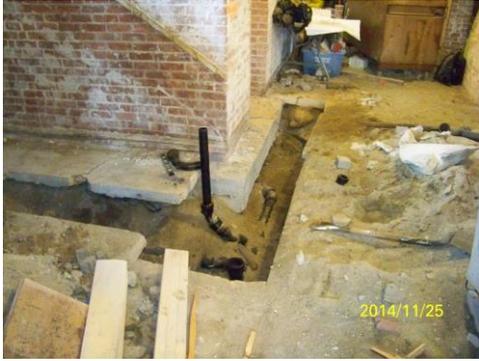
Photo showing piping in place in a trench.

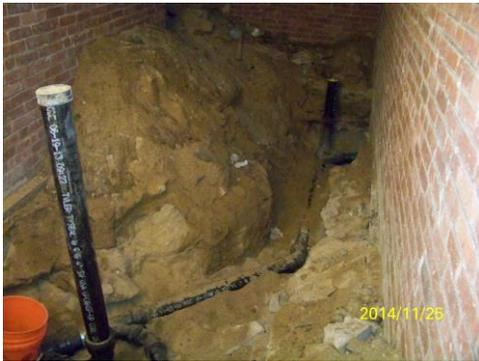
Photo showing more piping in place.

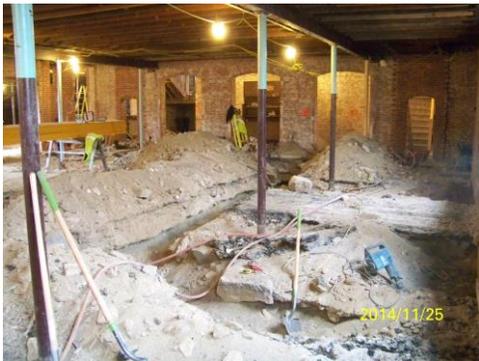
Photo showing trenches ready for plumbing.

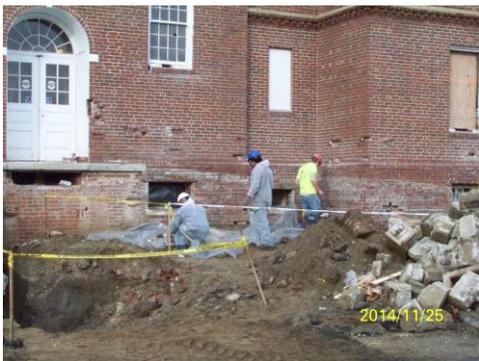
Photo showing abatement crew removing basement windows.

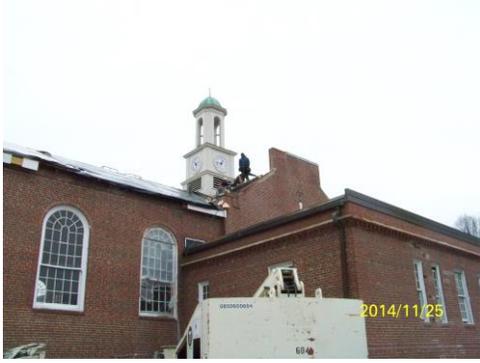
Photo showing roofers working on the ridge of the main roof.
