PHOTO INDEX

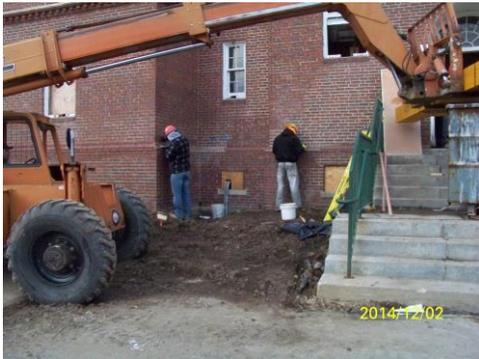
Photo showing masons pointing the masonry on the southeast elevation of the building.

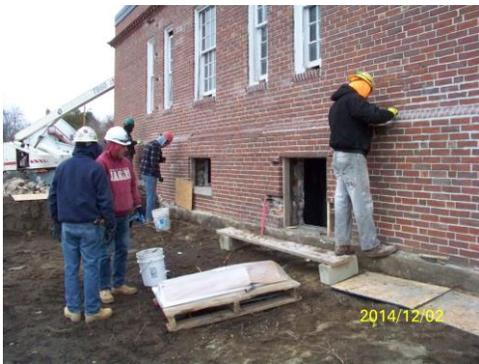
Photo showing masons working on the south elevation of the south wing.

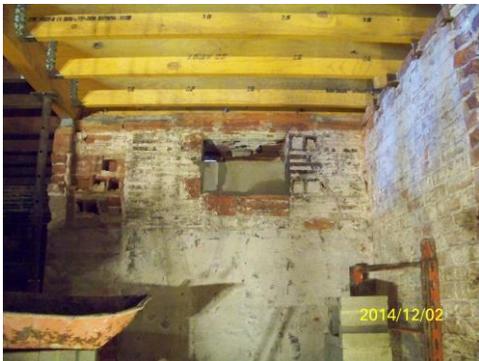
Photo showing a basement window being in the process of being infilled.

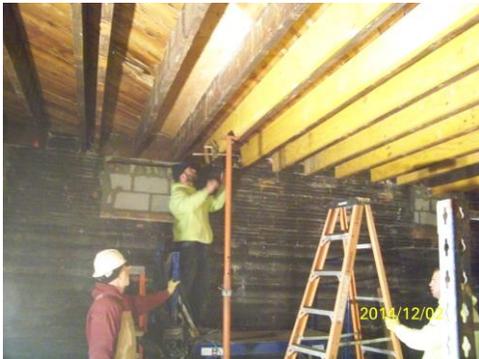
Photo showing carpenters getting LVLs into place to sister against the existing floor joists for the 1st floor.

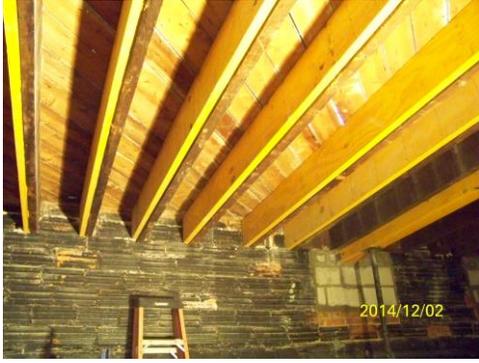
Photo showing LVLs in place for the 1st floor framing.

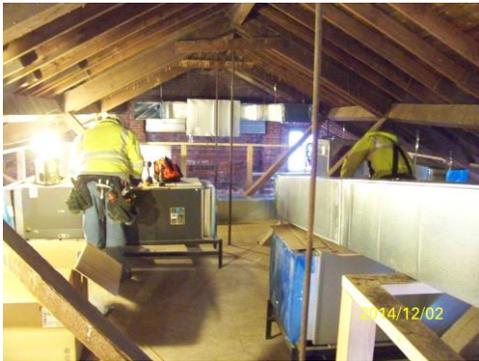
Photo showing HVAC workmen assembling ductwork in the attic.

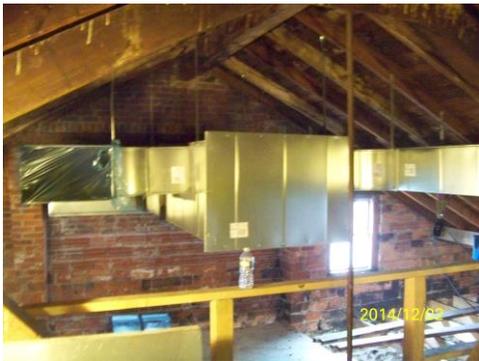
Photo showing some of the ductwork in place at the west end of the attic (above the meeting hall).

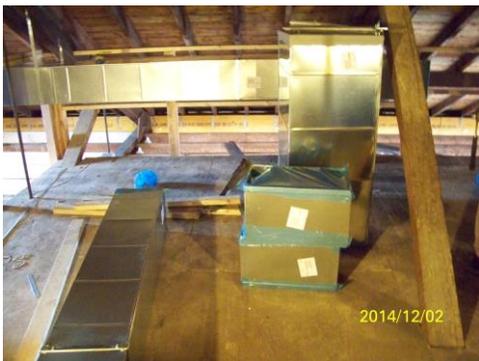
Photo showing some of the assembled ductwork.

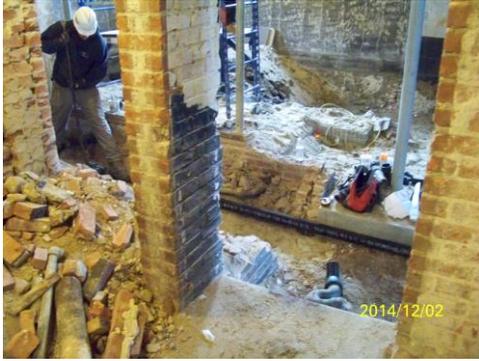
Photo showing plumbers laying pipe in a trench. This is located at the south side of the basement.

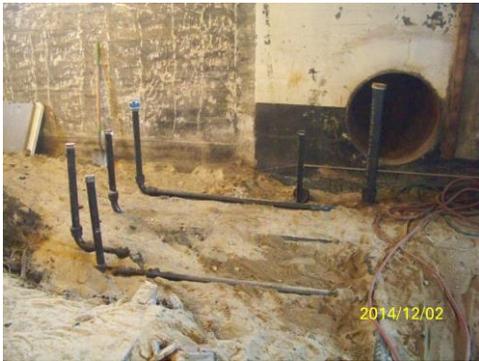
Photo showing some of the piping in place.

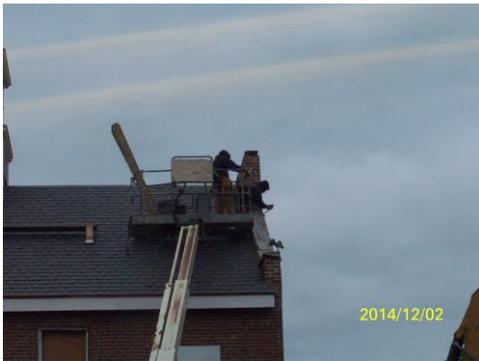
Photo showing roofers removing the existing parapet caps on the north elevation.

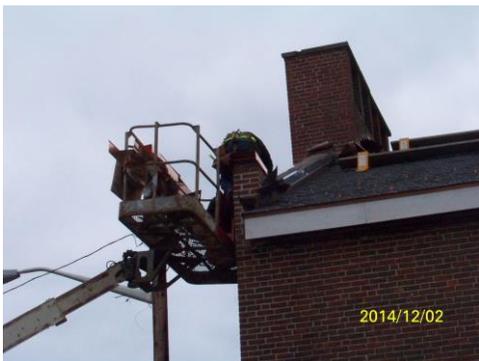
Photo showing roofers installing hook strips along the parapet on the west elevation.

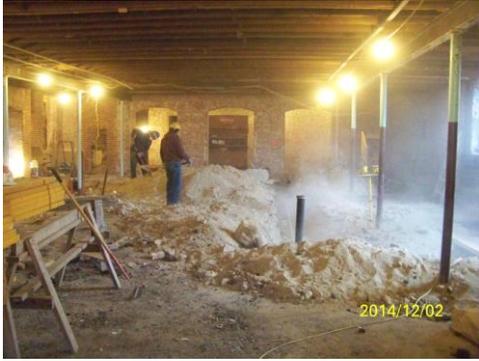
Photo showing workmen sifting soil and backfilling along a pipe trench.

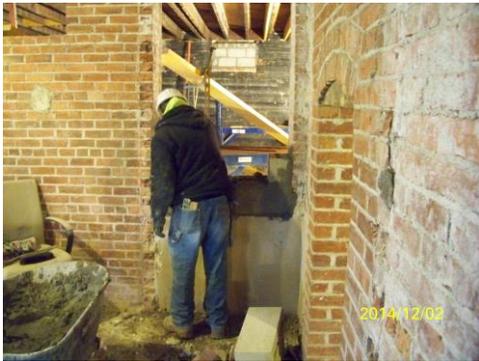
Photo showing mason infilling an opening in a masonry wall in the basement.
