PHOTO INDEX

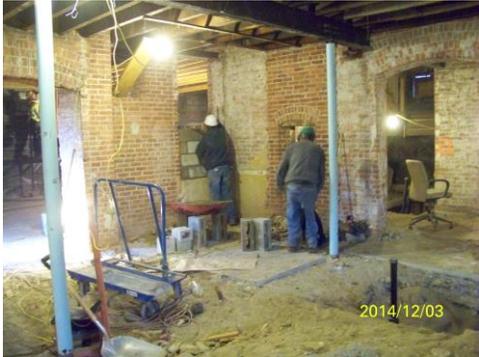
Photo showing masons working on bricking in a masonry open in the basement.

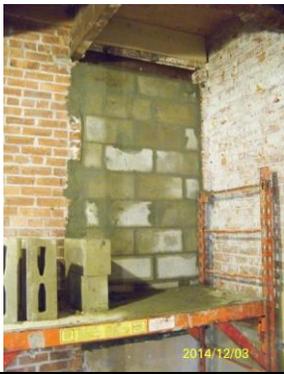
Photo showing completed brick infill.

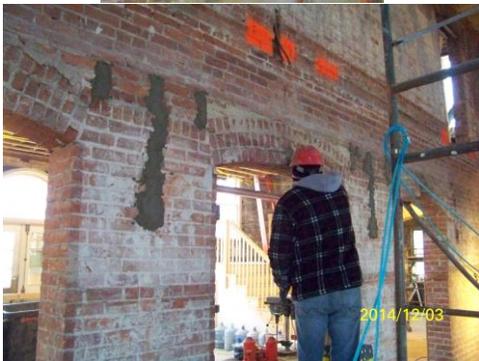
Photo showing mason infilling holes and voids in the masonry wall located on the east side of the meeting hall.

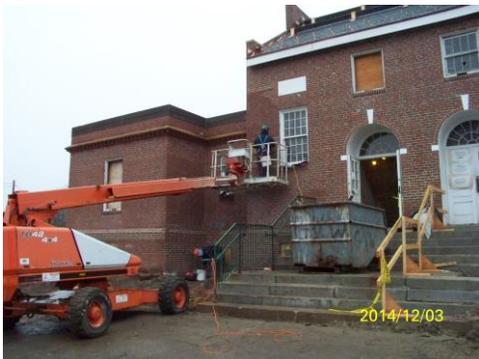
Photo showing masons working on the southeast portion of the east elevation pointing mortar joints.

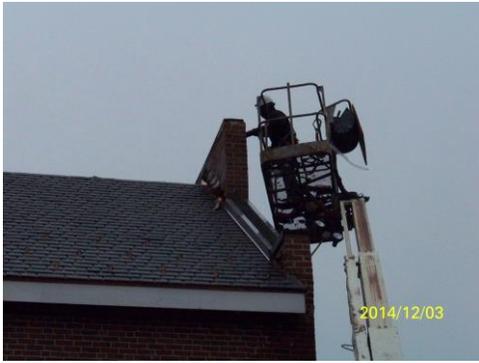
Photo showing mason working on rebuilding a section of the parapet on the north elevation. This is being done in order to provide a suitable substrate to secure the wood blocking for the parapet cap.

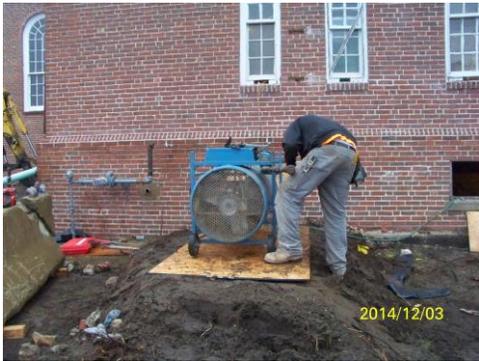
Photo showing plumber hooking up the temp gas heater.

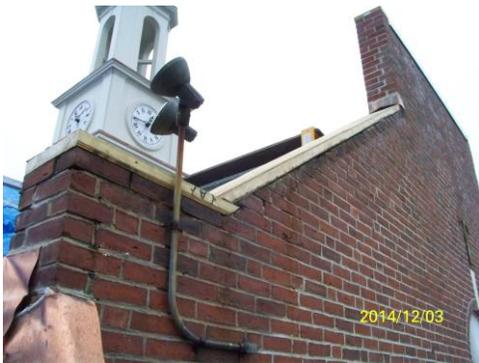
Photo showing a section of new wood blocking for parapet cap installation. This is on the south elevation.

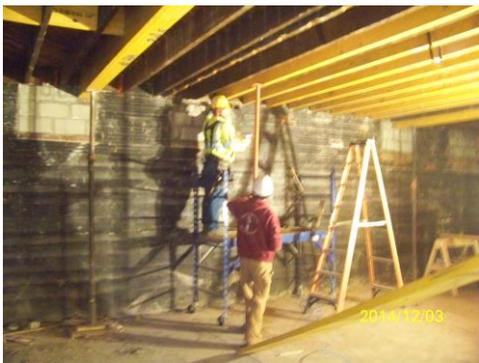
Photo showing carpenters working in the basement installing LVLs against existing floor joists.

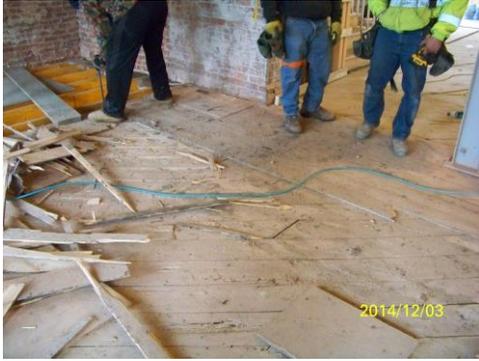
Photo showing carpenter removing a section of subfloor for new subfloor to be installed.

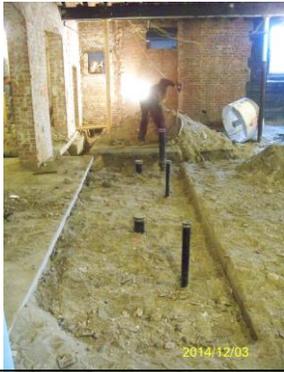
Photo showing a workman backfilling the trenches after the plumbing had been inspected.

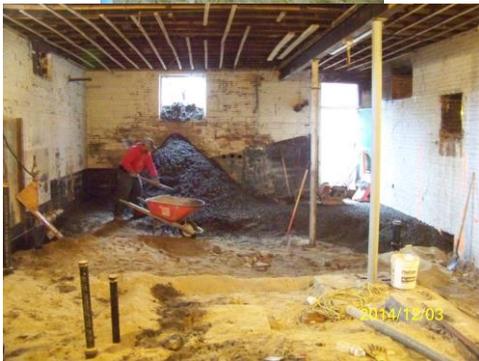
Photo showing workman infilling the mechanical room. This infill will be compacted and then a concrete slab will be placed on top.

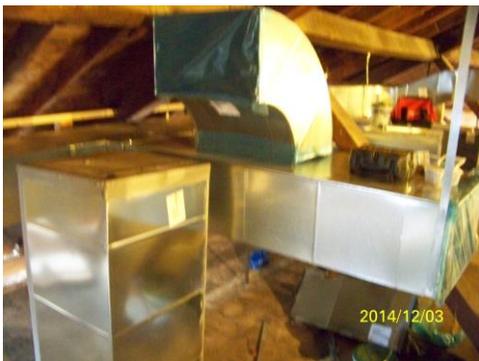
Photo showing some of the ductwork assembled and installed in the attic.

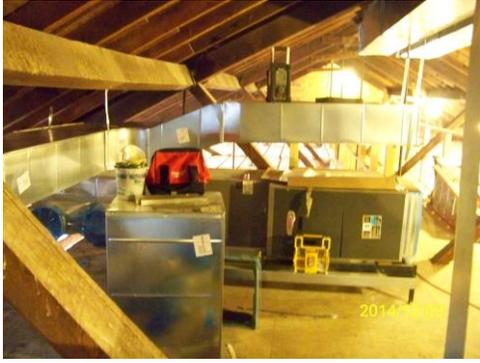
Photo showing more ductwork in place.

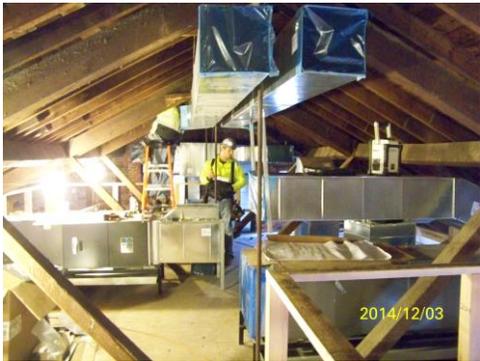
Photo showing HVAC workmen putting the ductwork into place.
