# PROJECT REPRESENTATIVE'S DAILY REPORT

Pg. 1  
 Report No. 075  
 Date: 2014-12-04  
 Day: Thursday

**Project:** Renovation and Addition to Tewksbury Town Hall

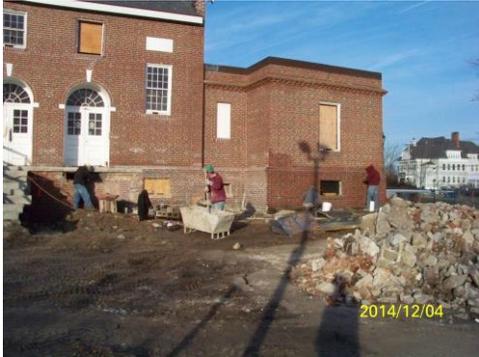
Photo showing masons working on the east elevation.

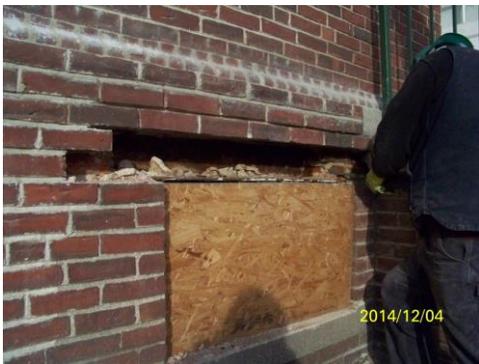
Photo showing mason starting to remove the lintel over one basement window. The lintel measured approximately  $5\frac{1}{2}''$  x  $5\frac{1}{2}''$  x  $\frac{3}{8}''$ .

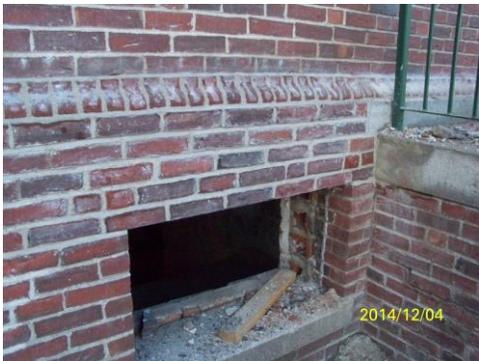
Photo showing the completed window lintel installation of the basement window.

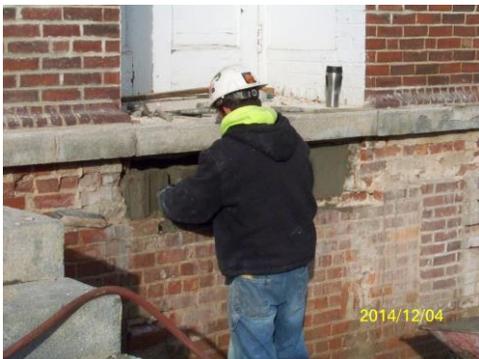
Photo showing mason bricking in hole beneath the landing of the original front doors.

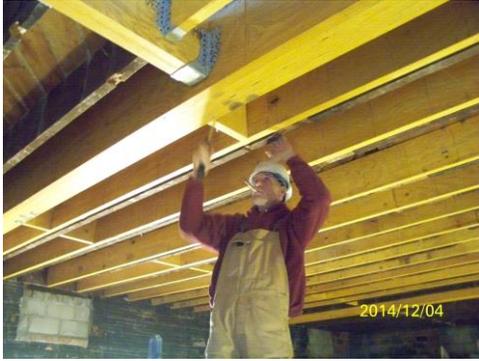
Photo showing carpenter working on blocking for the 1<sup>st</sup> floor framing.

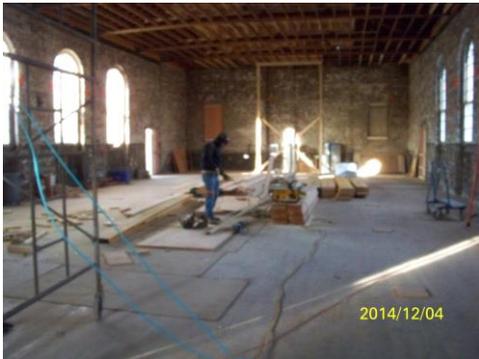
Photo showing carpenter working in the meeting hall measuring and cutting wood for 1<sup>st</sup> floor framing.

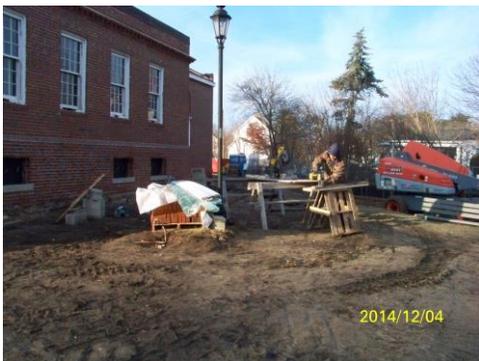
Photo showing carpenter cutting wood to cover over partially bricked in window openings.

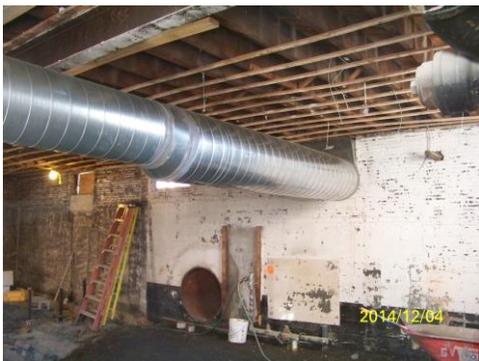
Photo showing temp heating ductwork in place. This spans from the south wall (seen) to the north corner of the meeting hall and up to the meeting hall.

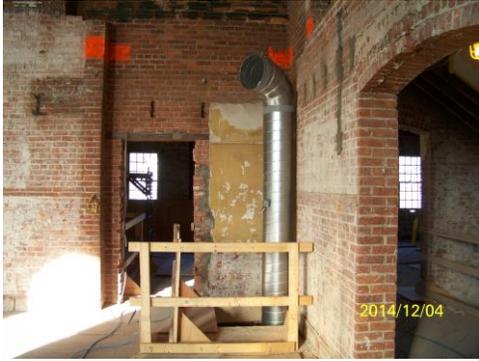
Photo showing where heating duct ends.

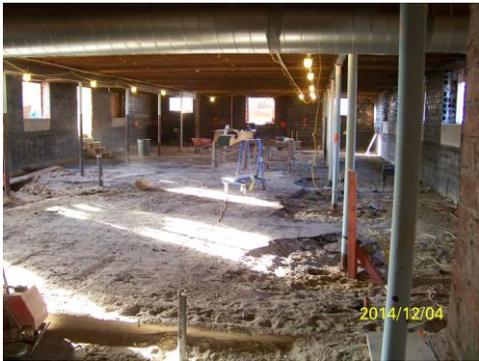
Photo showing backfilled trenches and piles of debris removed from the basement.

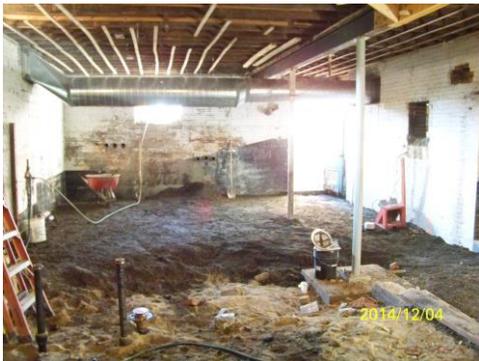
Photo showing mechanical room being infilled.

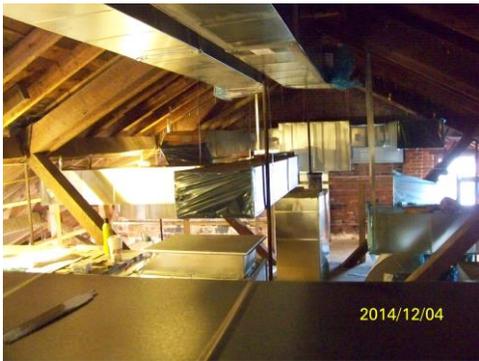
Photo showing the HVAC ductwork in place in the attic.

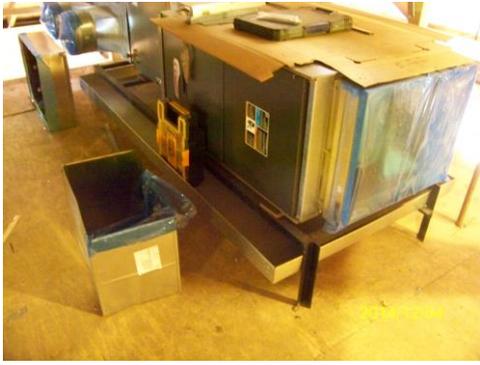
Photo showing a metal pan beneath one of the units. Before any finish work is started, the pans should be water tested to check for signs of leakage.
