PROJECT REPRESENTATIVE'S DAILY REPORT

Pg. 1
 Report No. 076
 Date: 2014-12-05
 Day: Friday

Project: Renovation and Addition to Tewksbury Town Hall

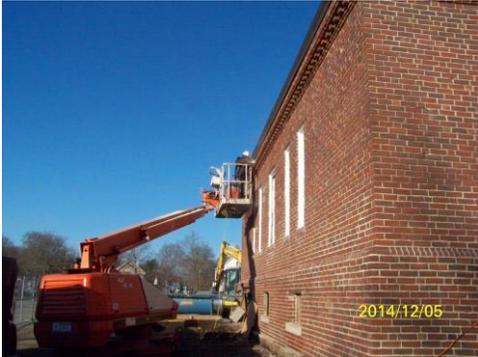
Photo showing mason cutting in the reglet for the roofer to install the copper flashing over the water table. This is along the south elevation of the south wing.

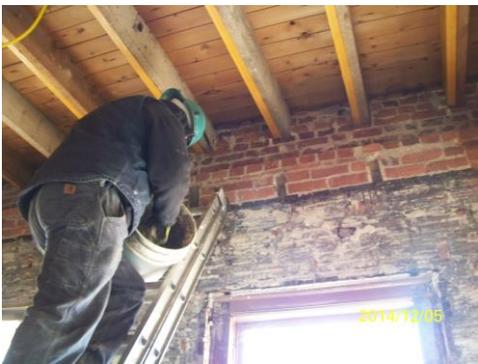
Photo showing a mason in the process of infilling the masonry pockets from removed joists.

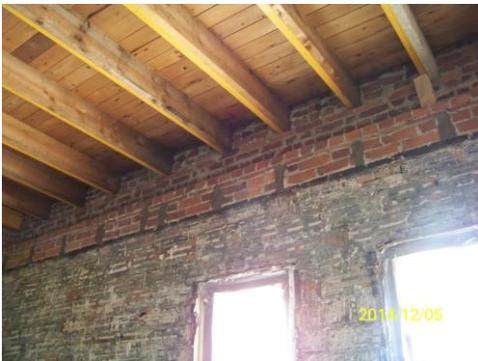
Photo showing the masonry pockets infilled.

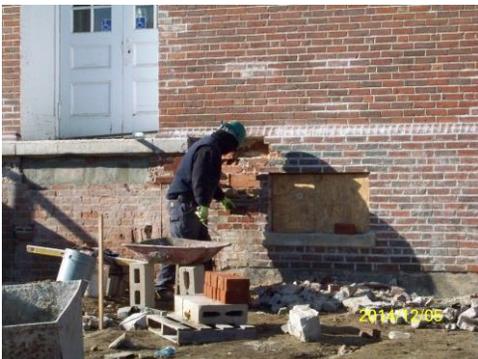
Photo showing a mason bricking in a void on the front (east) elevation of the building.

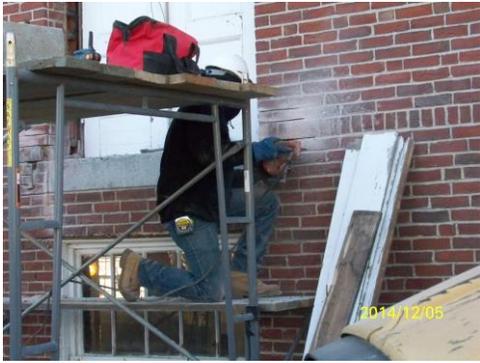
Photo showing a mason in the process of removing the stone sill from the meeting hall door on the north elevation.

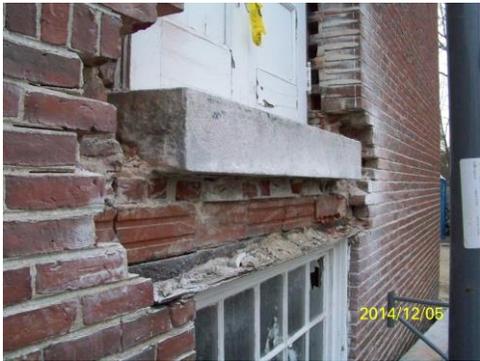
Photo showing exposed sill and lintel on the north elevation of the meeting hall ready to be removed.

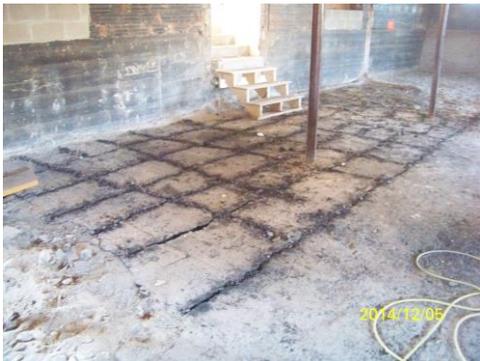
Photo showing the asphalt in the basement being sectioned for easier removal.

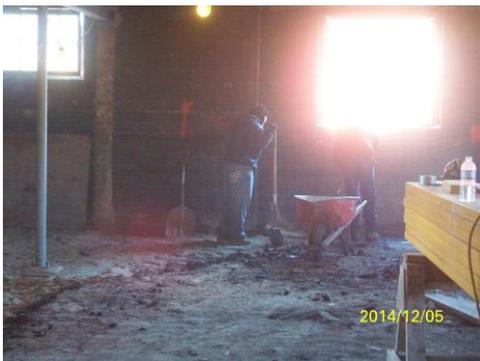
Photo showing workmen in the process of removing the asphalt from the basement.

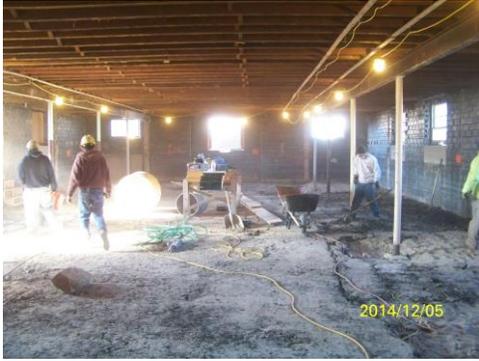
Photo showing workmen in the process of removing the asphalt.

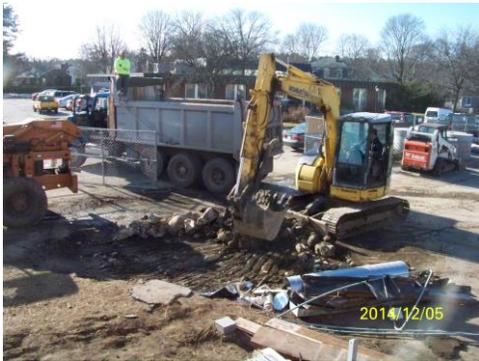
Photo showing site work crew in the process of removing debris from the site.

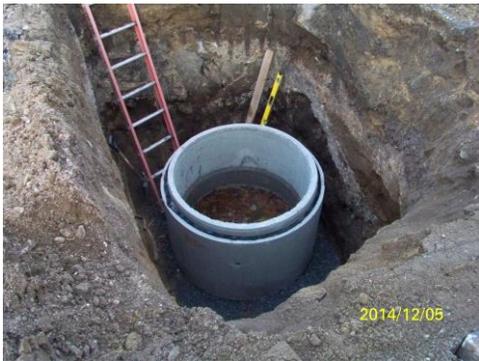
Photo showing catch basin installed in the parking lot.

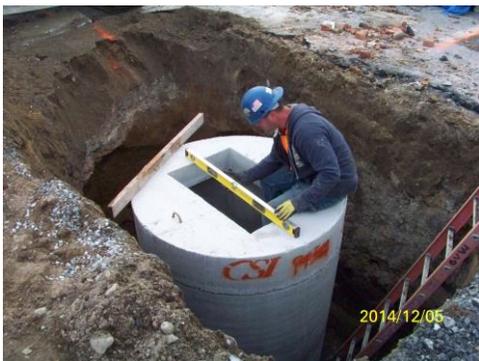
Photo showing catch basin being made level.

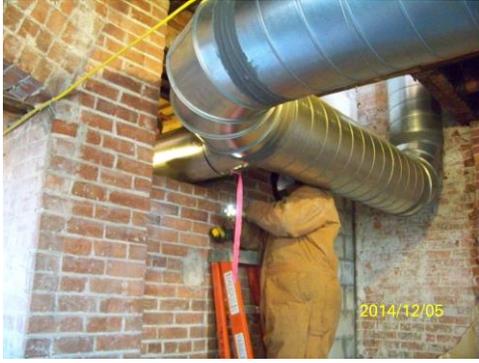
Photo showing temp facility workman sealing the duct seams for the temp heat system.

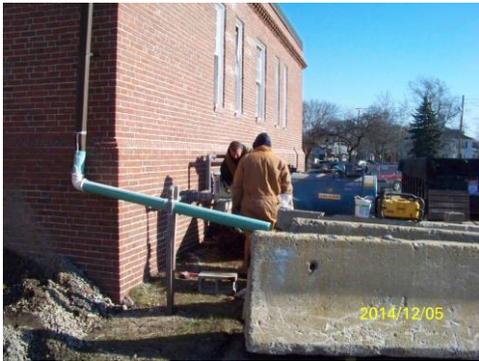
Photo showing workmen completing the installation of the temp heating system.

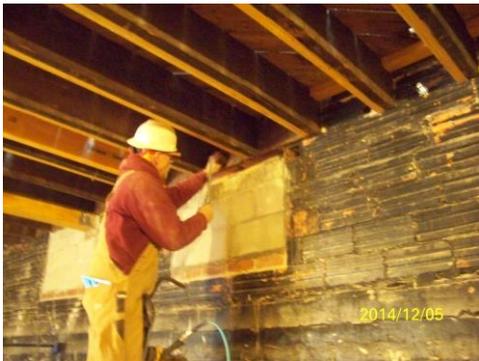
Photo showing a carpenter installing the bolts for the tie-backs.

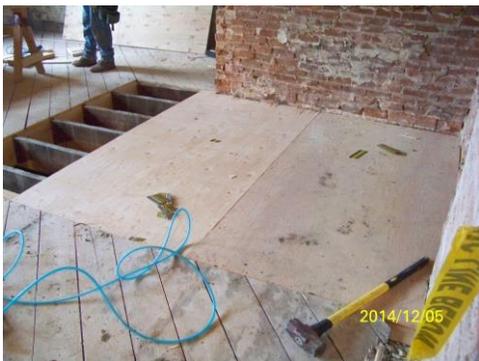
Photo showing the floor of the north wing being infilled.

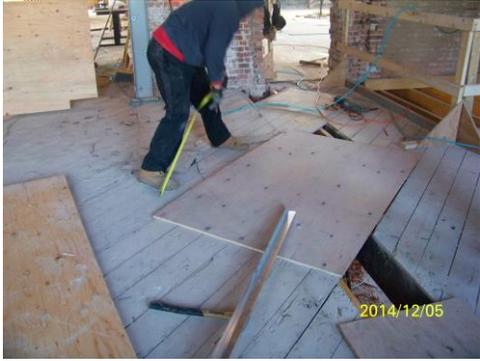
Photo showing carpenter laying out for floor infill.

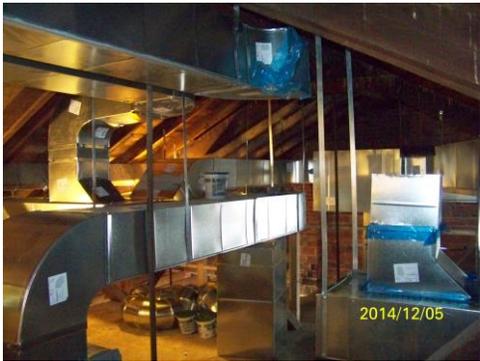
Photo showing ductwork in place in the attic.

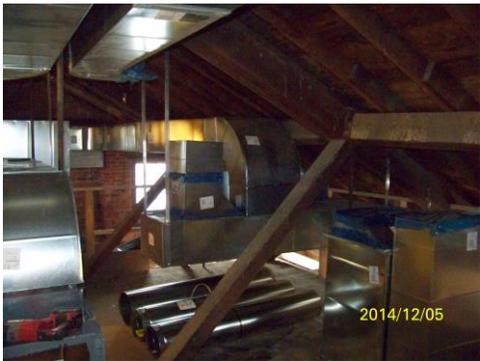
Photo showing ductwork in place in the attic.
