PROJECT REPRESENTATIVE'S DAILY REPORT

Pg. 1
 Report No. 080
 Date: 2014-12-11
 Day: Thursday

Project: Renovation and Addition to Tewksbury Town Hall

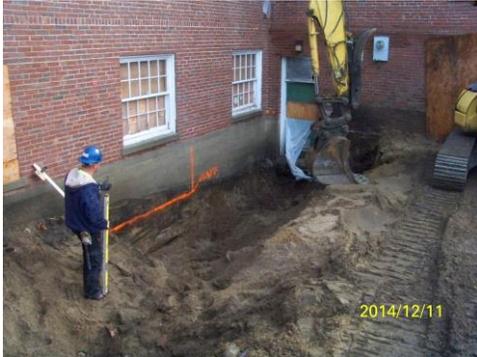
Photo showing excavation continuing along the south elevation of the meeting hall for the addition.

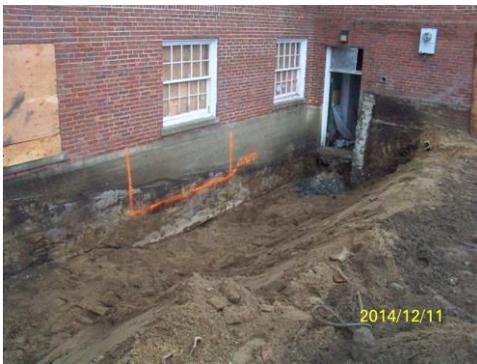
Photo showing extent of excavation and approximate location of elevator pit.

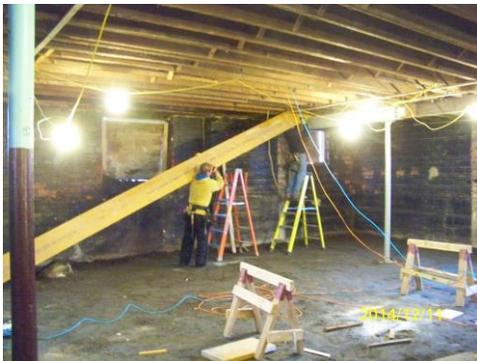
Photo showing carpenters in the process of installing the LVL beam for the 1st floor framing at the west end of the meeting hall.

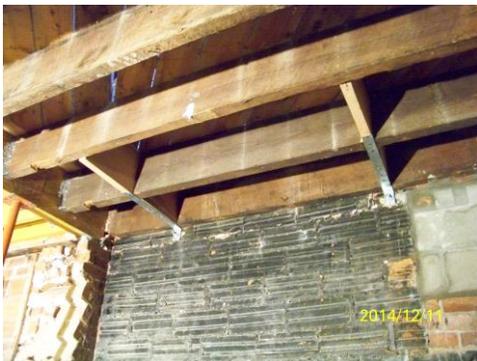
Photo showing tie-backs installed in the north wing for the 1st floor framing.

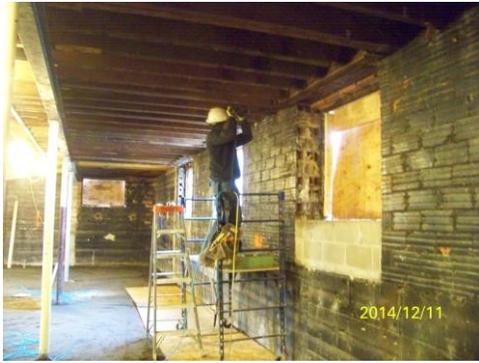
Photo showing carpenter starting the tie-back installation along the south wall of the basement.

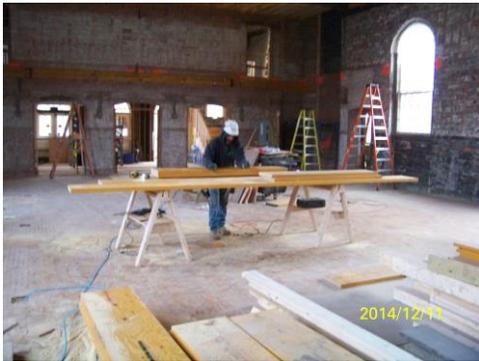
Photo showing carpenter prepping to continue the framing for the 2nd floor.

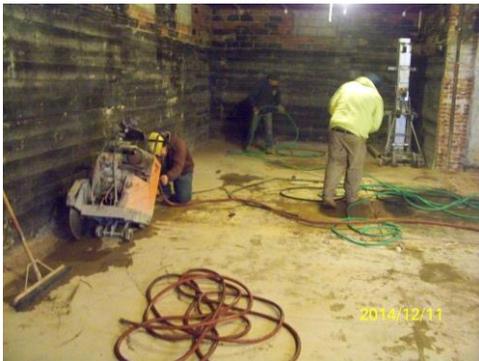
Photo showing workmen prepping to cut out and remove the concrete slab in the north wing of the basement.

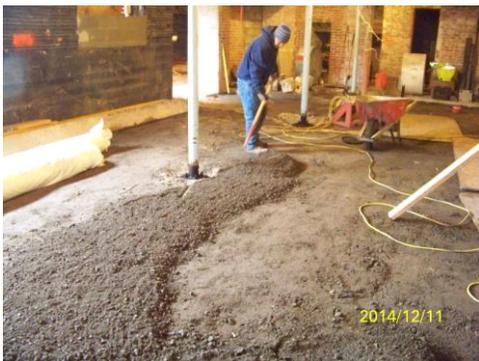
Photo showing workman placing additional fill for the basement subfloor in anticipation of placing the concrete slab next week.

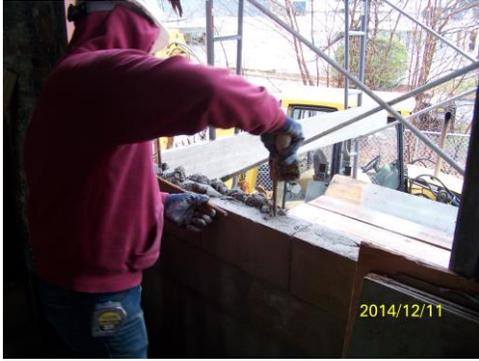
Photo showing mason working on blocking up the doorway on the north elevation of the meeting hall.

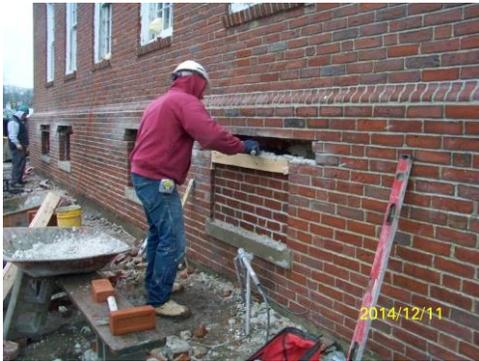
Photo showing masons working on removing lintels from above window openings to be bricked in, and bricking in those openings.

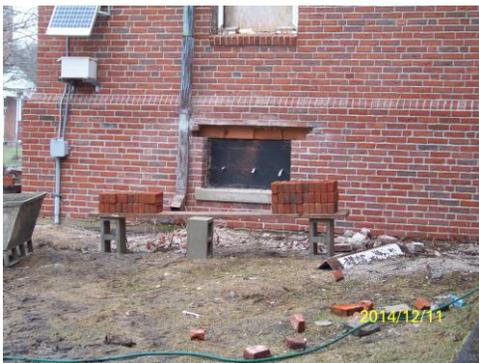
Photo showing a window opening with the lintel removed. This window is ready to be bricked in.

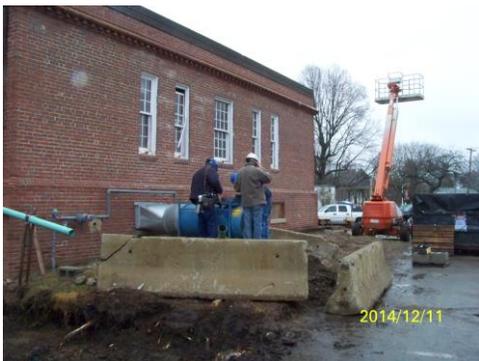
Photo showing electricians trying to get the gas fired heater operating for the temp heat.
