PHOTO INDEX

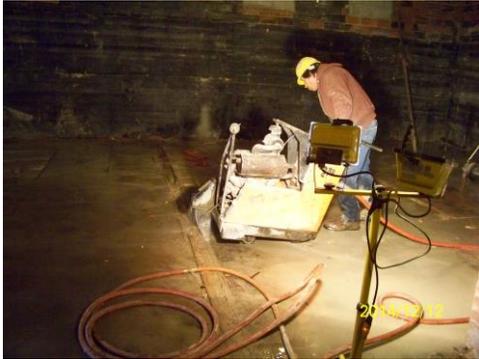
Photo showing workman cutting the concrete slab in the north wing of the basement for easier removal.

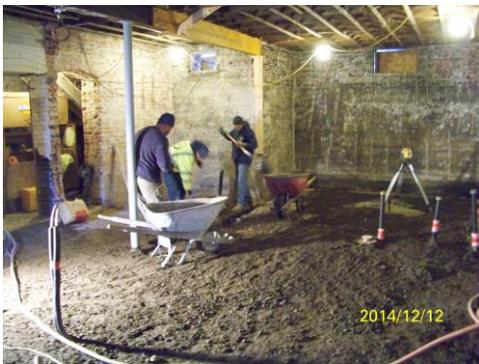
Photo showing workmen backfilling the mechanical room.

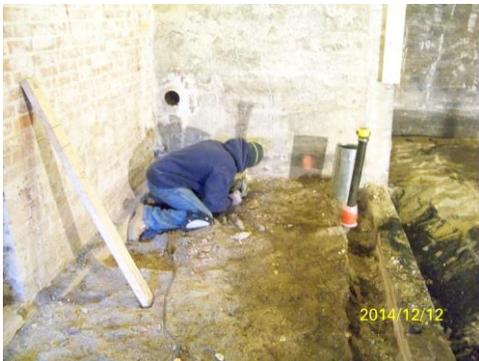
Photo showing workman drilling holes for dowels for new slab. This is in the south wing of the basement.

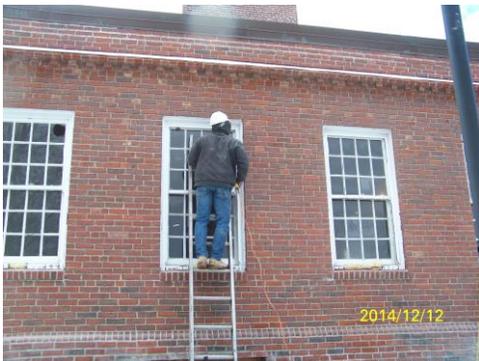
Photo showing mason removing the paint from the face of the brick around the window opening.

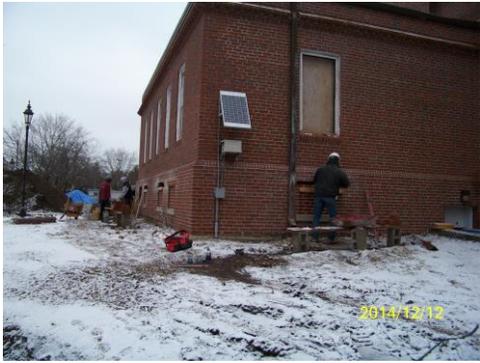
Photo showing masons working on bricking in window openings after the lintels were removed.

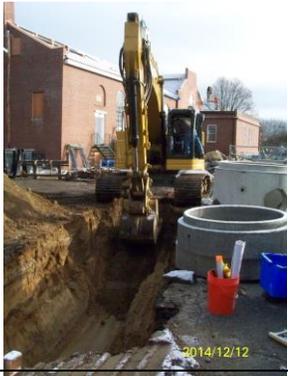
Photo showing excavation for drain pipe from manhole towards building.

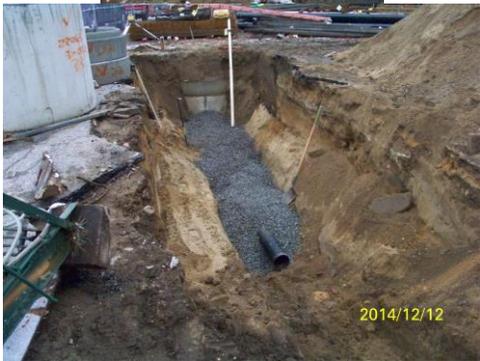
Photo showing drain pipe in place leading to the drain manhole.

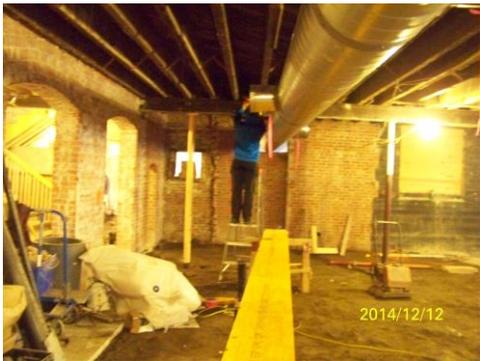
Photo showing carpenter laying out for LVL beam installation. This is at the east end of the meeting hall.

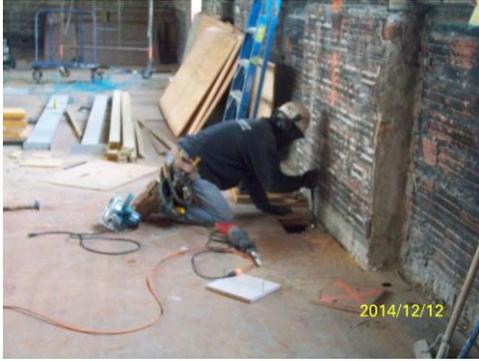
Photo showing carpenter making hole in meeting hall floor for 2nd floor framing.

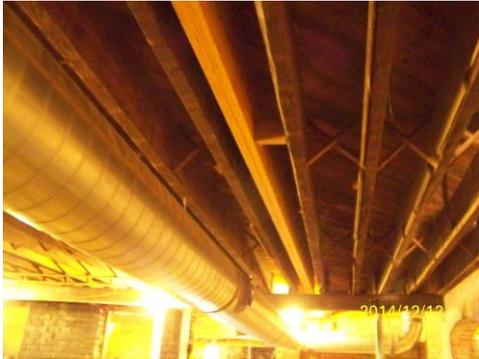
Photo showing LVL beam in place at the east end of the meeting hall framing.

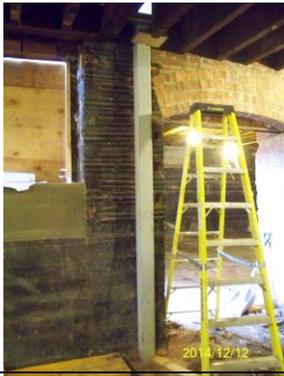
Photo showing post in place in the basement.

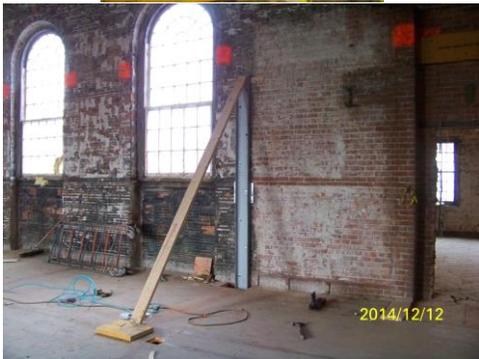
Photo showing channel in place in the meeting hall for the 2nd floor framing. This is directly above the post seen in the previous photo.

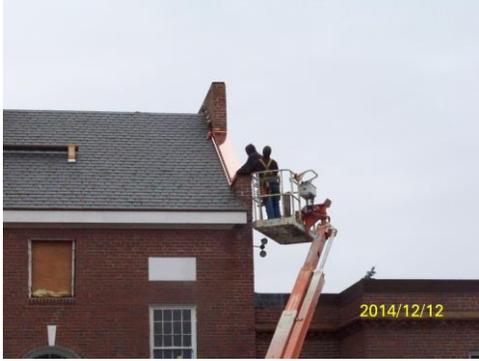
Photo showing the roofers installing the parapet cap on the north parapet.

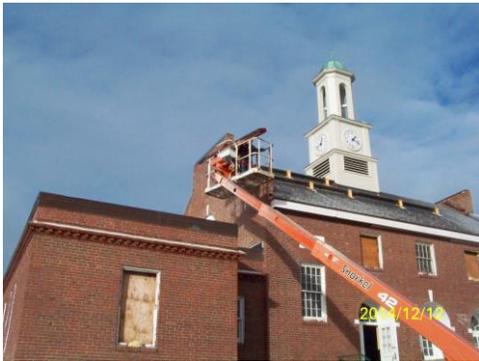
Photo showing roofers installing the parapet cap on the south parapet.

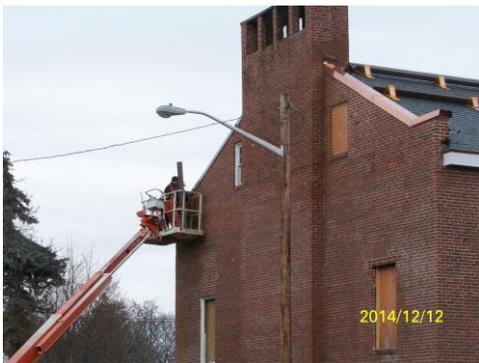
Photo showing roofers working on the north end of the parapet, west elevation.
