# PHOTO INDEX

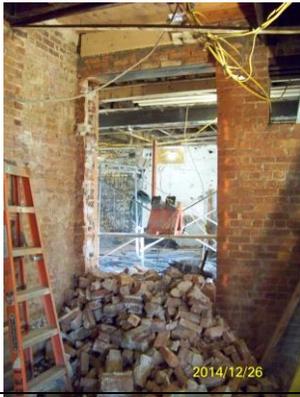
Photo showing masonry opening in a basement wall. This will become a doorway.

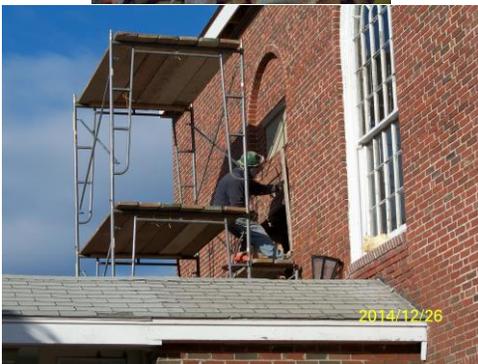
Photo showing a mason working on the south elevation of the meeting hall, creating a new window opening.

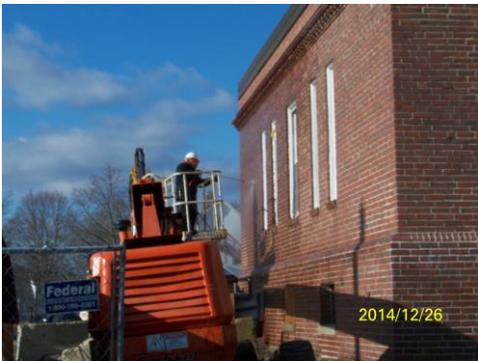
Photo showing a mason washing down the masonry on the south elevation of the south wing.

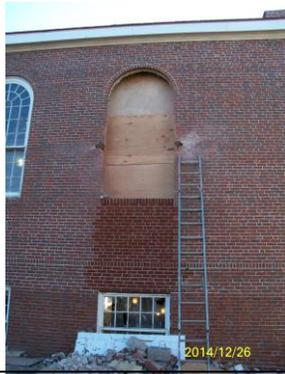
Photo showing completed masonry window opening on the north elevation of the meeting hall.

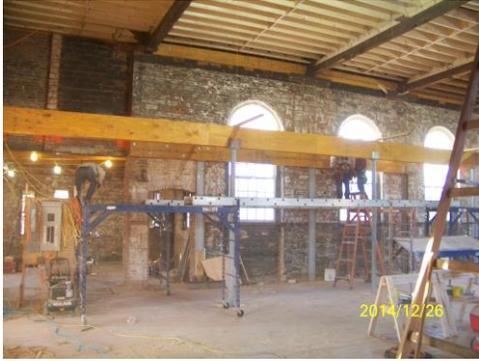
Photo showing carpenters working on the 2<sup>nd</sup> floor framing along the south wall of the meeting hall.

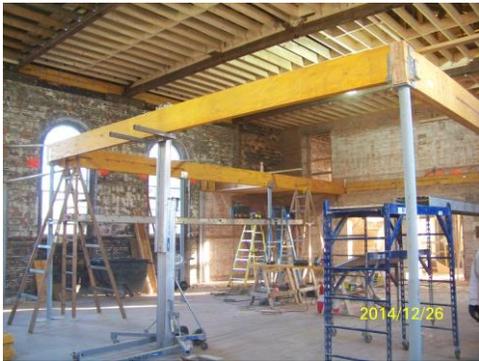
Photo showing 2<sup>nd</sup> floor rough framing in place.

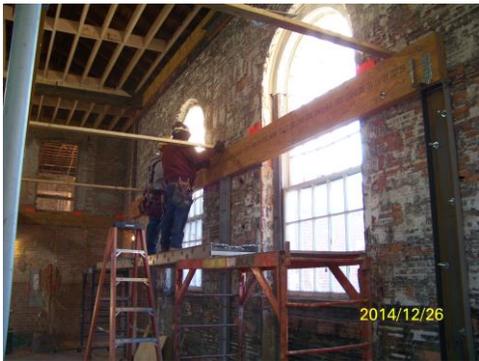
Photo showing carpenters installing rim joists along the south wall of the meeting hall. The two windows will be removed as the addition will be in this approximate location.

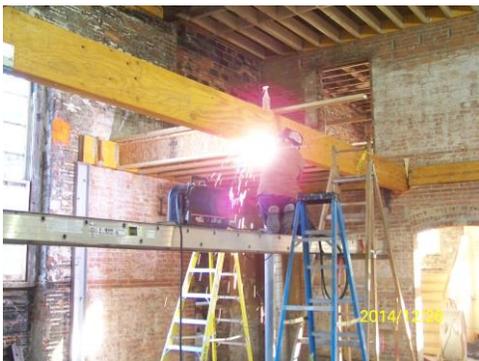
Photo showing welding taking place to secure the metal saddle to the top plate of the post.

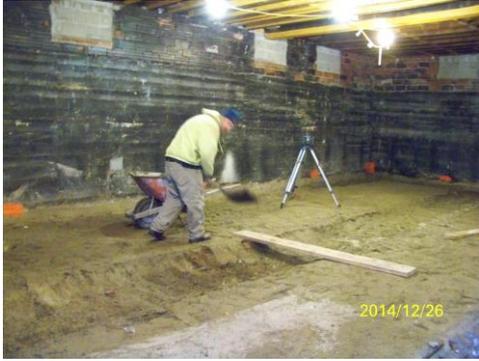
Photo showing workman preparing the north wing basement subfloor for concrete.

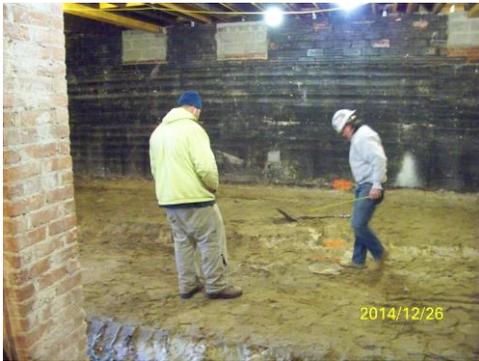
Photo showing workmen reviewing the prepped subfloor.

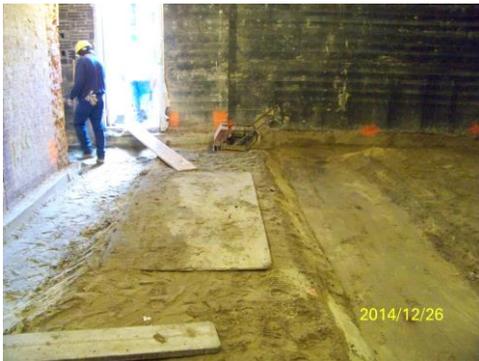
Photo showing the subfloor in the process of being compacted.

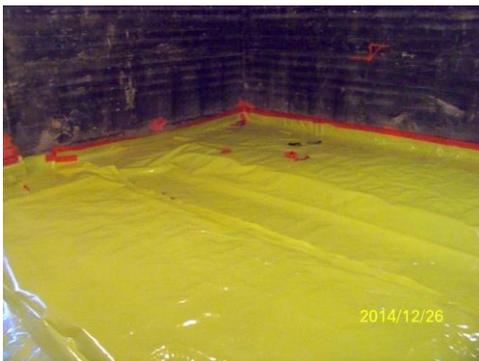
Photo showing the vapor barrier in place on the subfloor. The next step will be to have the reinforcement installed.

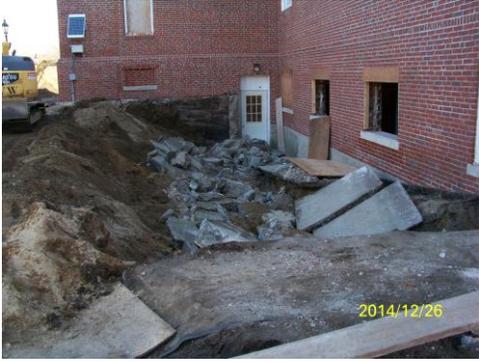
Photo showing the wall and ramp along the north elevation being demolished.
