PHOTO INDEX

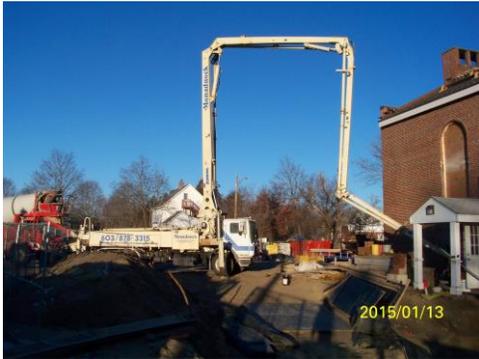
Photo showing the concrete pump truck in place pumping concrete into the basement.

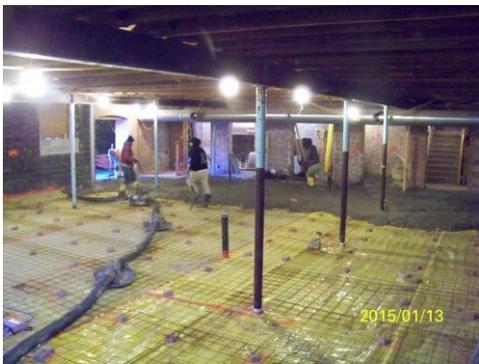
Photo showing the workmen spreading the concrete starting east and moving west.

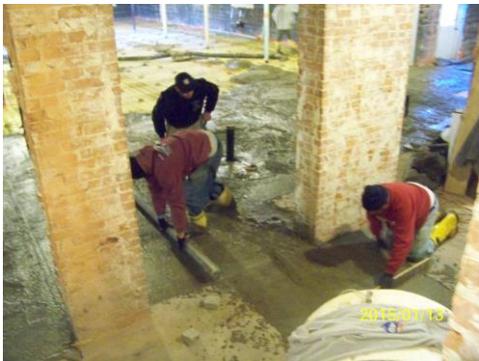
Photo showing the workmen working the concrete into place.

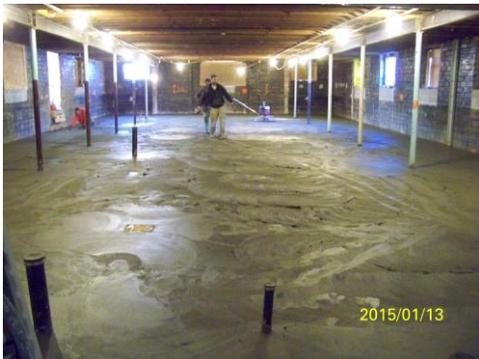
Photo showing the finishing process of the concrete in progress.

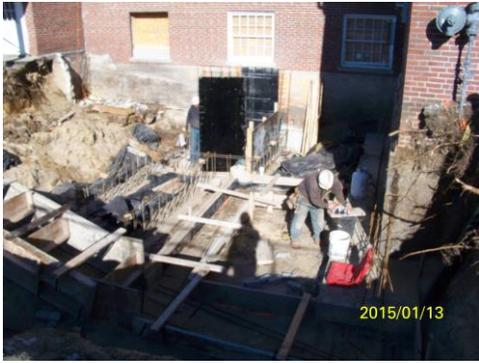
Photo showing additional formwork being installed for the addition.

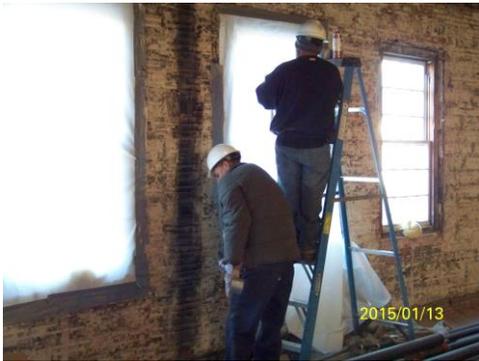
Photo showing abatement crew taping windows before the abatement process begins.

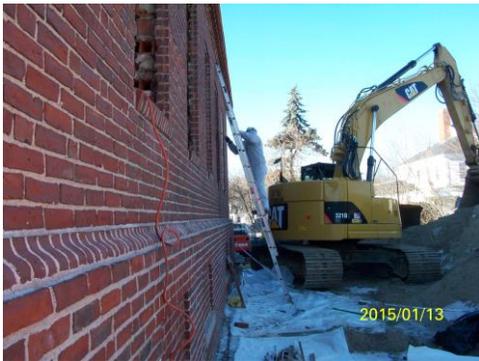
Photo showing a worker abating a window on the north elevation of the north wing.

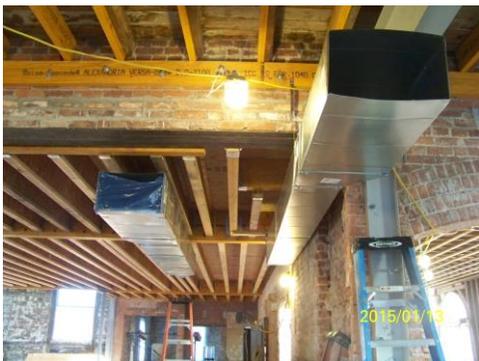
Photo showing some ductwork installed for the 1st floor.

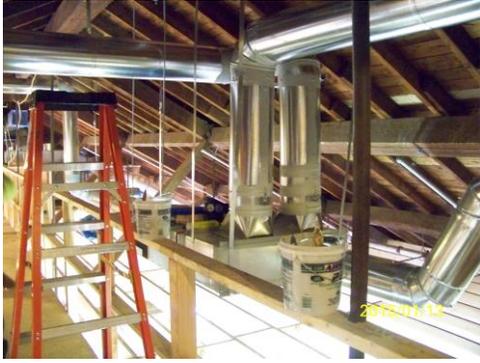
Photo showing HVAC ductwork in place in the attic.

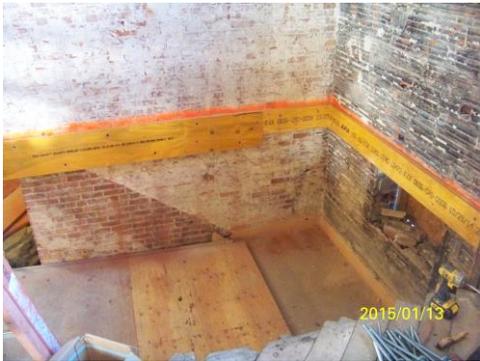
Photo showing the beginning of the framing for the south stairs (stair #3).

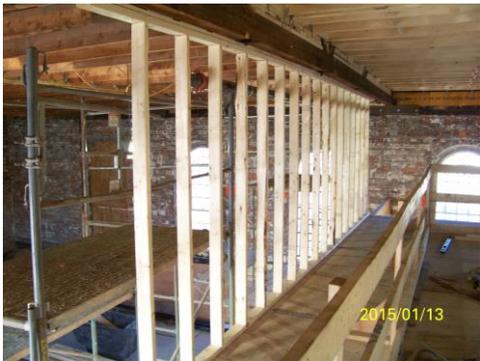
Photo showing a portion of the stud wall for the 2nd floor in place.

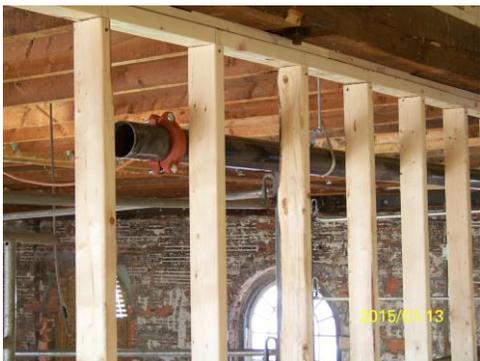
Photo showing the sprinkler pipe behind the studs.

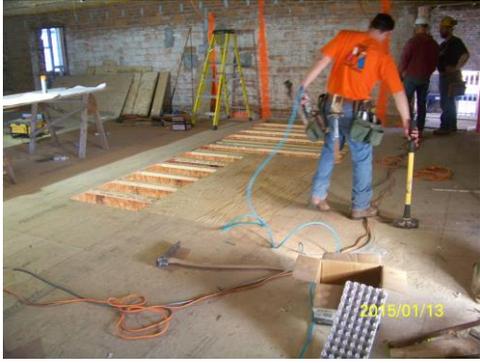
Photo showing carpenter installing marine grade plywood at the bathroom locations on the 2nd floor.
