PHOTO INDEX

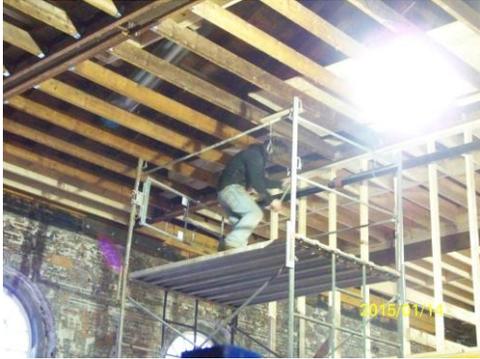
Photo showing workman installing sprinkler pipe for the meeting hall.

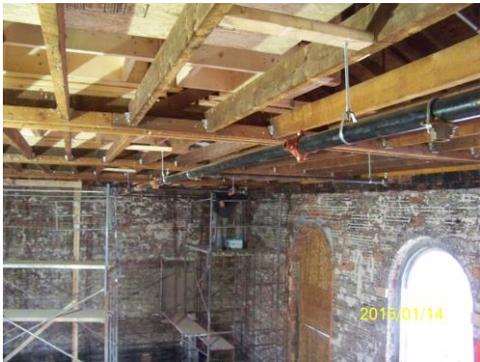
Photo showing some of the sprinkler pipe installed in the meeting hall.

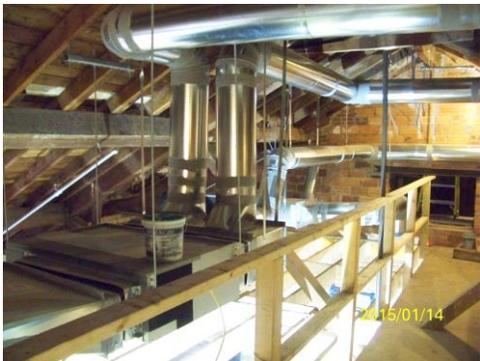
Photo showing additional ductwork installed in the attic.

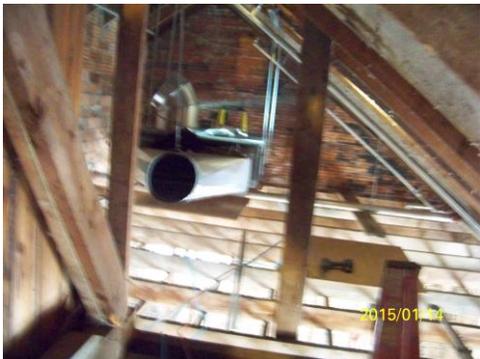
Photo showing HVAC unit installed in the attic along the east elevation.

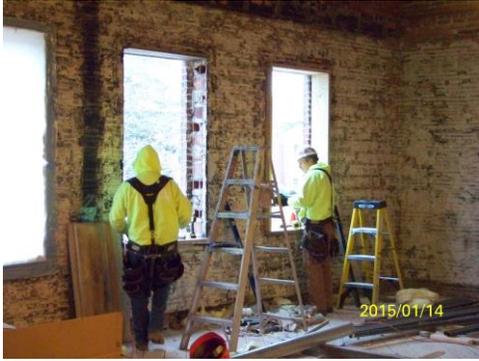
Photo showing carpenters installing blocking for the new windows.

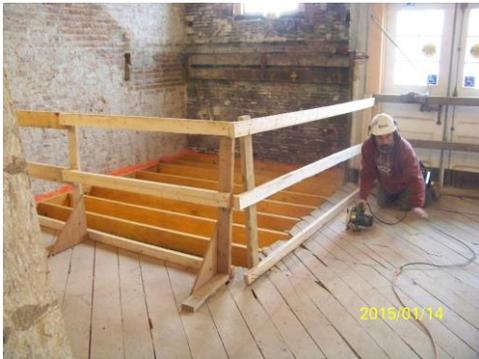
Photo showing carpenter working on the infill framing for stair #3.

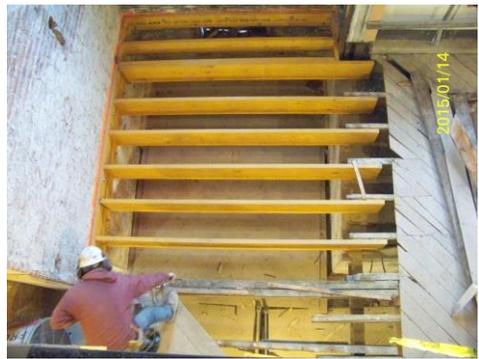
Photo showing the infill framing for stair #3.

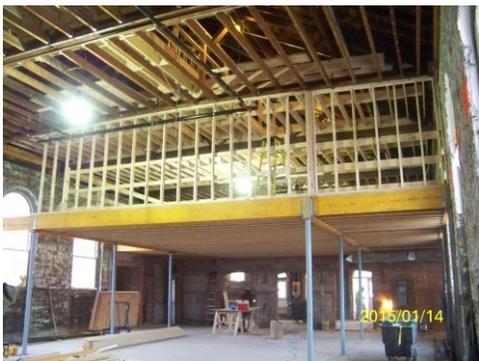
Photo showing the wood stud wall in place for the 2nd floor.

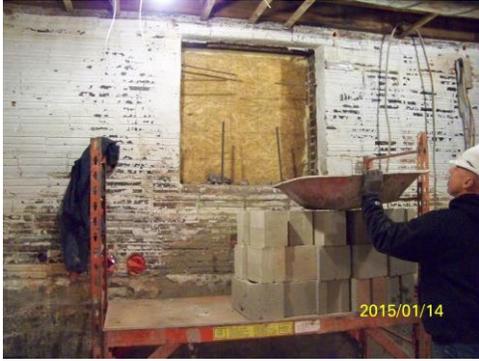
Photo showing mason setting up to infill a window opening on the west elevation of the south wing, basement.

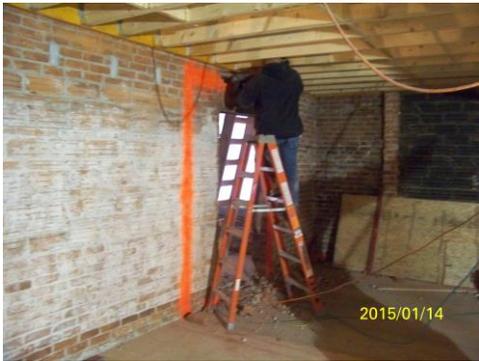
Photo showing mason working on making an existing doorway wider.

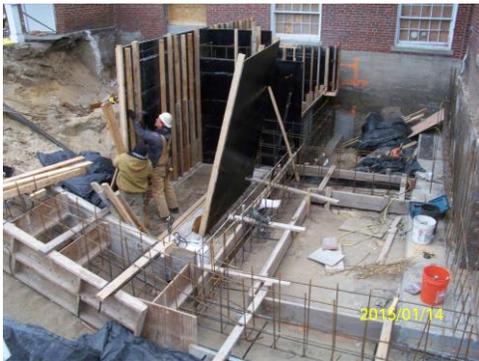
Photo showing workmen erecting formwork for the addition.

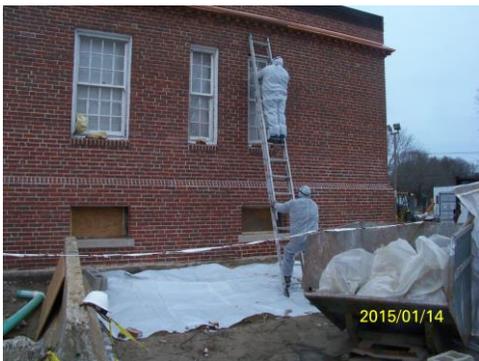
Photo showing abatement crew working on windows on the south elevation of the south wing.

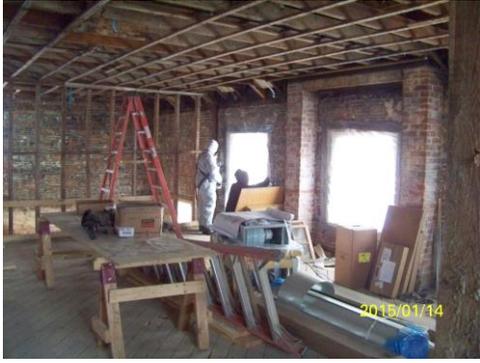
Photo showing abatement crew prepping windows for removal on the east elevation of the main building.
