PROJECT REPRESENTATIVE'S DAILY REPORT

Pg. 1
 Report No. 103
 Date: 2015-01-16
 Day: Friday

Project: Renovation and Addition to Tewksbury Town Hall

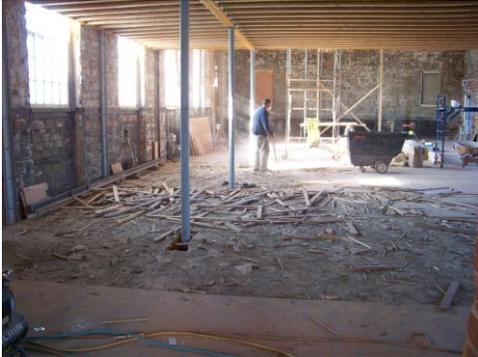
Photo showing workman removing the hardwood floor from the meeting hall.

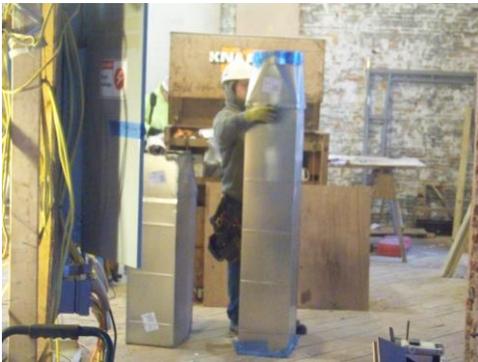
Photo showing tin knocker assembling ductwork.

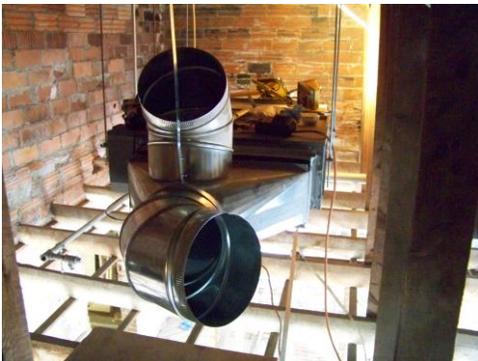
Photo showing additional HVAC equipment installed in the attic of the main building.

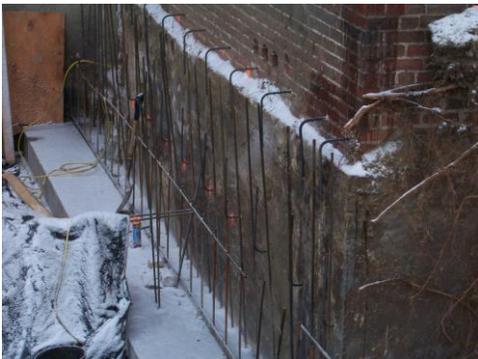
Photo showing additional reinforcement installed along the existing foundation wall per the engineer.

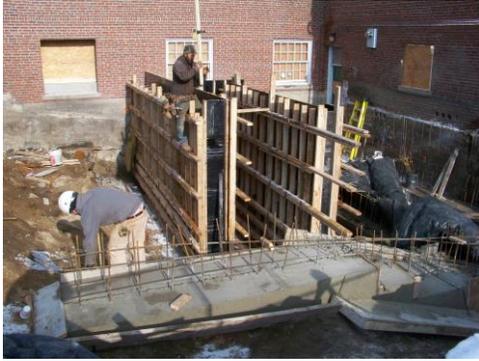
Photo showing workmen installing formwork for the addition.

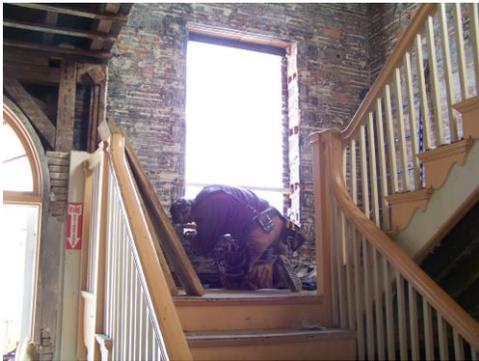
Photo showing carpenter installing blocking for the windows. This is on the east elevation of the main building.

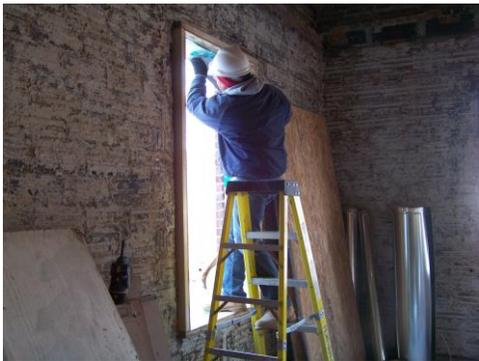
Photo showing a workman installing waterproofing membrane on the wood blocking for the windows.

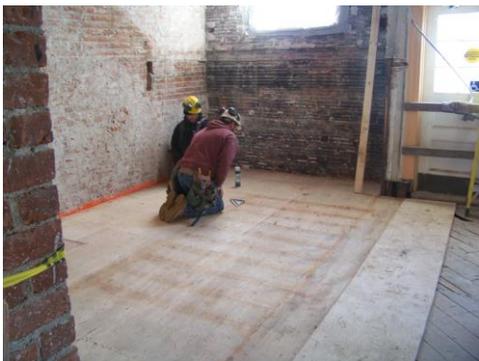
Photo showing carpenters laying out the framing for stair #3.

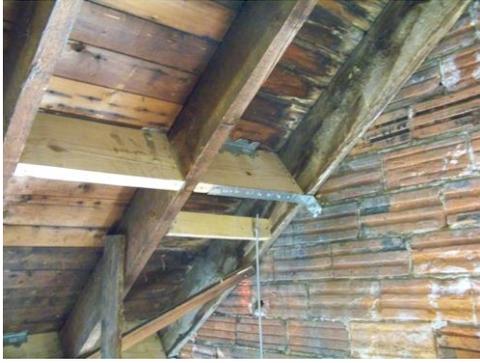
Photo showing tie-back installation along the south gable end of the main building.

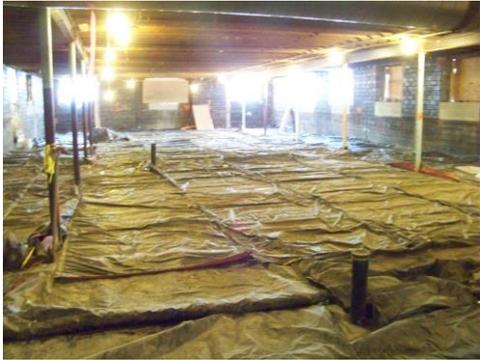
Photo showing the main basement slab covered and wet curing.
