PHOTO INDEX

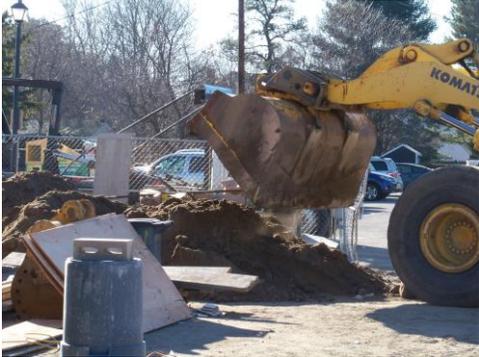
Photo showing soil being moved and stockpiled for backfilling around addition.

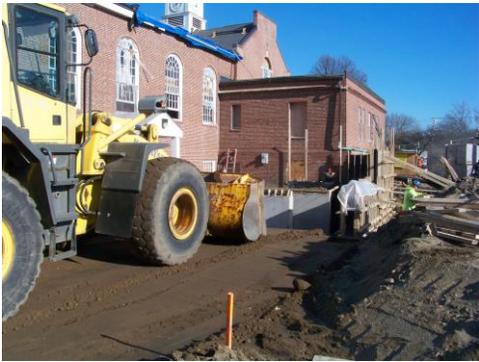
Photo showing the backfilling in progress.

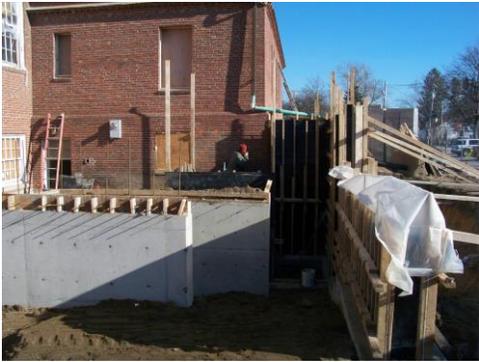
Photo showing a workman prepping the wall for form installation.

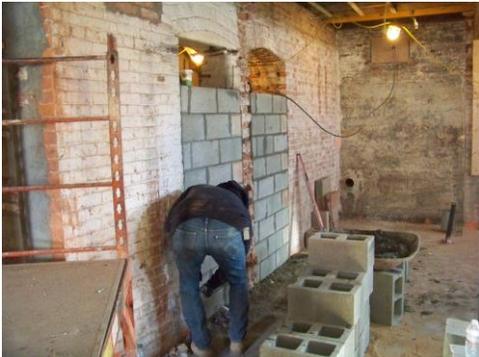
Photo showing mason working on blocking in the doorways in the basement.

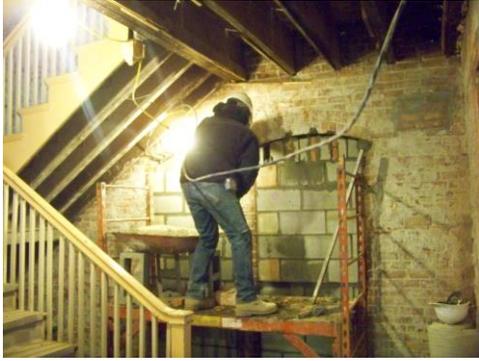
Photo showing mason finishing up the block infill.

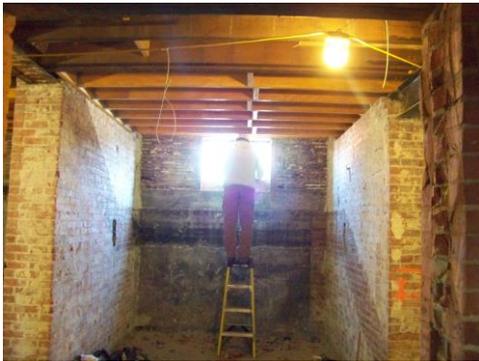
Photo showing carpenter working on blocking for window opening.

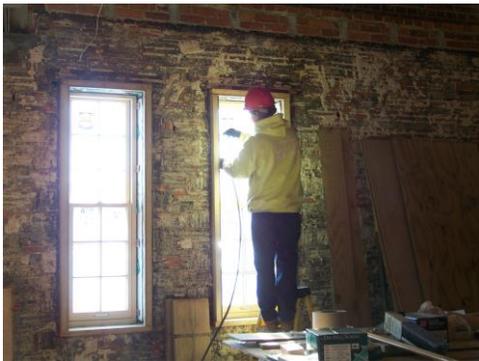
Photo showing carpenter installing backer rod around a window.

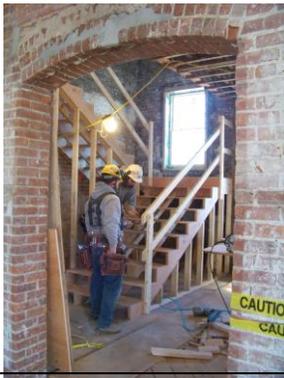
Photo showing stair #3 roughed in.

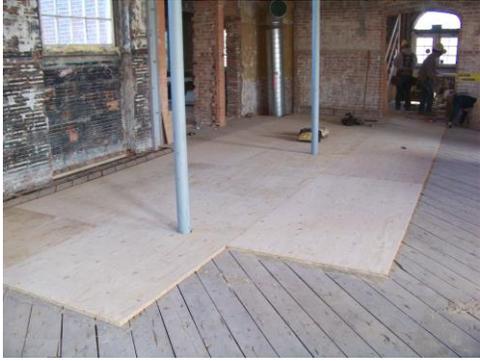
Photo showing plywood underlayment in place in the meeting hall.

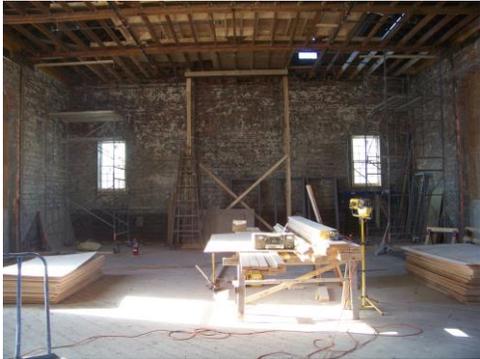
Photo showing meeting hall looking west.

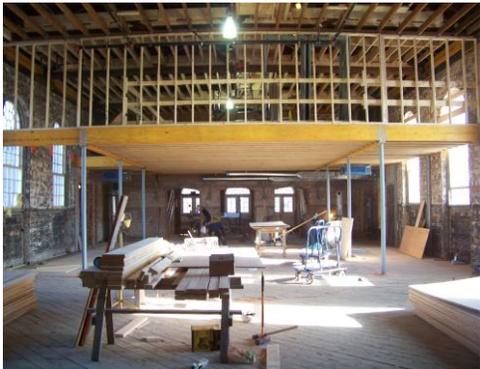
Photo showing meeting hall looking east.
