PHOTO INDEX

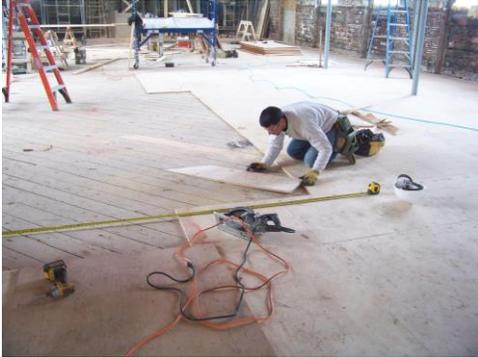
Photo showing the meeting hall subfloor being repaired prior to the plywood being installed.

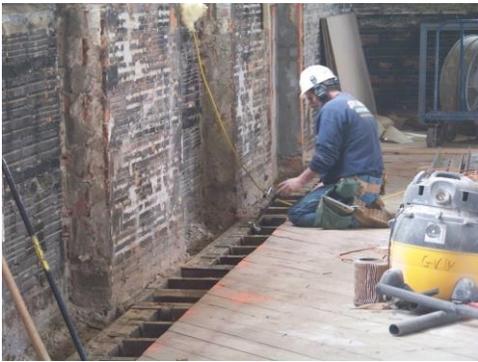
Photo showing a carpenter repairing the subfloor along the south wall of the meeting hall.

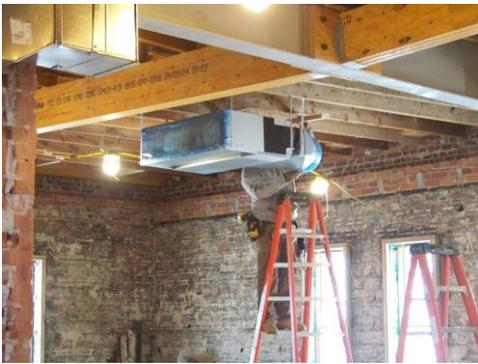
Photo showing tin knocker attaching ductwork to HVAC equipment on the 1st floor, south wing.

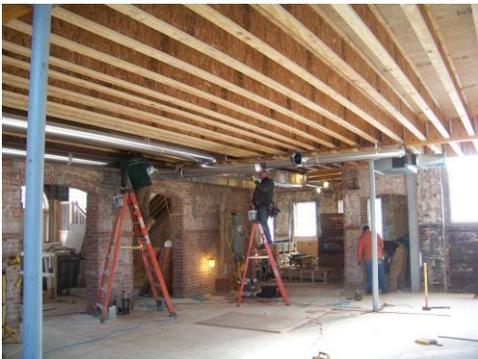
Photo showing tin knockers installing ductwork and sealing the ductwork joints. This is in the meeting hall.

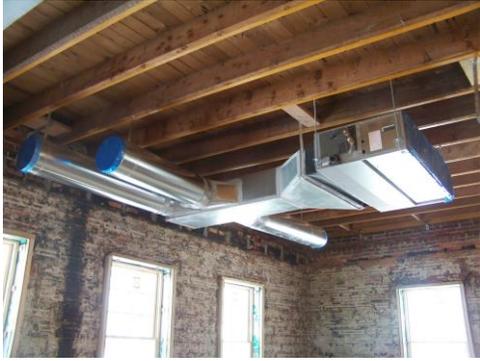
Photo showing ductwork installed for a piece of HVAC equipment.
