PHOTO INDEX

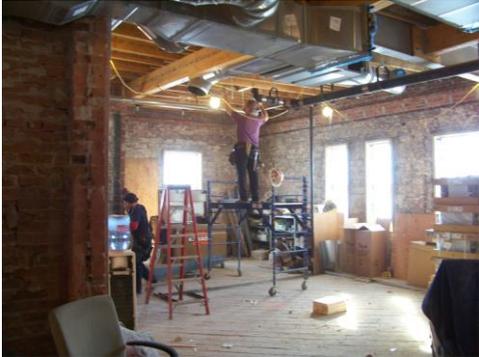
Photo showing carpenter installing wall track for the clerk's office.

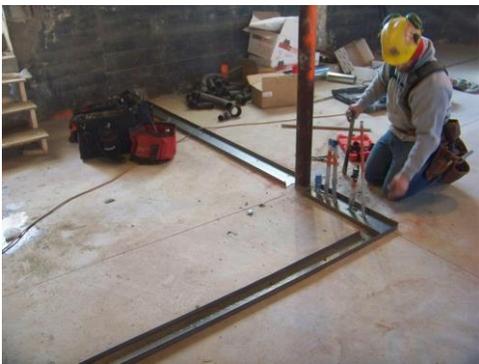
Photo showing wall track being installed for the nurse's office.

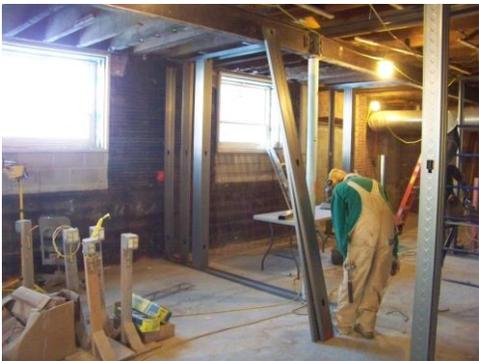
Photo showing stud framing being prepped for the building inspector's office.

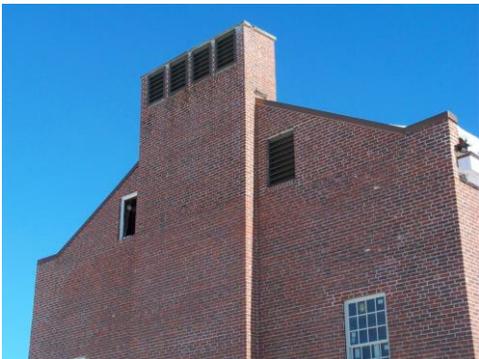
Photo showing one louver in place on the west end of the meeting hall, 2nd floor.

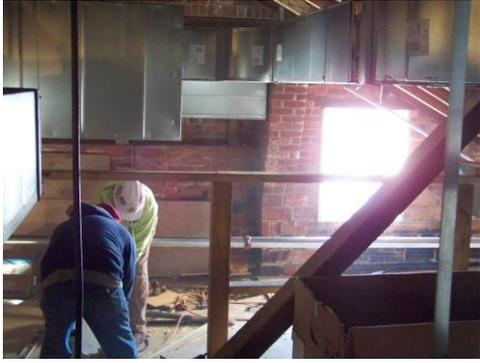
Photo showing carpenters prepping to install the other louver in the west end of the meeting hall.

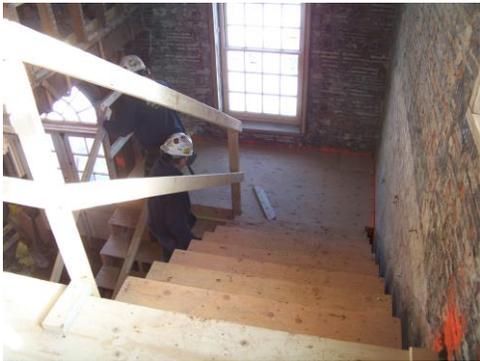
Photo showing stair #2 completed.

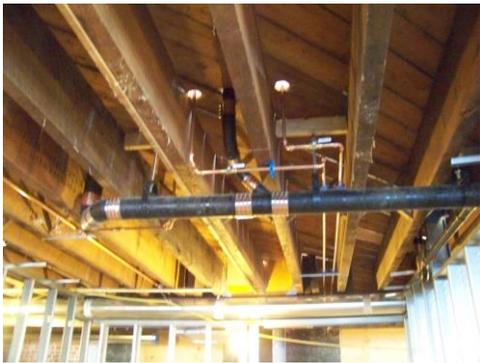
Photo showing some of the plumbing lines in the basement.

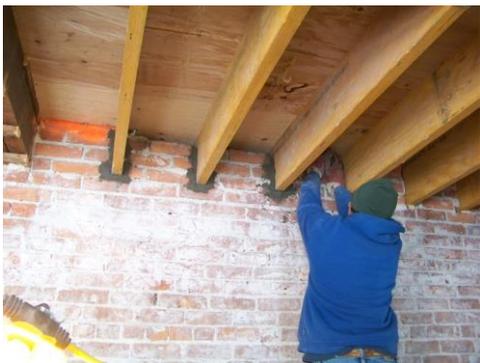
Photo showing workman infilling beam pockets for the 2nd floor landing.

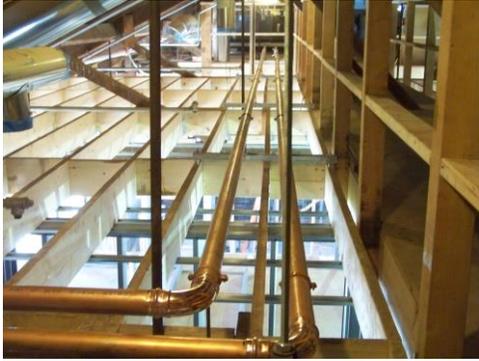
Photo showing some of the heating pipes in place in the attic.

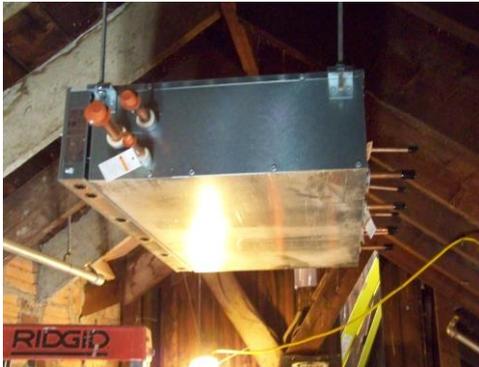
Photo showing fan coil unit in the attic of the main building.

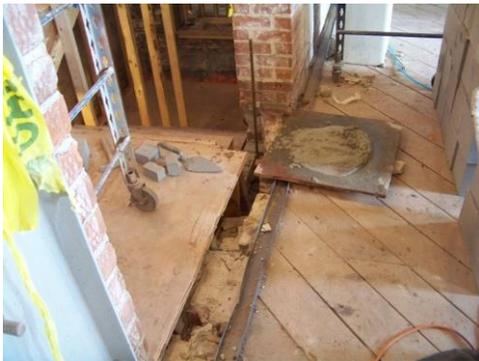
Photo showing masonry opening at the clerk's office that is going to be bricked in.

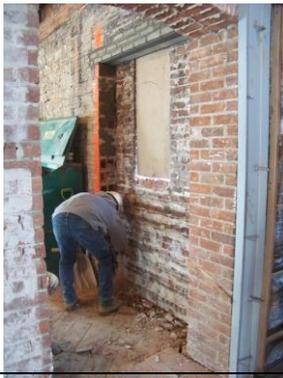
Photo showing mason finishing up at the opening for the lobby of the addition.
