PHOTO INDEX

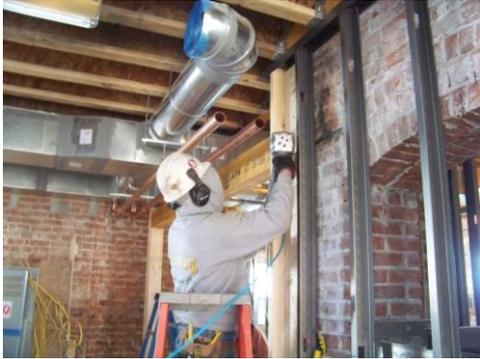
Photo showing carpenter framing in the opening for the Clerk's office service counter.

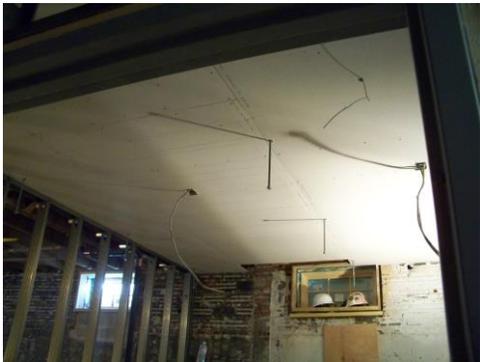
Photo showing sheetrock ceiling being installed in the mechanical room in the basement.

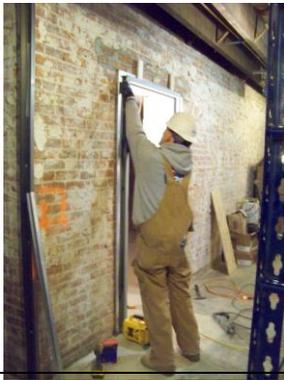
Photo showing carpenter framing doorway for storage room in the basement.

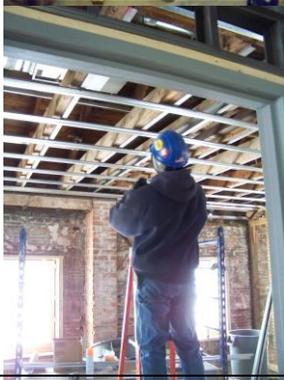
Photo showing electrician installing rough wiring in 2nd floor office.

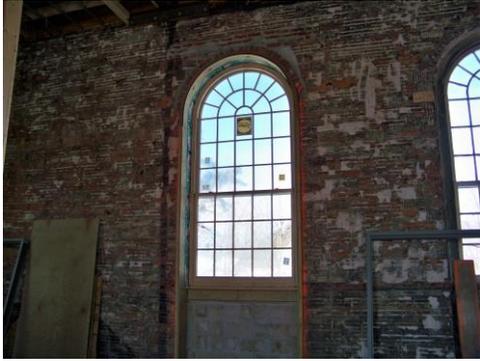
Photo showing window installed in meeting hall on north elevation.

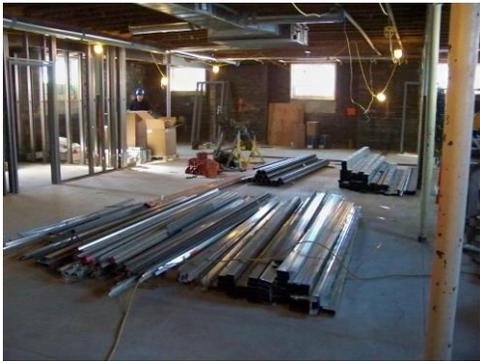
Photo showing framing stock and plumbing supplies stored in the basement.

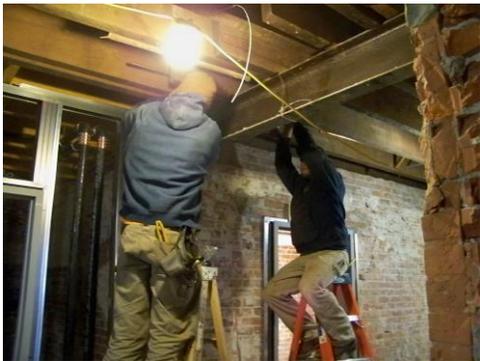
Photo showing plumbers installing piping in the basement.

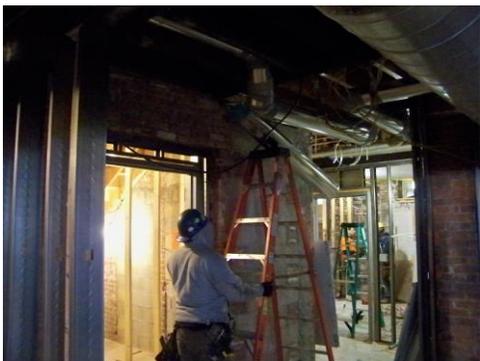
Photo showing tin knocker installing ductwork in the basement.

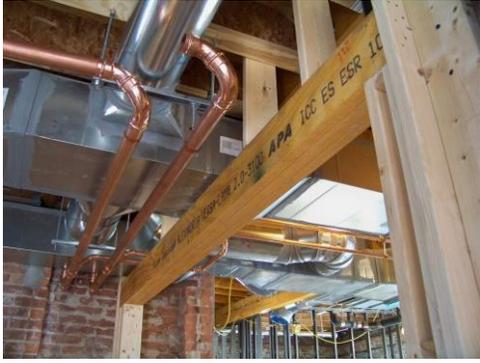
Photo showing framing and mechanical equipment in place.
