PHOTO INDEX

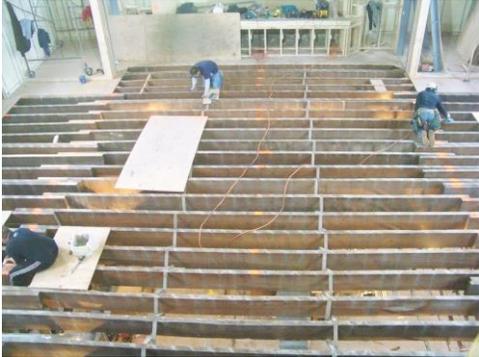
Photo showing carpenters starting to install the plywood subfloor.

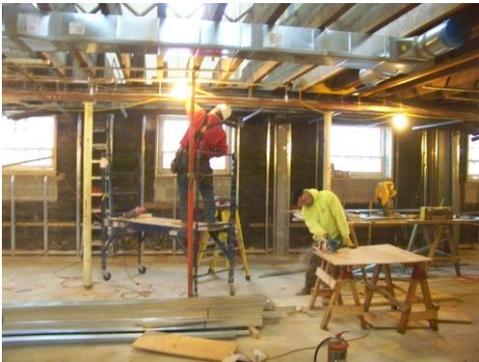
Photo showing carpenter shimming joists before the new subfloor is installed.

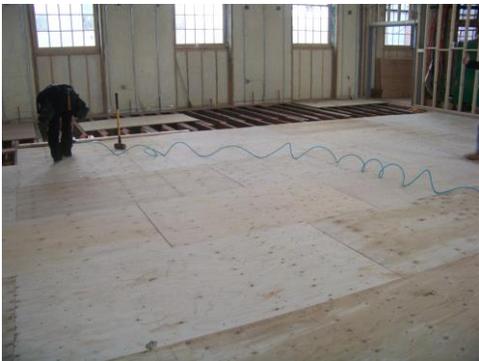
Photo showing the plywood subfloor being installed.

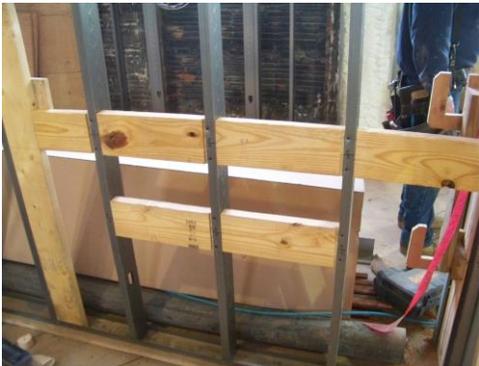
Photo showing the wall blocking installed in the bathrooms. The blocking is used to secure appurtenances such as grab bars, toilet paper dispensers and sinks.

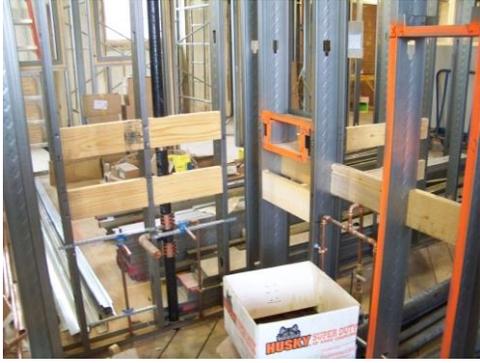
Photo showing typical wall blocking configurations.

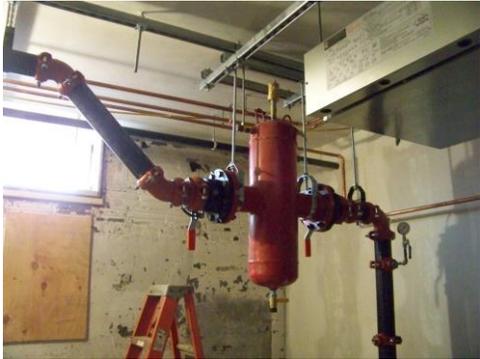
Photo showing some of the fire suppression equipment installed.

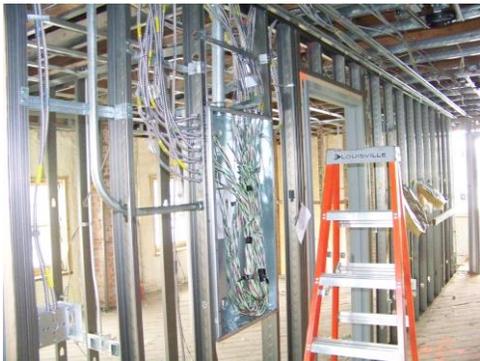
Photo showing electric panel in place in the 2nd floor hallway.

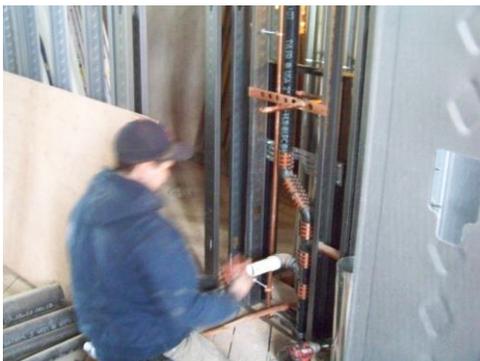
Photo showing plumber getting ready for rough inspection.

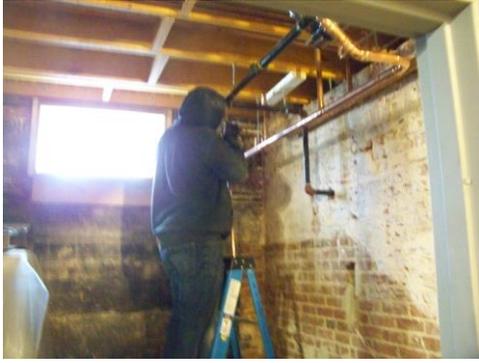
Photo showing HVAC mechanic working in the mechanical room that will service the vault.

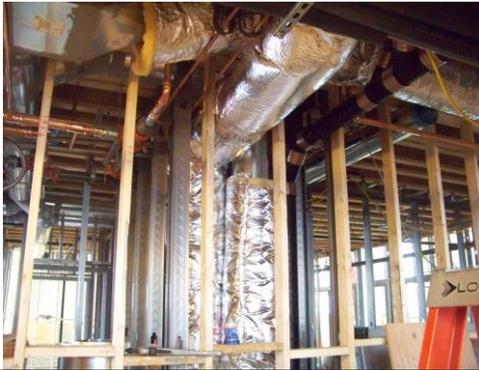
Photo showing some of the duct insulation in place.

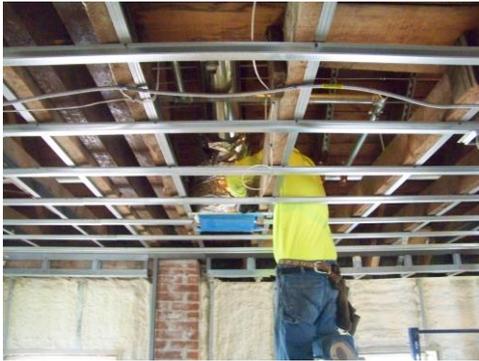
Photo showing workman installing duct insulation.

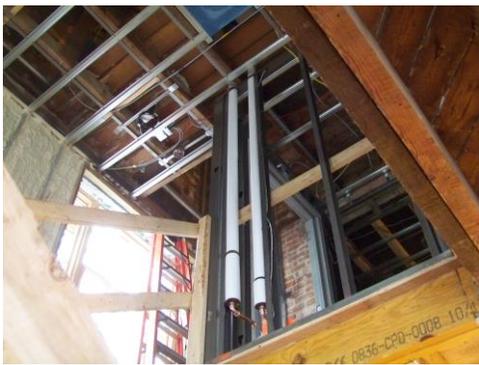
Photo showing some piping insulation in place.
