PHOTO INDEX

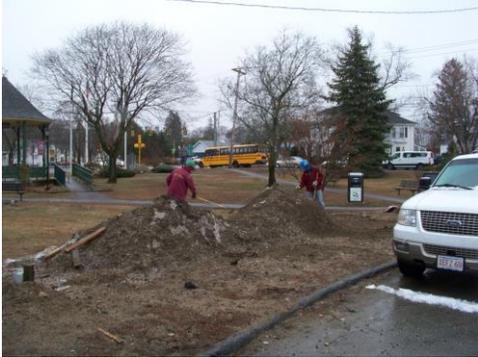
Photo showing workmen clearing debris from snow removal operations.

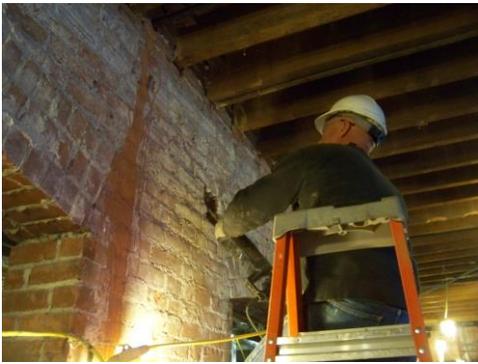
Photo showing mason working on the masonry wall in the lobby.

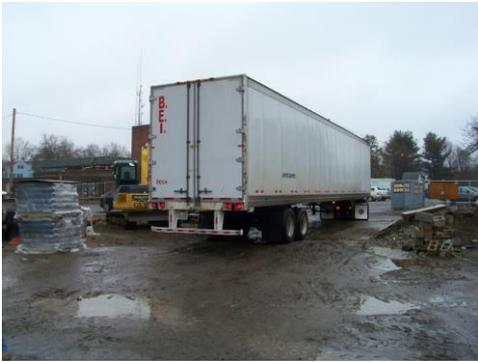
Photo showing delivery truck with the vault.

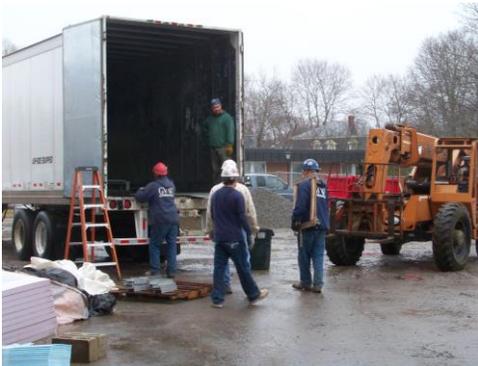
Photo showing the vault starting to be offloaded.

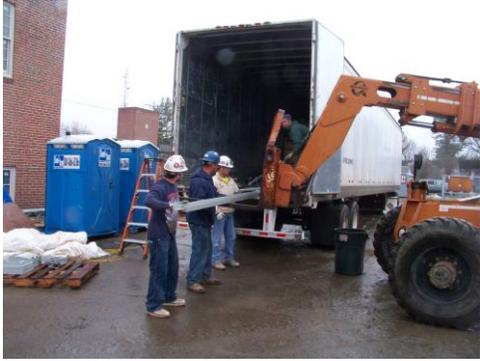
Photo showing vault components being offloaded.

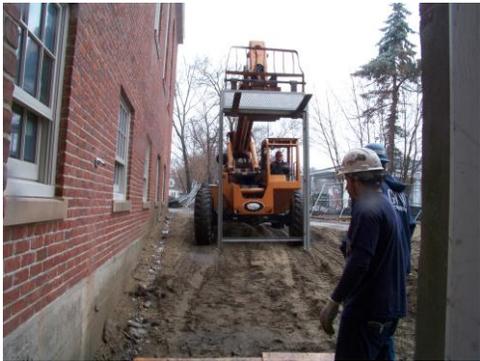
Photo showing vault panels being brought to the building.

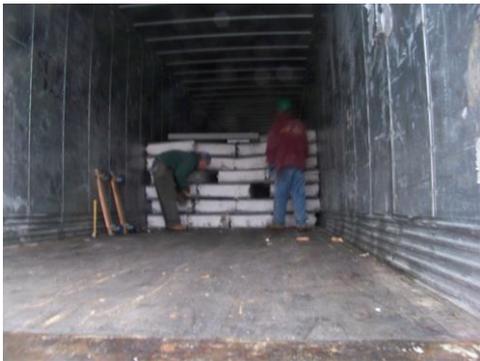
Photo showing vault panels being readied to remove.

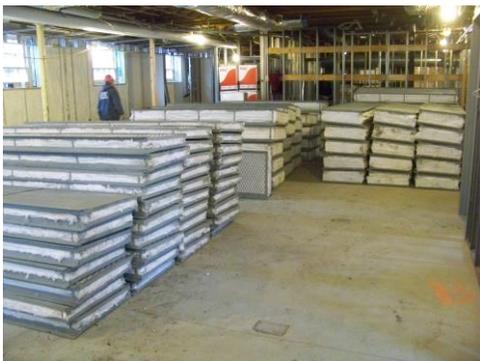
Photo showing vault components stored in the basement.

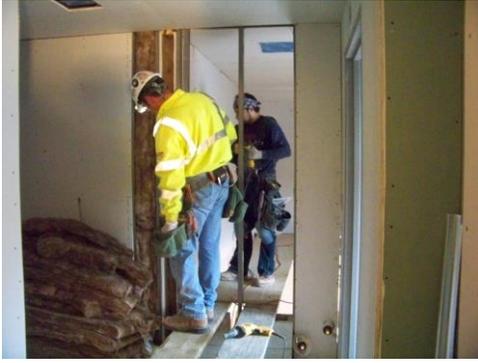
Photo showing carpenters installing GWB on the 2nd floor.

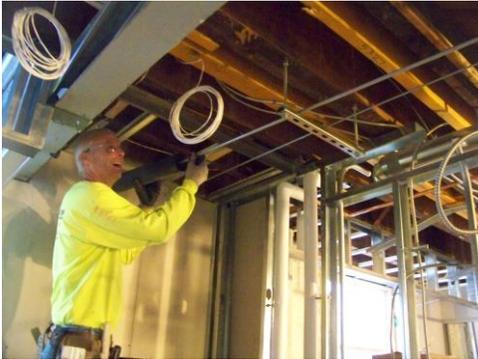
Photo showing insulator plying his trade on the VRV piping in the basement.

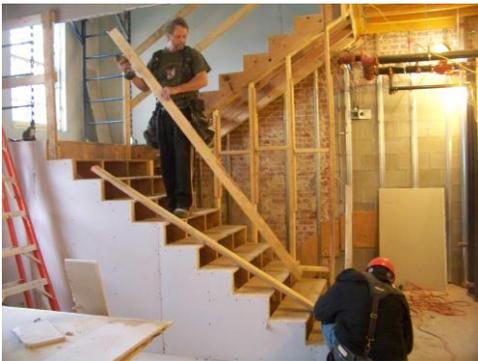
Photo showing carpenters putting temp handrails back in place after installing GWB in the stairwell.

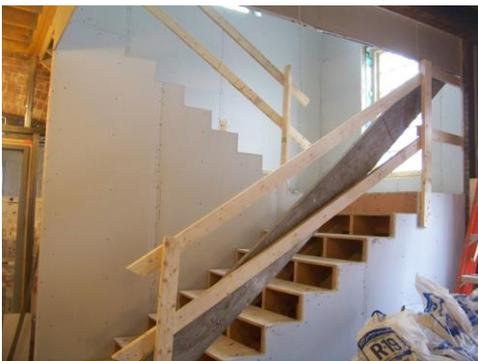
Photo showing stairwell #3 with GWB installed.
