PHOTO INDEX

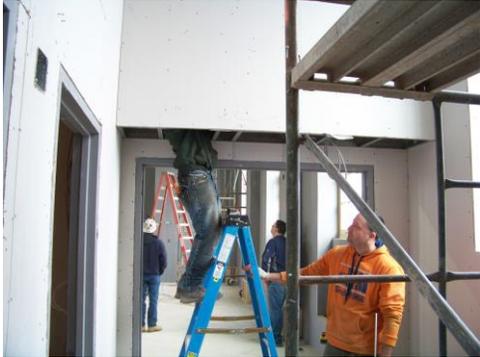
Photo showing fire protection crew working inside a soffit to adjust the sprinkler system.

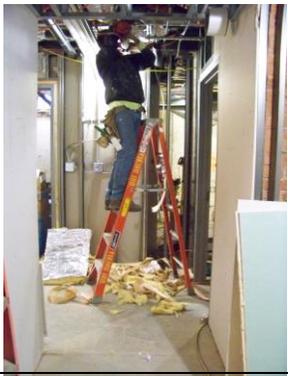
Photo showing workman insulating HVAC piping.

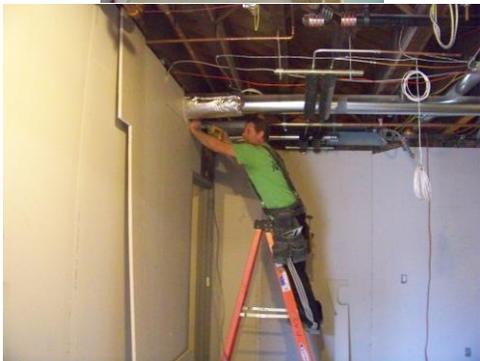
Photo showing carpenter installing sheetrock in an office in the basement.

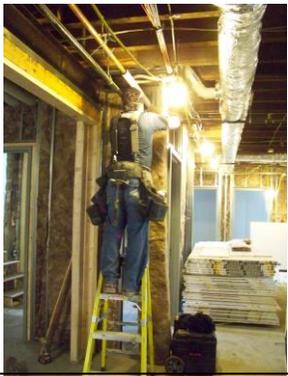
Photo showing acoustical insulation being installed.

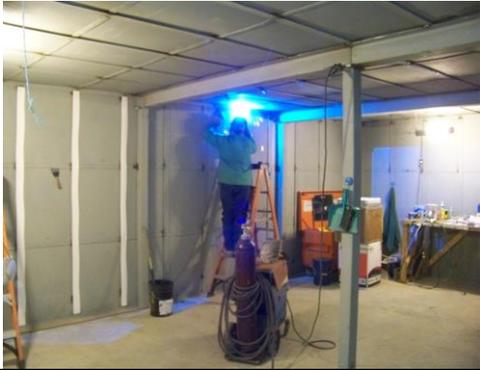
Photo showing workman welding vault panels.

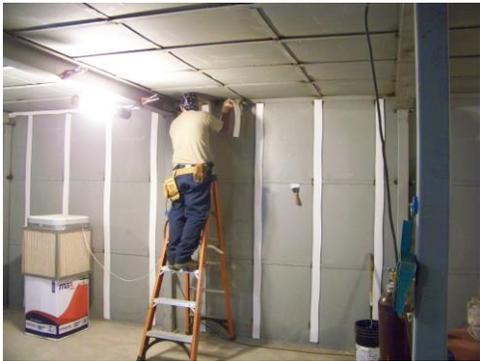
Photo showing workman applying strips of the insulation over the seams in the panels as an added safety measure against heat ingress.

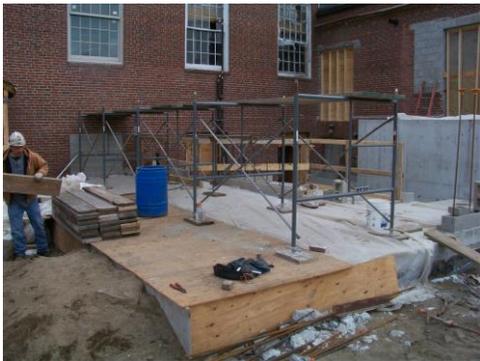
Photo showing the start of the staging installation.

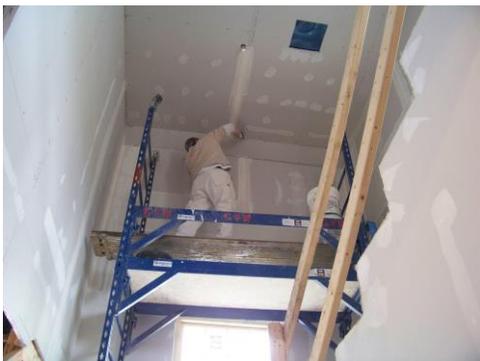
Photo showing stairwell #2 being taped and mudded.

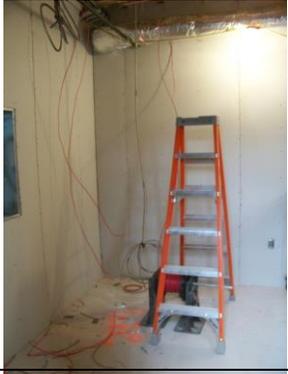
Photo showing fire alarm wiring being installed on the 1st floor.

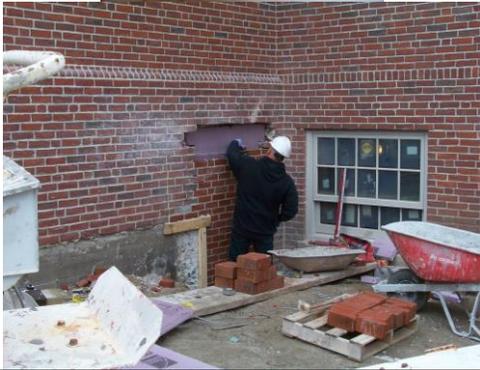
Photo showing mason bricking in the doorway at the basement level.
