# PROJECT REPRESENTATIVE'S DAILY REPORT

Pg. 1  
 Report No. 233  
 Date: 2015-07-23  
 Day: Thursday

Project: Renovation and Addition to Tewksbury Town Hall

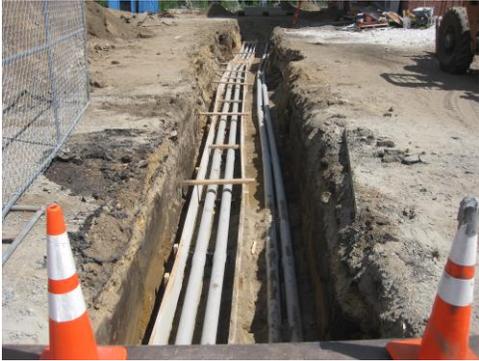
Photo showing conduits inside the formwork for the duct bank.

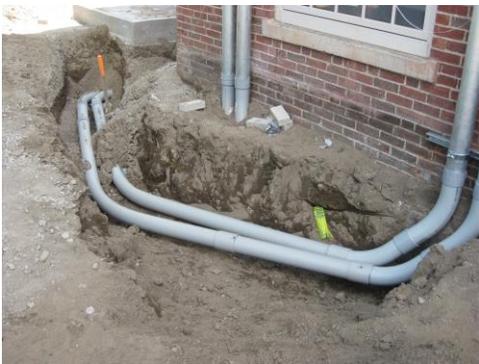
Photo showing conduits installed for the generator.

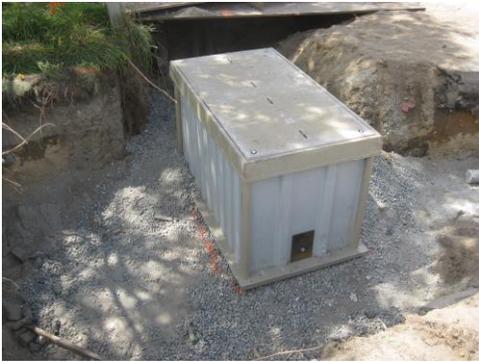
Photo showing handhold in place and ready for conduits to be installed.

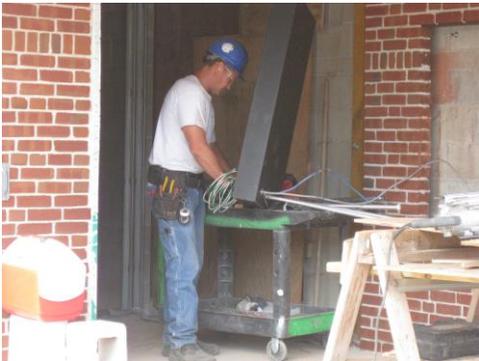
Photo showing electrician working on the FACP.

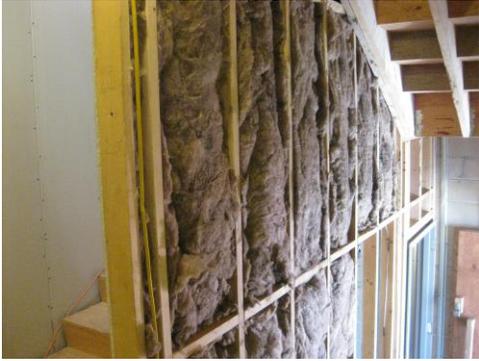
Photo showing acoustic insulation installed in the stairwell in the addition.

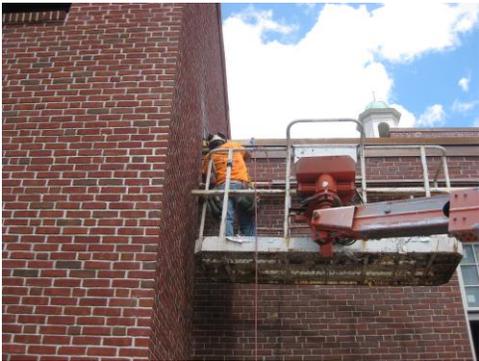
Photo showing carpenter installing wood blocking for the copper water table.

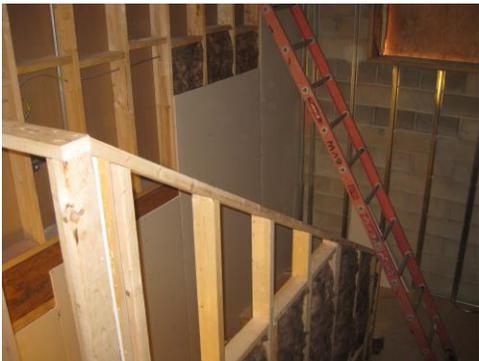
Photo showing progression of sheetrock installation in the stairwell of the addition.

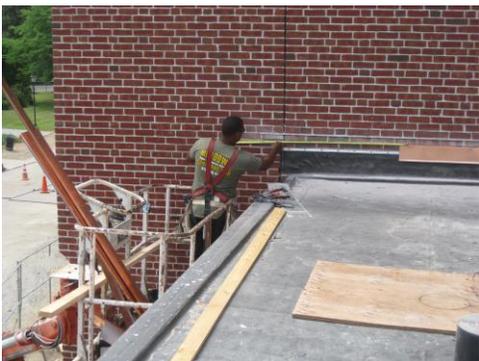
Photo showing roofer installing copper flashing along the east wall of the low roof.

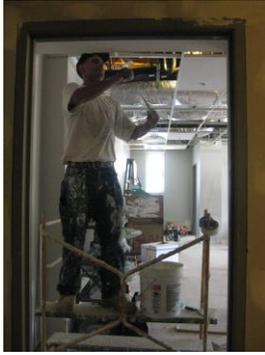
Photo showing workman mudding joints in the addition.

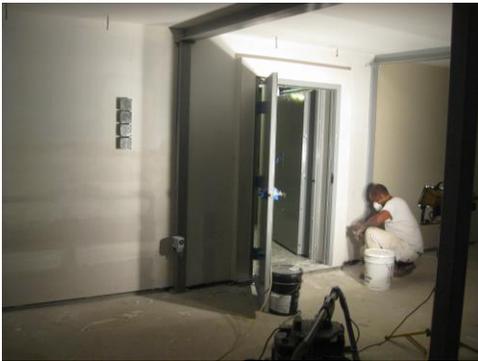
Photo showing painter working in the basement vault.

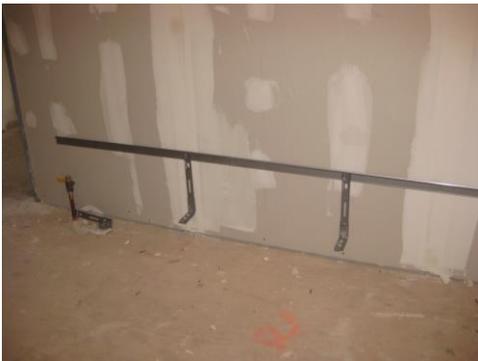
Photo showing radiator brackets installed in the addition, ready for the radiators.

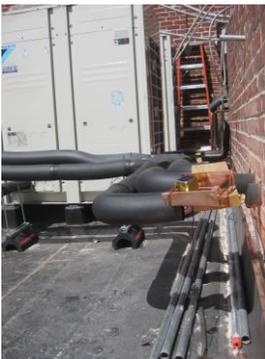
Photo showing piping insulation for the RTUs.

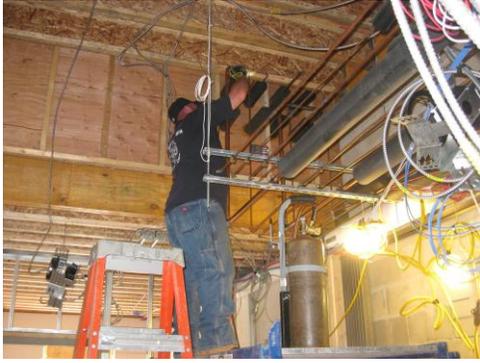
Photo showing HVAC technician working on the piping for the RTUs on the addition.
