# PROJECT REPRESENTATIVE'S DAILY REPORT

Pg. 1  
Report No. 71  
Date: 2014-11-28  
Day: Friday

**Project:** Renovation and Addition to Tewksbury Town Hall

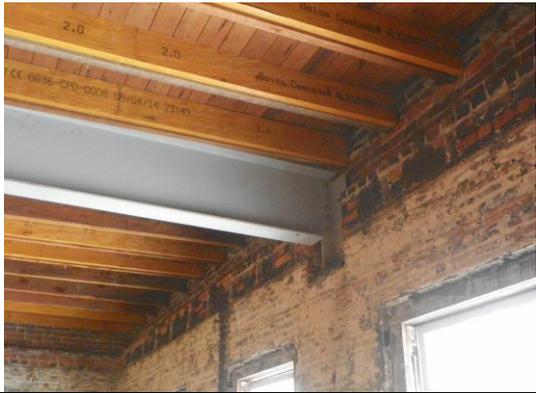
<p>Steel beams have been installed at the low roof areas and new LVLs are being installed.</p>

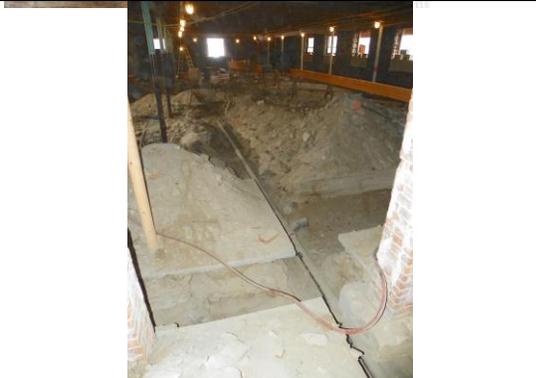
<p>Pipe trenches have been excavated in the basement.</p>

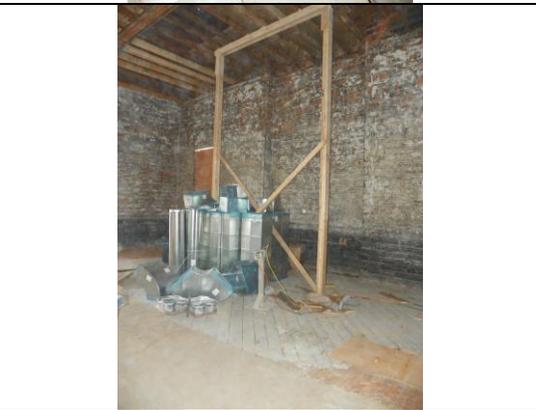
<p>Duct work has been stock piled on site in the main hall. HVAC contractor will be on site next week to begin the installation.</p>

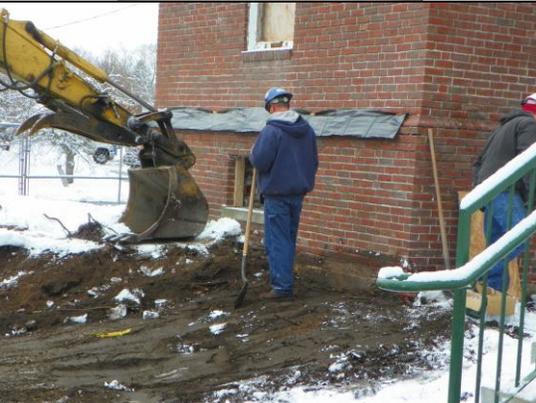
<p>Site excavation is ongoing at the front of the building. Note the black plastic that has been installed above the brick water table to protect the mortar joints that were previously cut.</p>
