Committee: Tewksbury North and Trahan School Reuse Committee

North Street Elementary School Map 62 Lot 11 Wetland Resource Area Evaluation

**North and Trahan Schools
133 North Street and 12 Salem Road
Tewksbury, MA**

MEPFP Evaluation

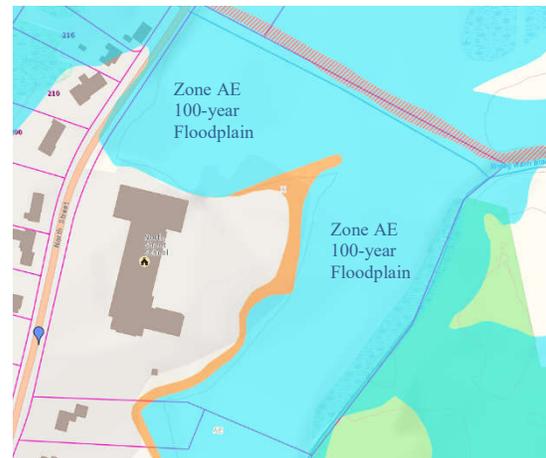
According to the most current Federal Emergency Management Agency (FEMA) Flood Insurance Rate Map (FIRM) for the area, a portion of the site is located within the 100-year floodplain which means it is a Wetland Resource Area in the Wetlands Protection Act (known as **Bordering Land Subject to Flooding**). The National Flood Hazard Layer FIRMette Map downloaded from the FEMA website is attached to this report.

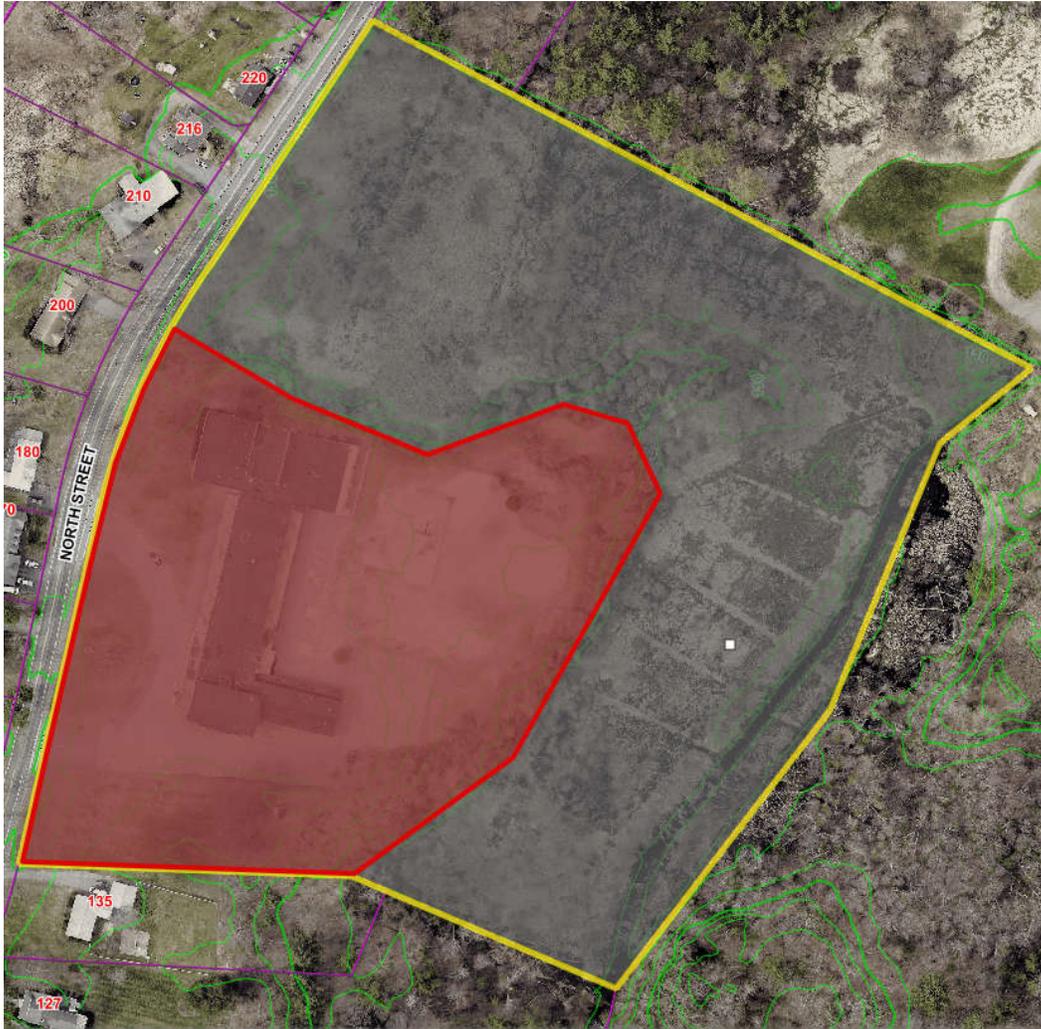
Based on the information above, I have estimated where the potential buildable area is on the site.

Total Parcel Area = 740,520 sf (outlined in yellow in the image above)
17 acres

Total Buildable Area = 295,379 sf (red area in the image above)
6.8 acres
40% of the parcel

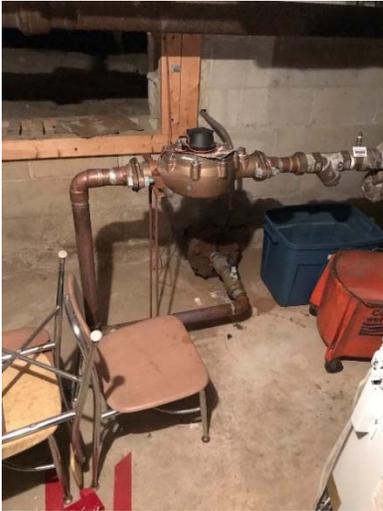
Water Meter

The building water service and water meter appears to be 2". Domestic hot water is generated through a gas fired hot water heater with storage. Domestic cold water and domestic hot water is distributed throughout the building with a piping system.

The existing plumbing systems appear to be more than 25 years old and should be replaced.

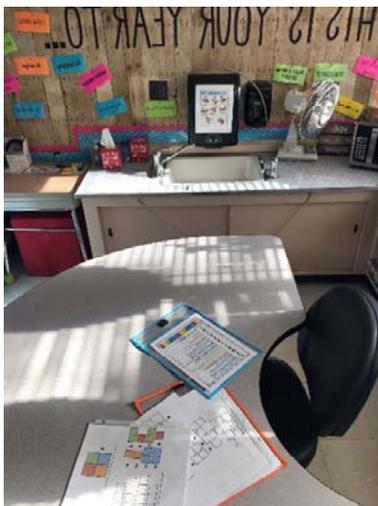
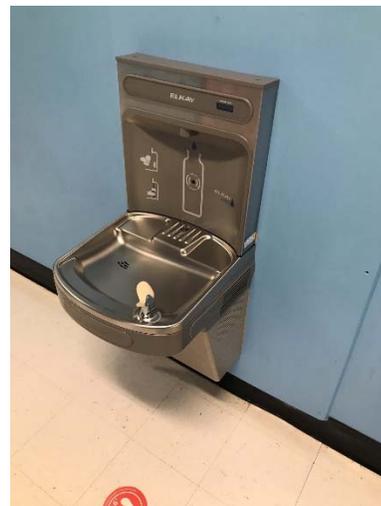
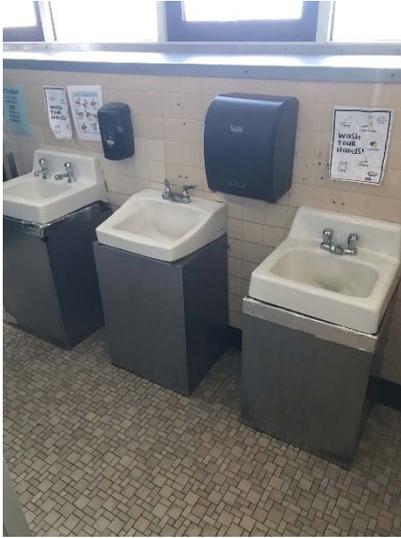
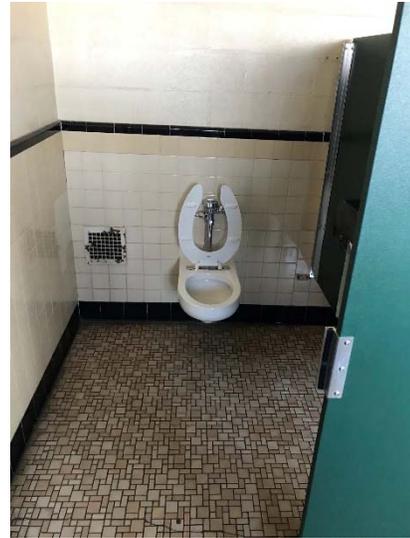
Plumbing fixtures throughout the building were various types and states of condition. Waste piping throughout the building is through gravity.

Typical Classroom Sink

Water Bubbler

Typical Fixtures

Lab Sink

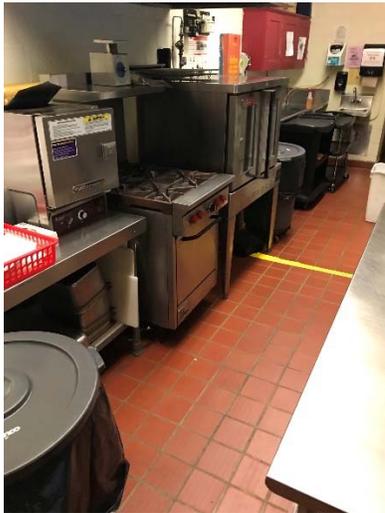
Natural Gas Pipe to Kitchen Appliances

Natural gas is utilized within the school for hot water heating and kitchen cooking appliances. The gas piping was steel pipe with threaded fittings. It was noted that the gas line under the hood did not appear to have the latest CO interlock safety devices.

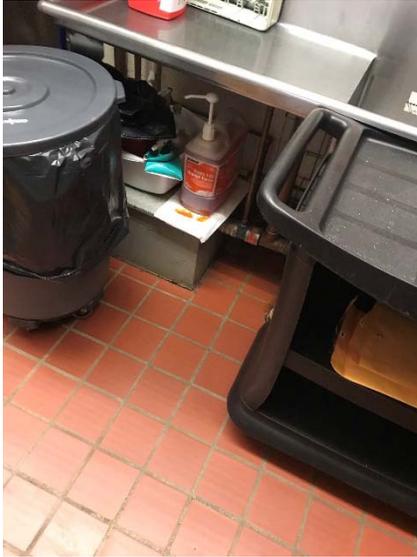
Grease Interceptor

Kitchen grease interceptor is located within the kitchen below the kitchen pot sink.

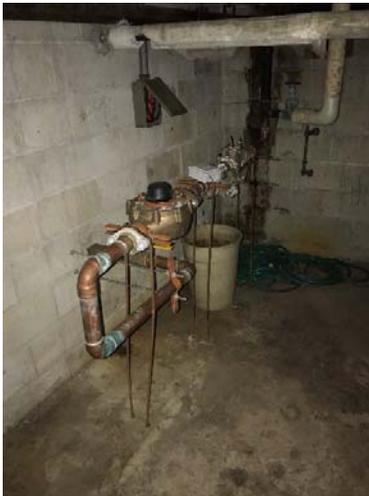
Water Meter

The building water service and water meter appears to be 2". Domestic hot water is generated through a gas fired hot water heater with storage. Domestic cold water and domestic hot water is distributed throughout the building with a piping system.

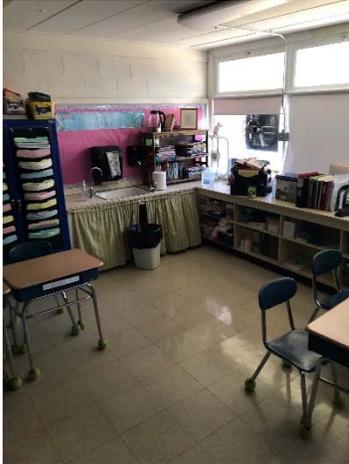
Typical Classroom Sink

Plumbing fixtures throughout the building were various types and states of condition. Waste piping throughout the building is through gravity.

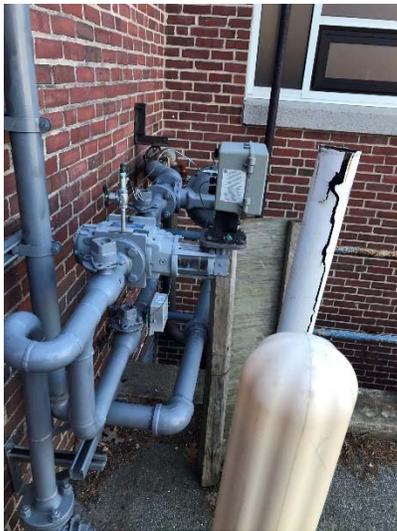
Gas Meter

Natural gas is utilized within the school for hot water heating and kitchen cooking appliances. The gas piping was steel pipe with threaded fittings. It was noted that the gas line under the hood did not appear to have the latest CO interlock safety devices.

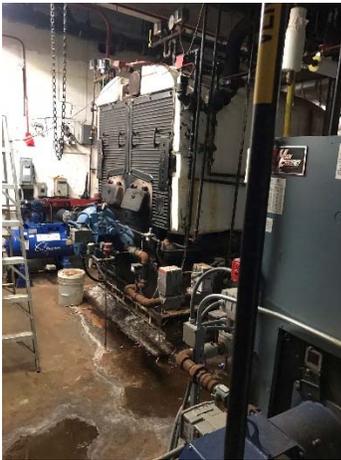
***Steam Boiler #1***

The building is heated with (2) steam water boilers (Smith Boiler) with a heating capacity of 3,978 MBH each. The boilers operating efficiency is approximately 80%. Each boiler has been provided with natural gas fired burners. The boilers and condensate transfer system appears more than 25 years old.

Hot water boiler, pumps, water specialties, controls, unit ventilators, cabinet unit heaters, roof top units, air handling units and exhaust fans are more than 25 years old and at the end of their useful life expectancy and should be replaced.

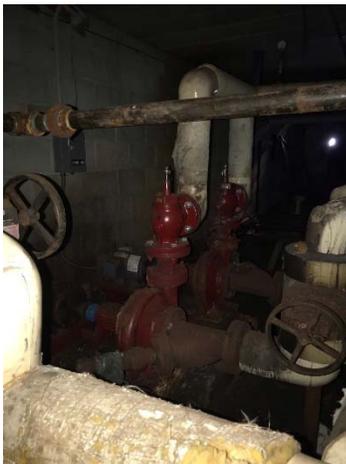
***Typical Hot Water Pumps***

Steam is distributed throughout the building with a steam supply distribution piping and condensate return piping systems. Heating is also provided through hot water heating system through a hot water heat exchanger. Hot water supply and return piping distribution system and hot water system specialties including air separator and expansion tanks. Water is pumped through the piping systems with (2) base mounted pumps. The pumps, water specialties and piping appear to be more than 25 years old.

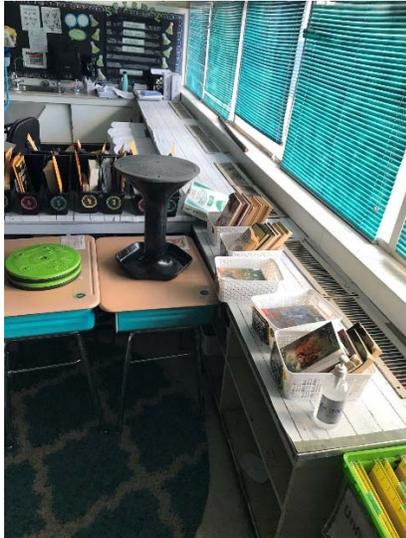
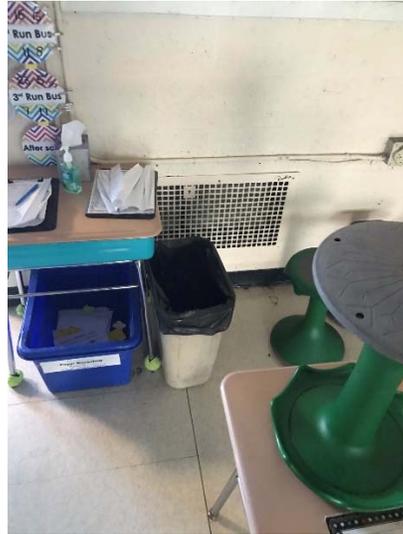
The original building classrooms are heated with finned tube radiation. Ventilation air is provided through a central ventilation system that consists of air handling unit, heating coil, plenum distribution and air outlets. Exhaust air is provided through roof mounted exhaust fans, exhaust ductwork and exhaust registers. The heating systems, ventilation systems and exhaust systems appear to be more than 25 years old.

Typical Finned Tube Radiation

Typical Supply Register

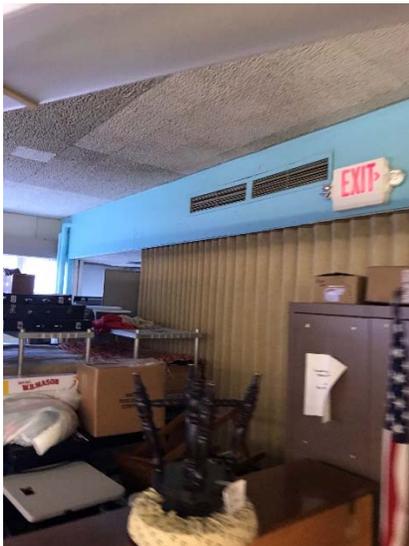
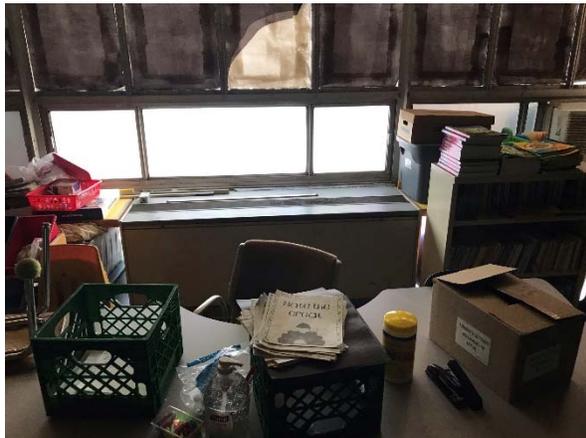
The classrooms that were added (Greenhouse Area) are heated and ventilated with unit ventilators with hot water heating coils. Exhaust air is provided through roof mounted exhaust fans, exhaust ductwork and exhaust registers. The unit ventilators system and exhaust fans appear to be more than 25 years old.

Unit Ventilator – Supply Register

Typical Unit Ventilator – Greenhouse Addition

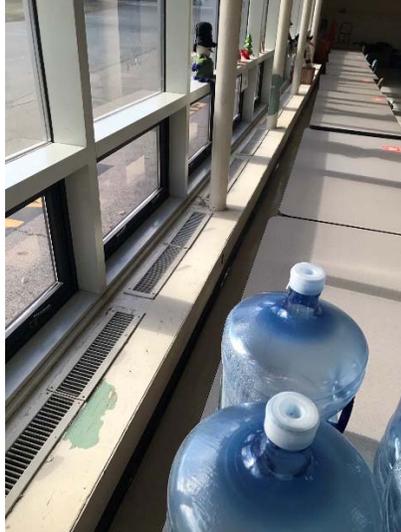
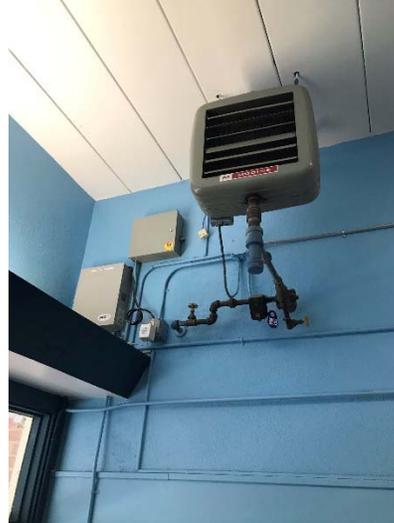
Common space and office areas are heated with finned tube radiation and unit heaters. Each heater is controlled with a pneumatic hot water control valve and space thermostat. Ventilation air is provided through operable windows. The finned tube radiation and unit heater systems appear to be more than 25 years old.

Typical Finned Tube Radiation

Unit Ventilator

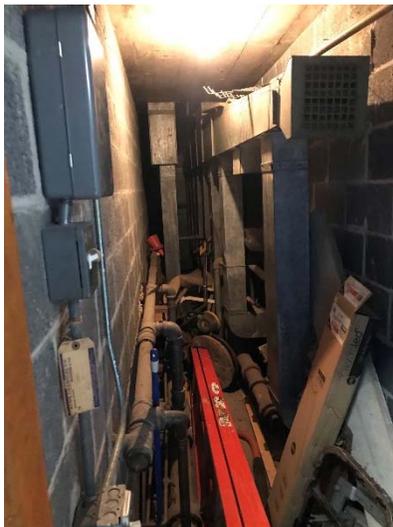
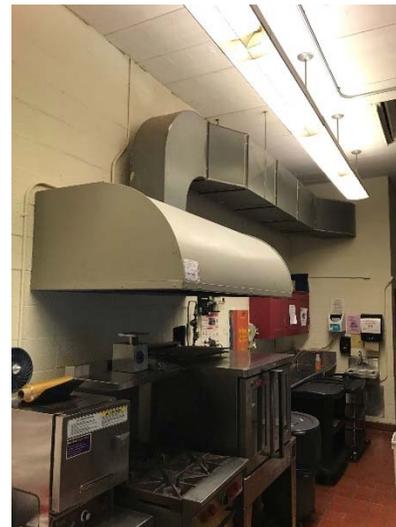
Bathroom and locker room exhaust is through roof mounted exhaust fans. Exhaust ductwork extends from the roof fan and extends to each bathroom and locker rooms and terminates with an exhaust register. Kitchen hood exhaust is through a roof mounted up-blast exhaust fan. Hood exhaust ductwork extends from the fan and extends down to hood.

Typical Exhaust Fan

Kitchen Exhaust

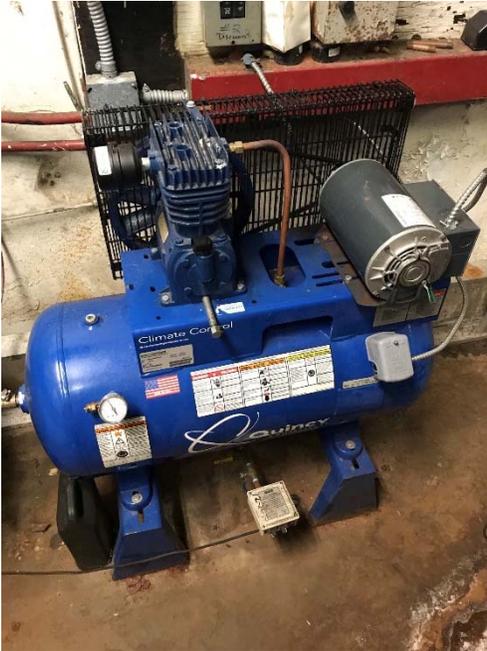
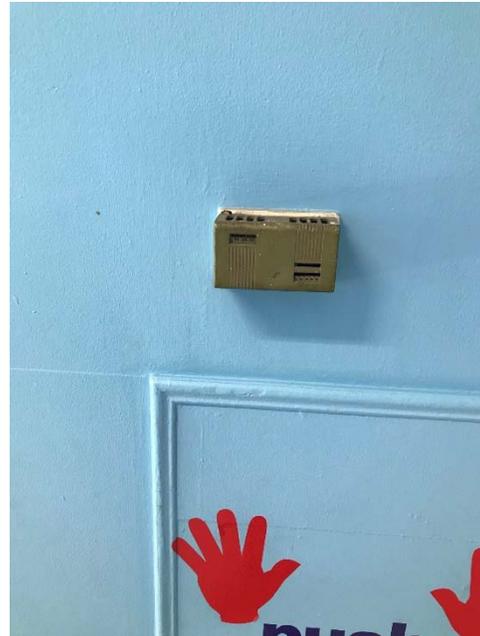
The building controls are pneumatic with the air compressor located within the mechanical room. Pneumatic tubing extends from the mechanical room to controllers throughout the building.

Air Compressor

Typical Wall Thermostat

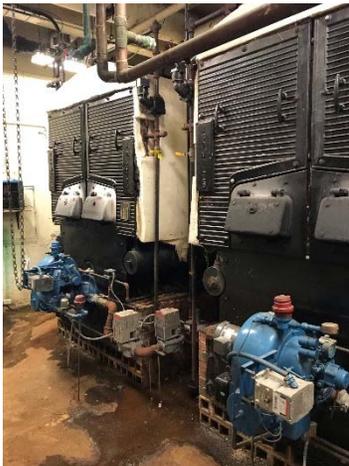
Steam Boiler #1

The building is heated with (2) steam water boilers (Smith Boiler) with a heating capacity of 3,978 MBH each. The boilers operating efficiency is approximately 80%. Each boiler has been provided with natural gas fired burners. The boilers and condensate transfer system appears more than 25 years old.

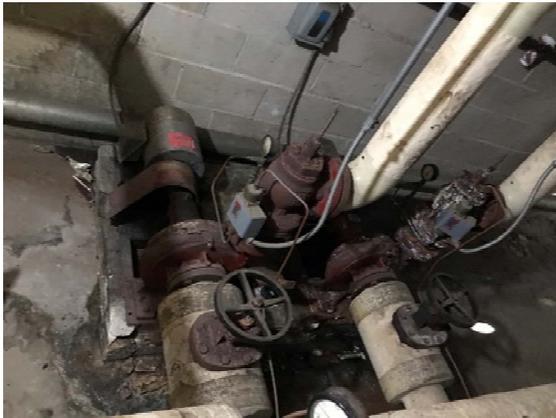
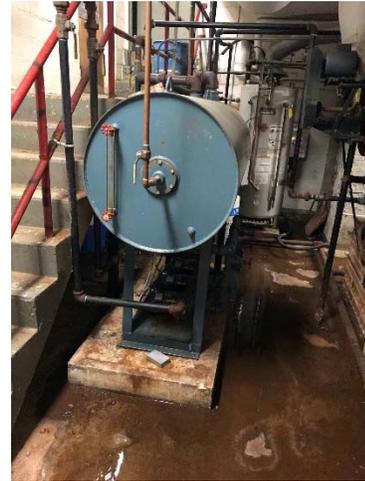
Steam is distributed throughout the building with a steam supply distribution piping and condensate return piping systems. Heating is also provided though hot water heating system through a hot water heat exchanger. Hot water supply and return piping distribution system and hot water system specialties including air separator and expansion

tanks. Water is pumped through the piping systems with (2) base mounted pumps. The pumps, water specialties and piping appear to be more than 25 years old.

Typical Hot Water Pumps

Boiler Feed

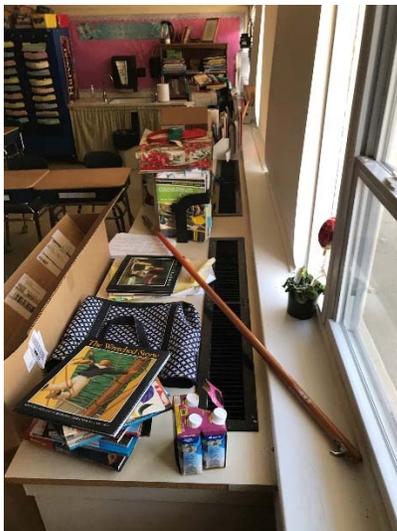
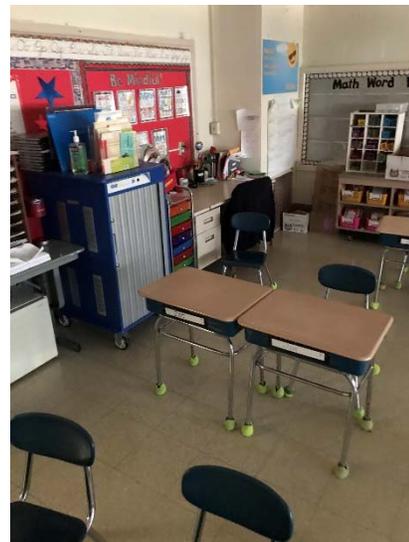
The original building classrooms are heated with finned tube radiation. Ventilation air is provided through a central ventilation system that consists of air handling unit, heating coil, plenum distribution and air outlets. Exhaust air is provided through roof mounted exhaust fans, exhaust ductwork and exhaust registers. The heating systems, ventilation systems and exhaust systems appear to be more than 25 years old.

Typical Finned Tube Radiation

Typical Supply Register

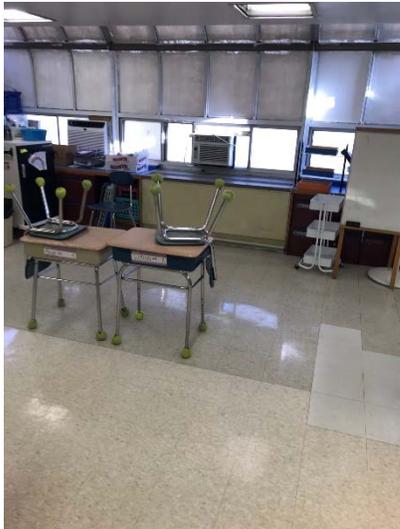
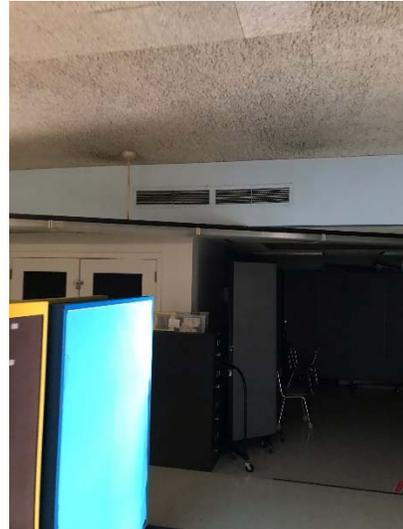
The classrooms that were added (Greenhouse Area) are heated and ventilated with unit ventilators with hot water heating coils. Exhaust air is provided through roof mounted exhaust fans, exhaust ductwork and exhaust registers. The unit ventilators system and exhaust fans appear to be more than 25 years old.

Unit Ventilator – Supply Register

Typical Unit Ventilator – Greenhouse Addition

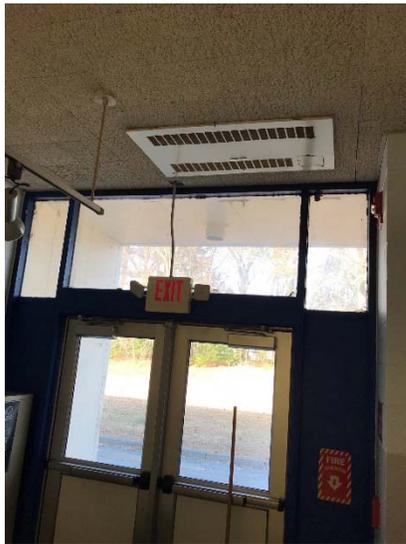
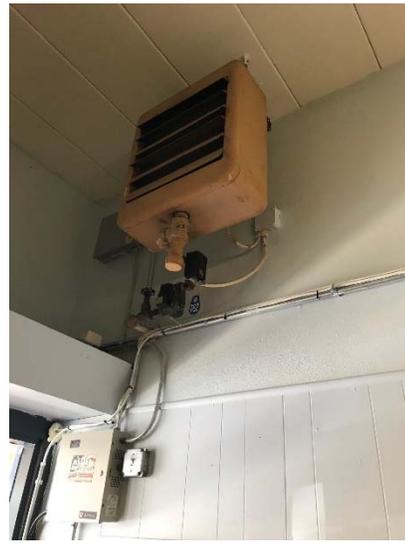
Common space and office areas are heated with finned tube radiation and unit heaters. Each heater is controlled with a pneumatic hot water control valve and space thermostat. Ventilation air is provided through operable windows. The finned tube radiation and unit heater systems appear to be more than 25 years old.

Cabinet Unit Heater

Unit Heater

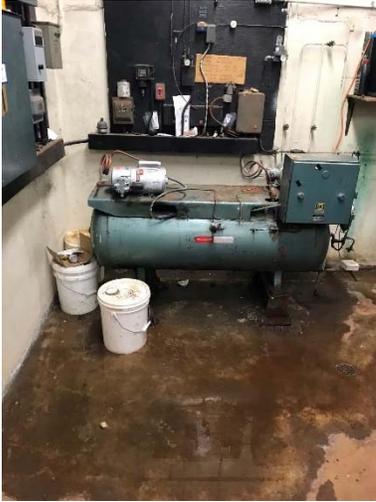
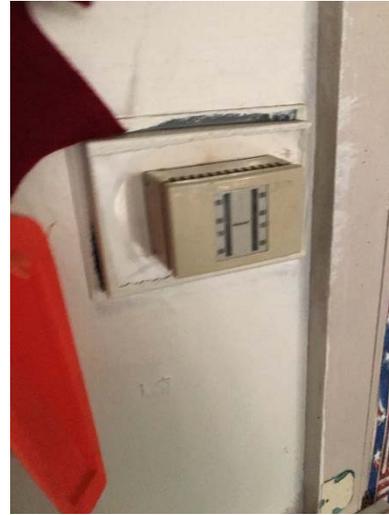
The building controls are pneumatic with the air compressor located within the mechanical room. Pneumatic tubing extends from the mechanical room to controllers throughout the building.

Air Compressor

Typical Wall Thermostat

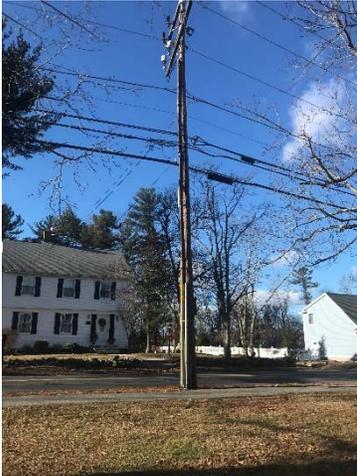
NGRID Pirmary Pole

The building’s service originates from a utility pole on North Street; primary conductors and conduit run underground to (3) 25 KVA below-grade submersible-type can transformers. The service size is 400 amps at 120/208 volt 3-phase 4-wire. The secondary service conductors terminate in a 400 amp disconnect. The switchboard is rated 400 amps, 208 volt 3-phase and is from the original construction (ca. 1952). The switchboard is located in the building’s main electric room at the basement level.

The existing service and electrical panels are well past their useful lives and would be inadequately sized for any repurposing of the building. The existing transformer vault would not meet the utilities' requirements and could not be reused. A new primary underground service conduit(s) and a new padmount transformer would be required for a new service to the building. All of the existing electrical infrastructure should be removed/demolished.

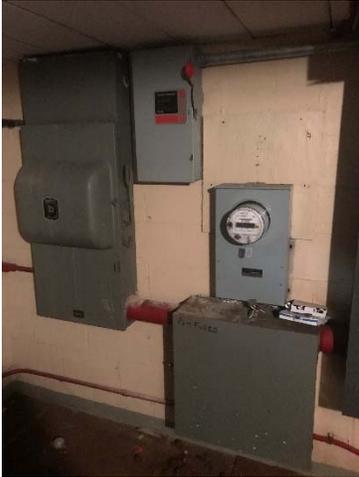
400 AMP Disconnect and Meter

The switchgear was manufactured by Square D. The gear consists of a distribution section, which contains draw-out fusible switches. The gear is well past the expected useful life for switchgear by 18 years or more. The switches in the switchboard feed other panels throughout the school. The other panels in the school were also manufactured by Square D and are from the original construction. A few other load centers were added over the years due to new loads being required. The original panels have also exceeded their expected lifespans.

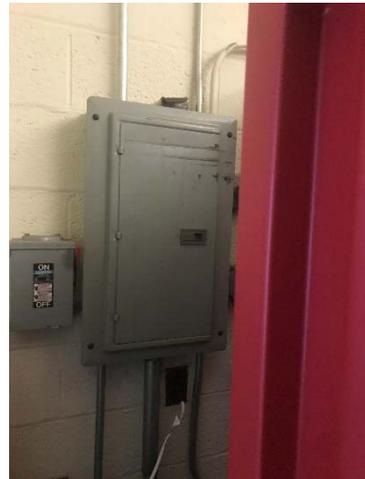
(3) 25 KVA Transformers

Switchboard

400 AMP Main Switchboard

Load Center

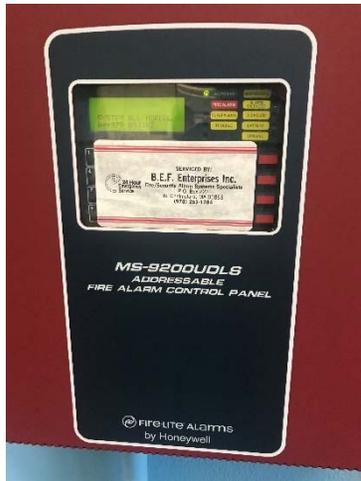
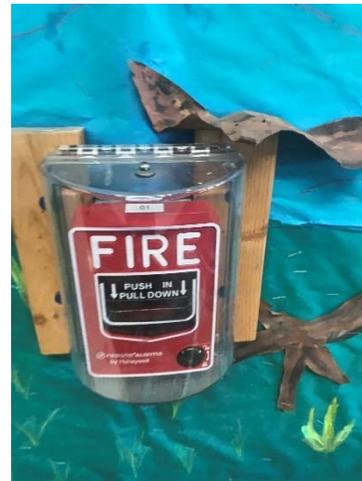
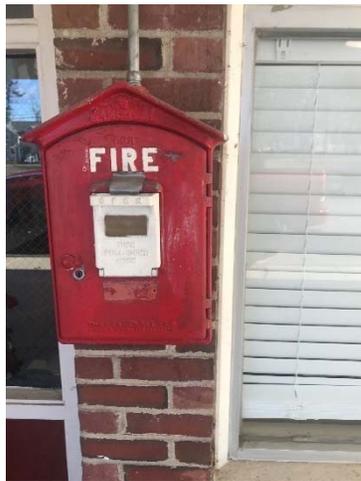
The building has a complete fire alarm system which was installed approximately 4 years ago. The system consists of an addressable Fire-Lite MS-9200 UDLS control panel, manual addressable pull stations at exit doors, an interior digital Masterbox connected to the city's fire department; horn/strobe devices in common public spaces. There was minimal smoke ore heat detector coverage. There were no horn/strobe devices in the classrooms. The building is not sprinklered, therefore there is no tamper and flow switch connections to the control panel.

The system appears to be in good working condition and has approximately 16 years of remaining expected life.

Main FACP

Manual Pull Station

Non-Functioning Masterbox

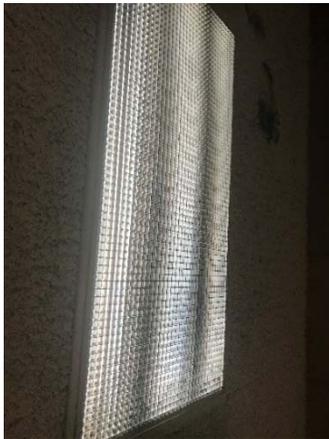
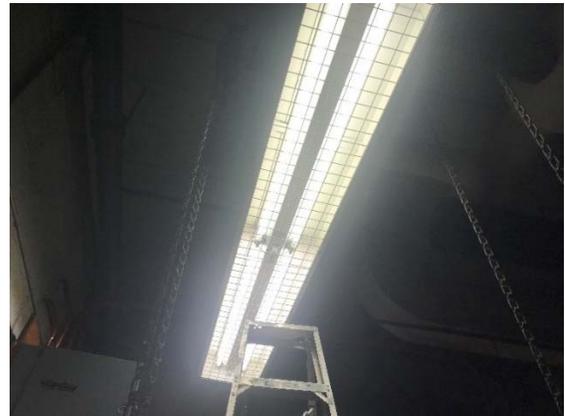
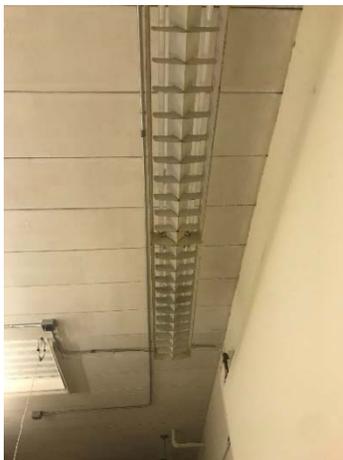
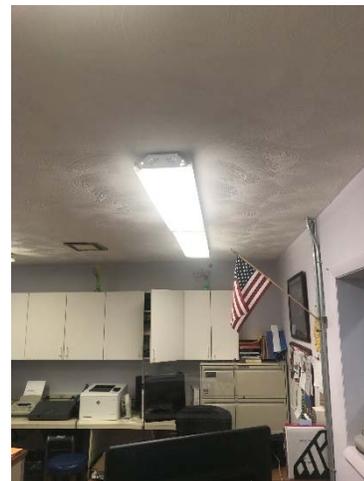
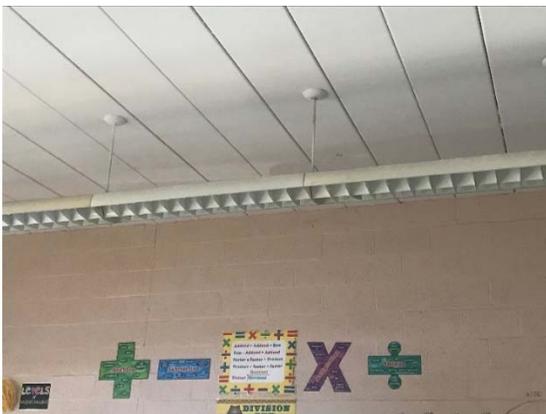
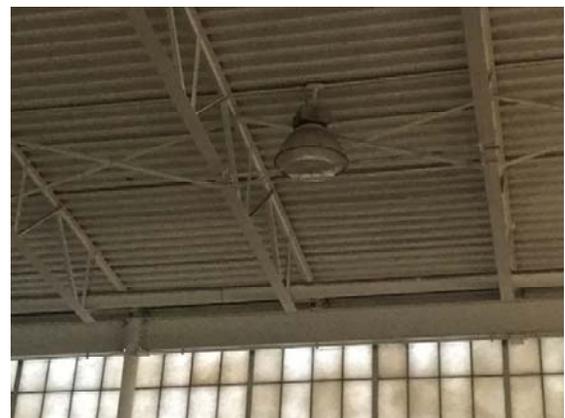
The building's lighting is mostly inefficient fluorescent-lamped fixtures. Fixture types include 2'x4' paracube surface-mounted, 8' 2-lamp T12 industrials, incandescent sockets, 8' 2-lamp suspended classroom fixtures, 4' surface wraparounds, fluorescent high-bay gym fixtures.

The fixtures are all inefficient, at or past their expected useful lives, lenses are discolored from age. None of the fixtures would be worth salvaging.

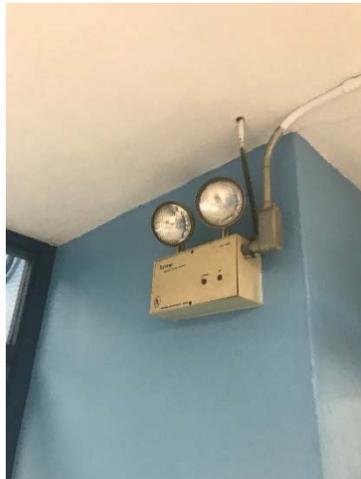
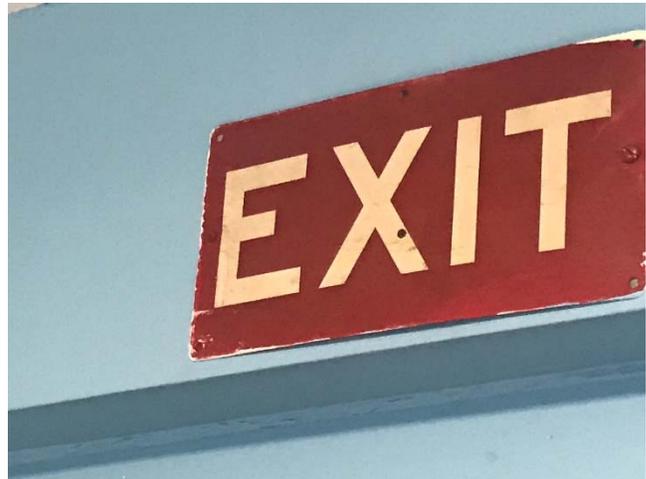
The building's emergency lighting consists of remote emergency heads, non-illuminated (Code Violation), illuminated exit signs. The emergency lighting equipment is all dated and approaching the end of their expected useful life.

Remote Emergency Heads

Non-Illuminated Exit Sign

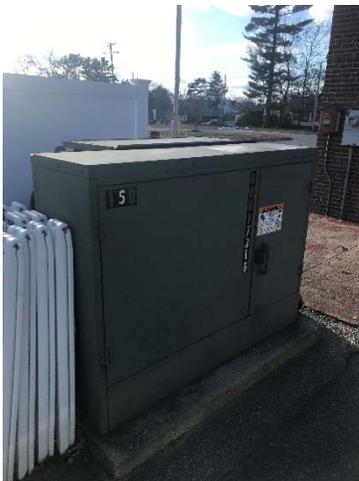
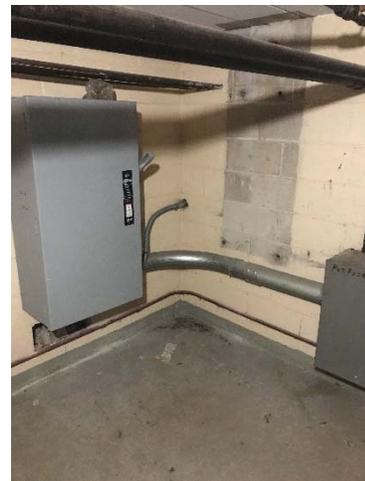
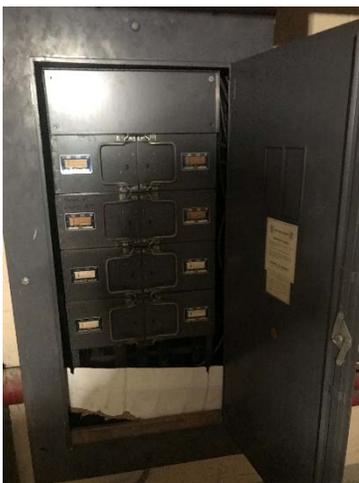
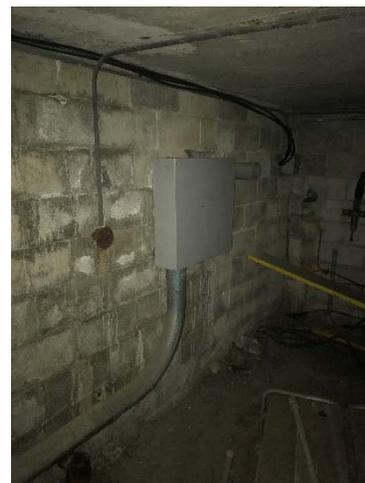
The building’s service originates from a utility pad-mounted transformer (150KVA). The service size is 400 amps at 120/208 volt 3-phase 4-wire. The secondary service conductors terminate in a 400 amp disconnect. The switchboard is rated 400 amps, 208 volt 3-phase and is from the original construction (ca. 1952). The switchboard is located in the building’s main electric room at the basement level.

The switchgear was manufactured by Square D. The gear consists of a distribution section, which contains draw-out fusible switches. The gear is well past the expected useful life for switchgear by 18 years or more. The switches in the switchboard feed other panels throughout the school. The other panels in the school were also manufactured by Square D and are from the original construction. A few other load centers were added over the years due to new loads being required. The original panels have also exceeded their expected lifespans.

Trahan School Transformer

400 Amp Main Building Disconnect

Main Switchboard

4" 400 Amp Incoming Service

The existing service and electrical panels are well past their useful lives and would be inadequately sized for any repurposing of the building. The existing transformer vault would not meet the utilities' requirements and could not be reused. A new primary underground service conduit(s) and a new padmount transformer would be required for a new service to the building. All of the existing electrical infrastructure should be removed/demolished.

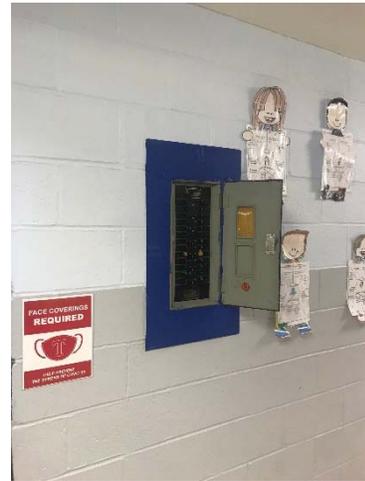
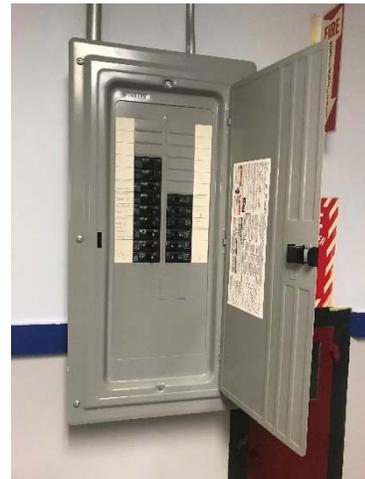
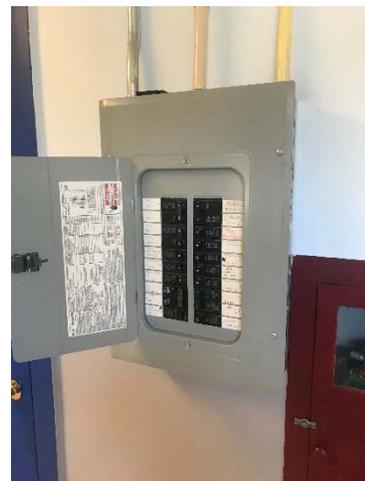
Original Panel

Newer Panelbaord

Newer Loadcenter

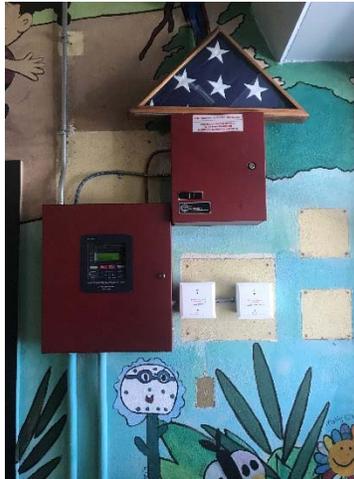
Fire Alarm Control Panel

The building has a complete fire alarm system which was installed approximately 4 years ago. The system consists of an addressable Fire-Lite MS-9200 UDLS control panel, manual addressable pull stations at exit doors, an interior digital Masterbox connected to the city's fire department; horn/strobe devices in common public spaces. There was minimal smoke or heat detector coverage. There were no horn/strobe devices in the classrooms. The building is not sprinklered, therefore there is no tamper and flow switch connections to the control panel.

The system appears to be in good working condition and has approximately 16 years of remaining expected life.

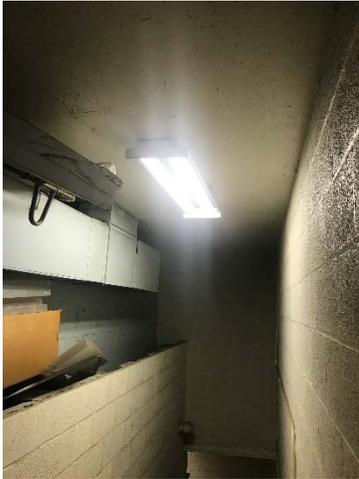
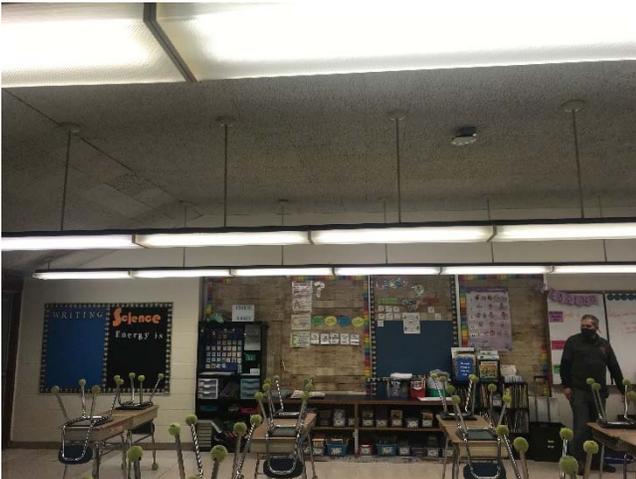
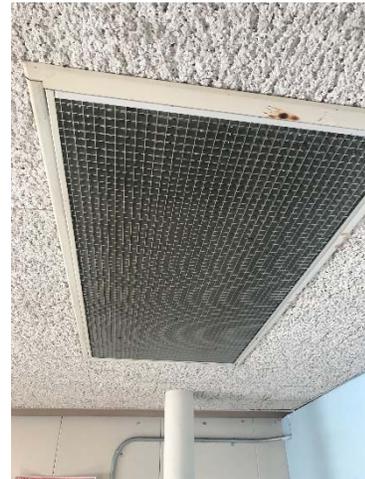
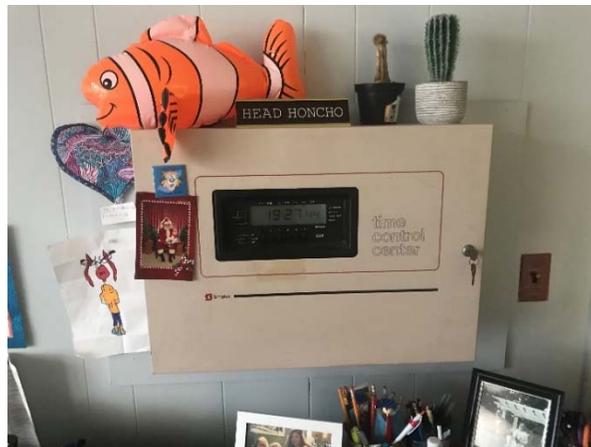
The building's lighting is mostly inefficient fluorescent-lamped fixtures. Fixture types include 2'x4' paracube surface-mounted, 8' 2-lamp T12 industrials, incandescent sockets, 8' 2-lamp suspended classroom fixtures, 4' surface wraparounds, fluorescent high-bay gym fixtures.

The fixtures are all inefficient, at or past their expected useful lives, lenses are discolored from age. None of the fixtures would be worth salvaging.

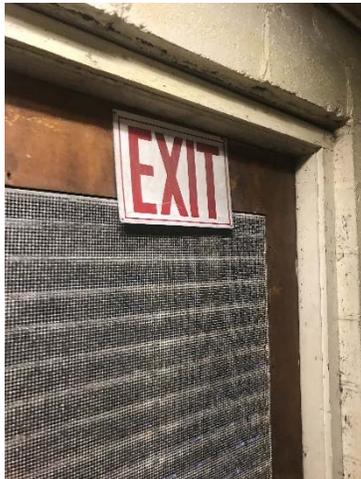
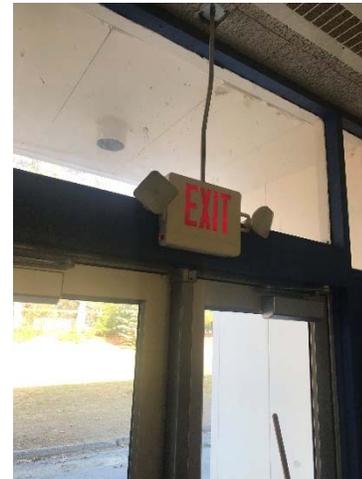
The building's emergency lighting consists of remote emergency heads, non-illuminated (Code Violation), illuminated exit signs. The emergency lighting equipment is all dated and approaching the end of their expected useful life.

Non-Illuminated Exit Sign

Exit/Emergency Fixture
